BUILDING DILAPIDATION REPORT

The following inspection has been carried out to check and report on the current structural condition of the property prior to construction commencing on the Northern Distributor freeway extension.

Sample Report

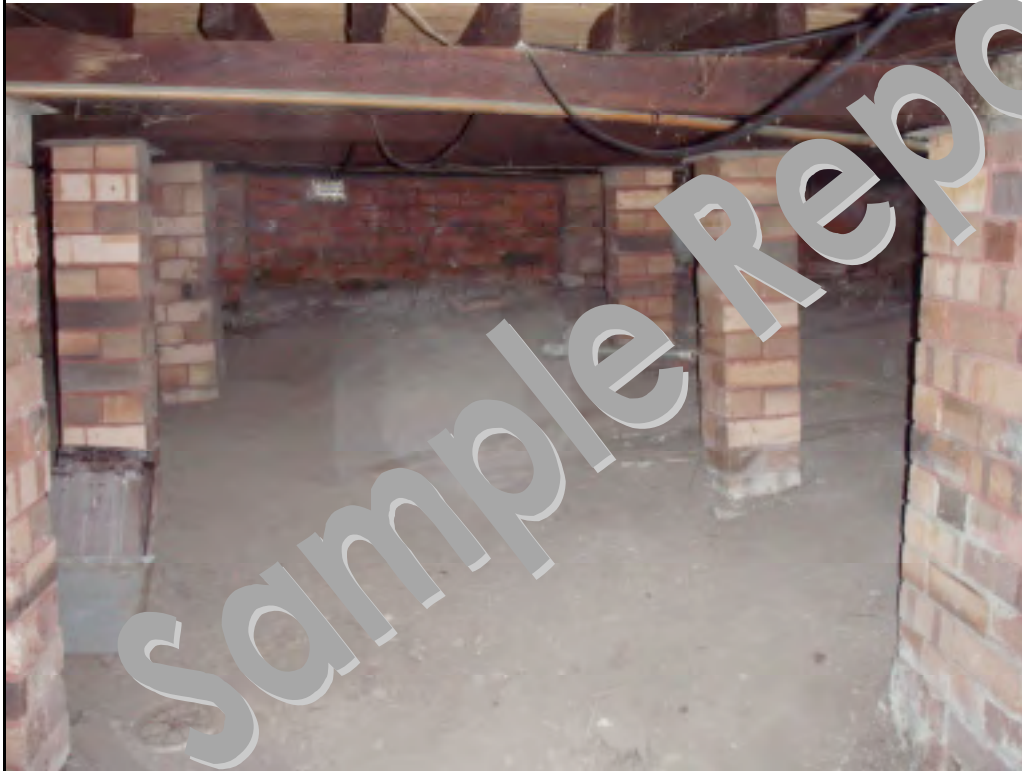
Most piers throughout the subfloor have subsided and have become unstable.

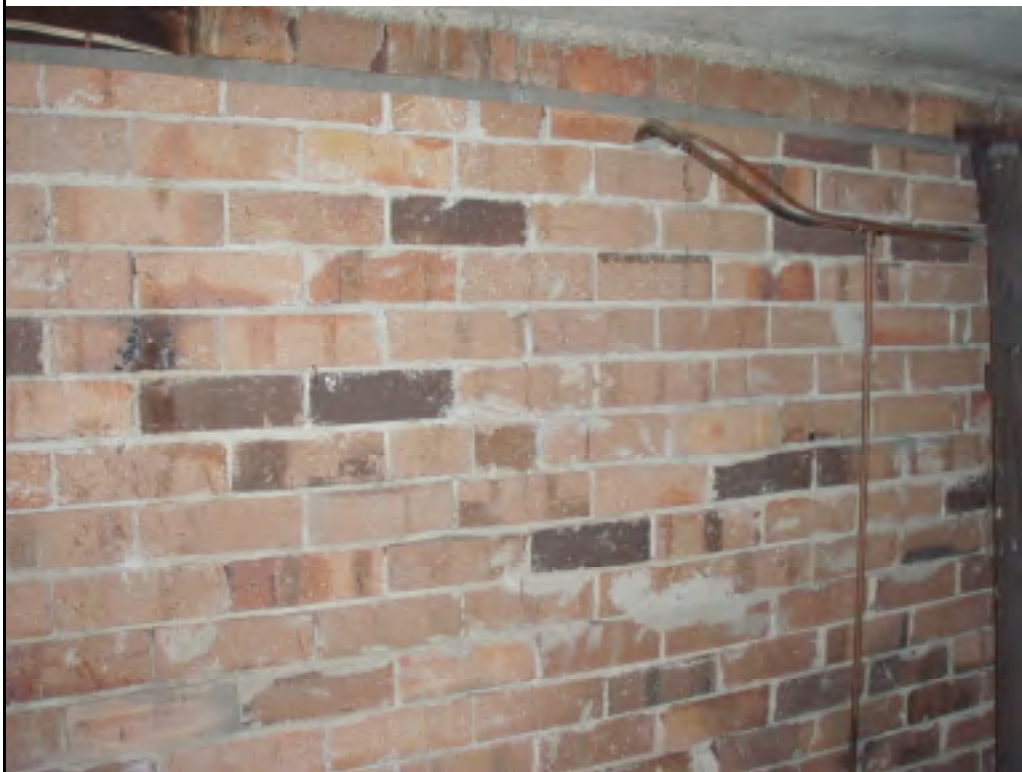
Large crack noted to the subfloor wall to the left side of the bathroom.

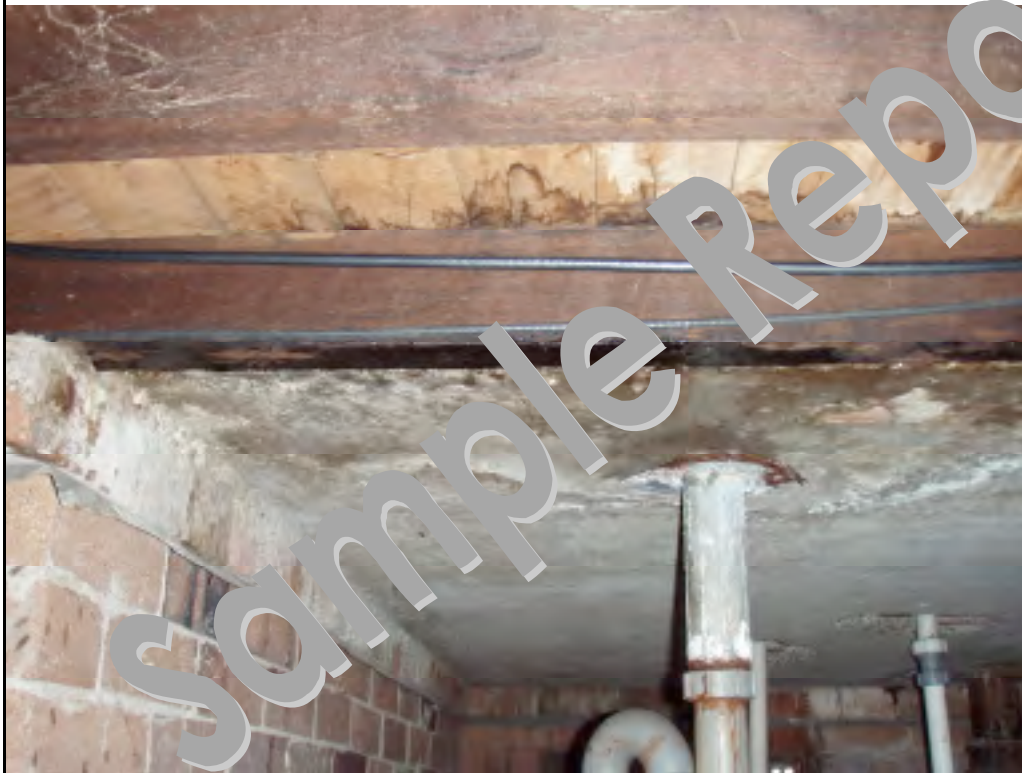
A shower leak was noted in the subfloor.

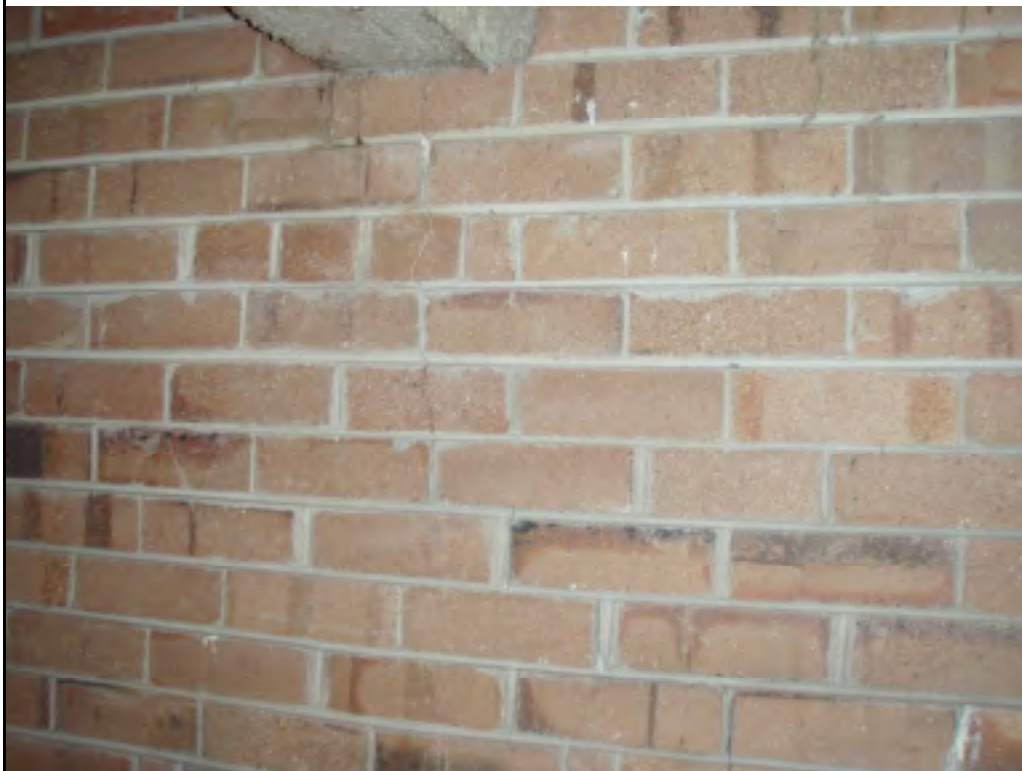
Crack in the garage wall below the beam to the right side.

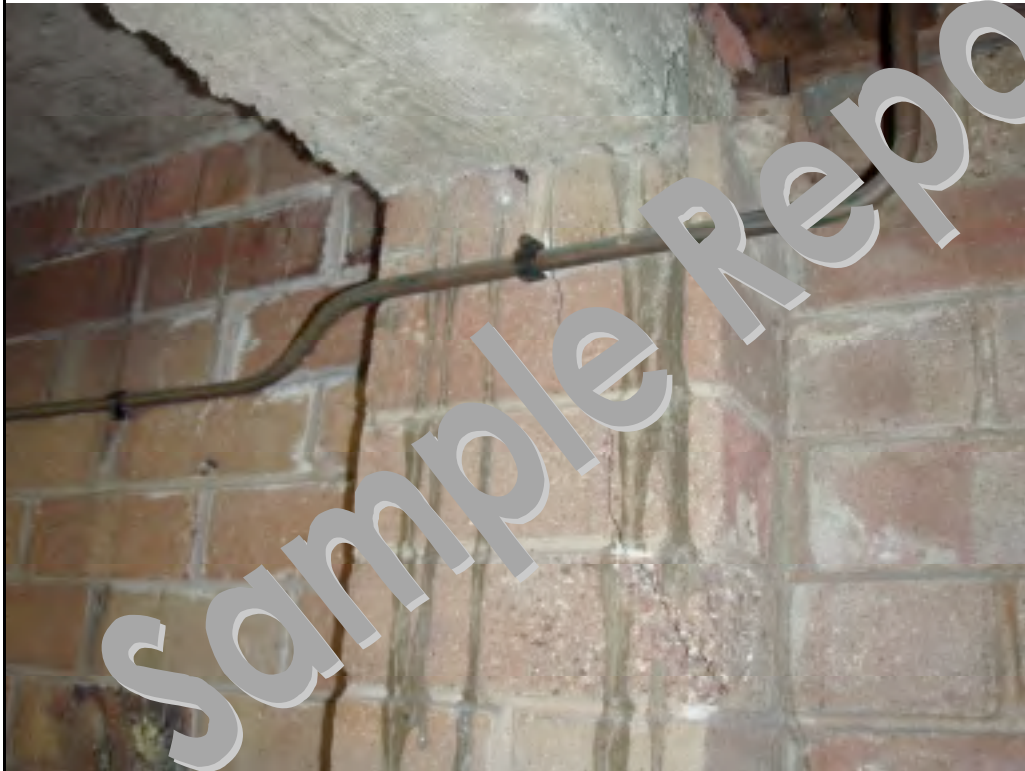
Crack in the garage wall below the beam to the left side.

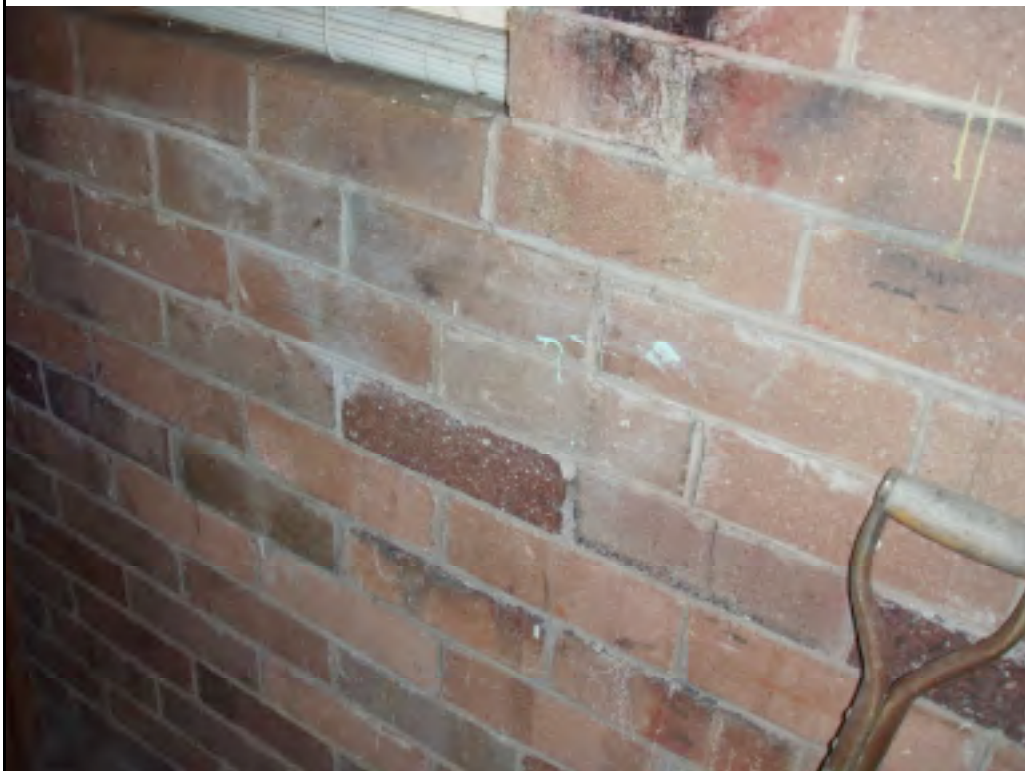
Crack below the garage window.

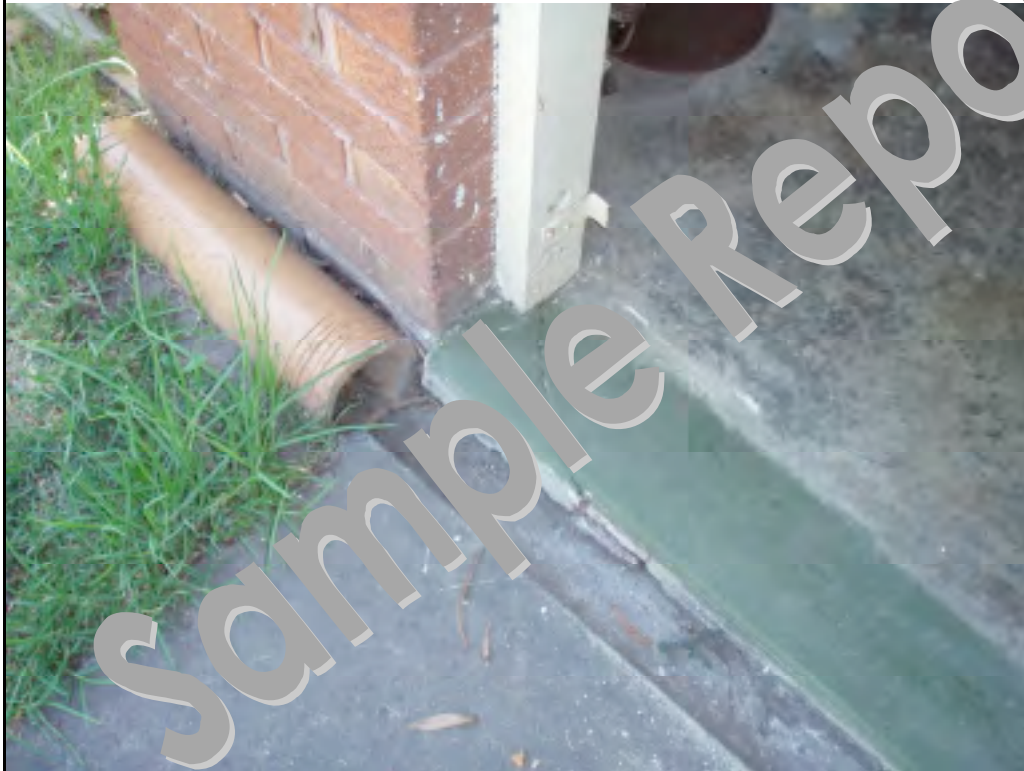
Crack to the slab at the left side of the garage.

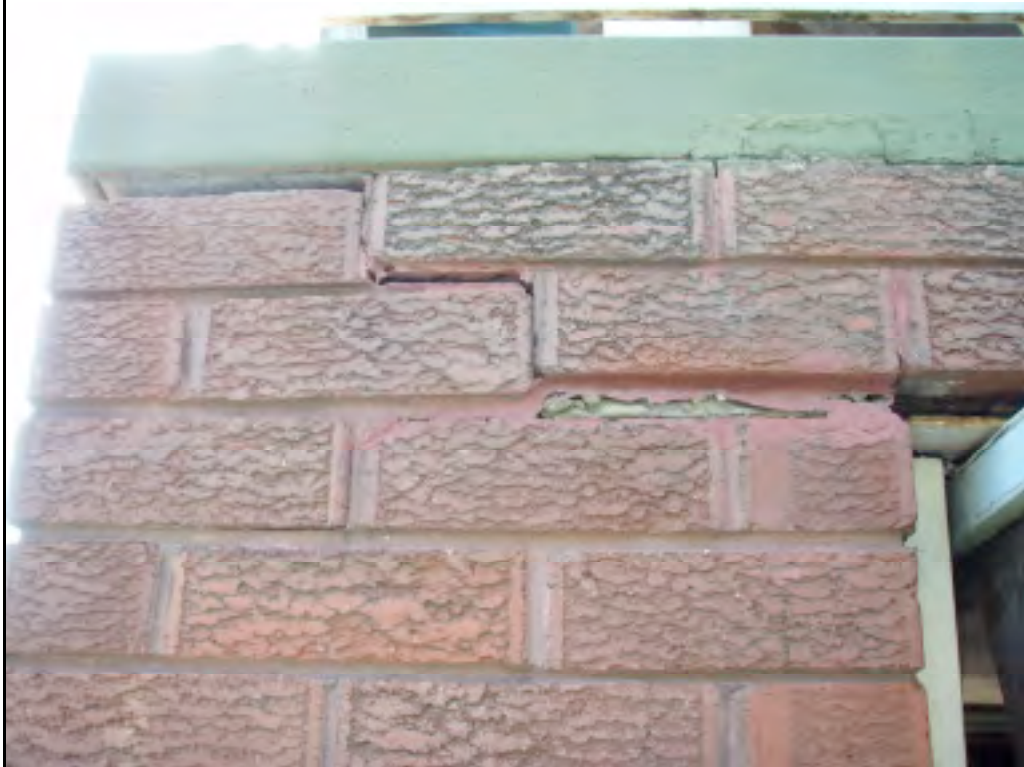
Crack above the garage door to the left side.

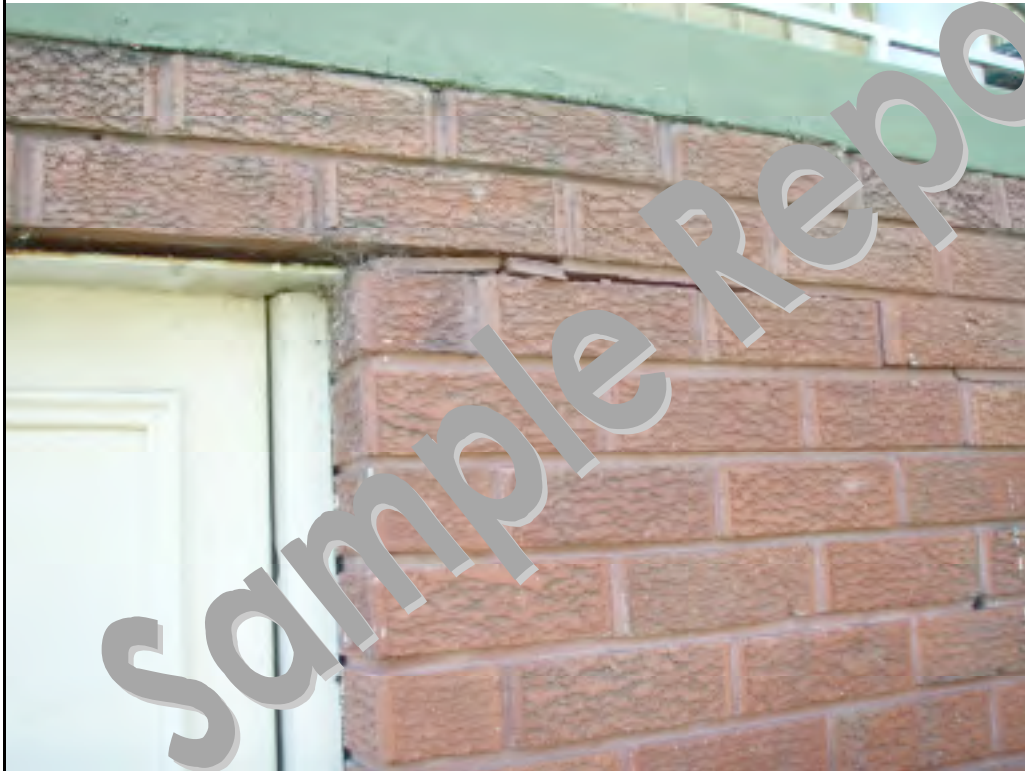
Crack above the garage door to the right side.

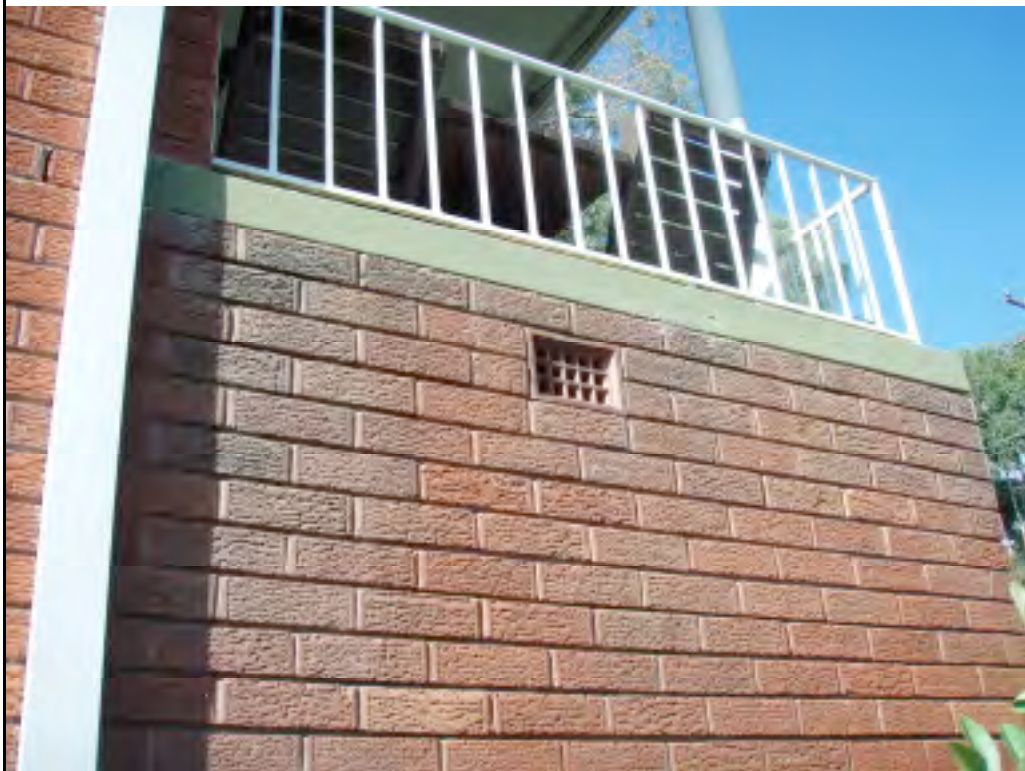
Cracks to the verandah slab edge on the left side.

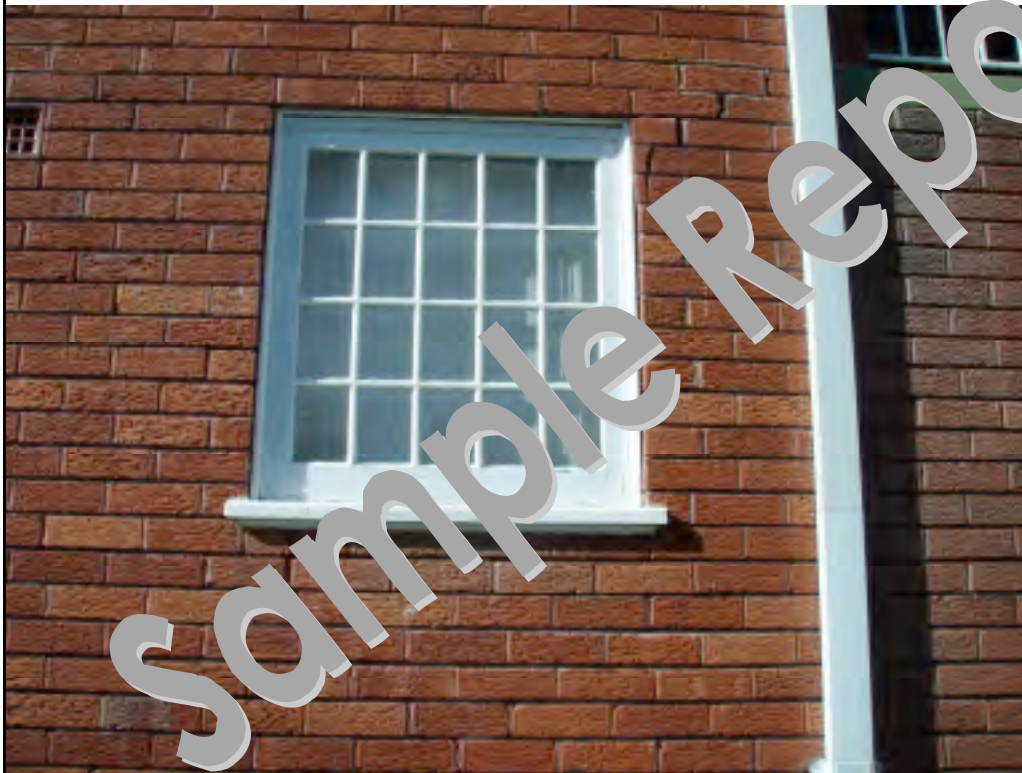
Cracks above and below the garage window.

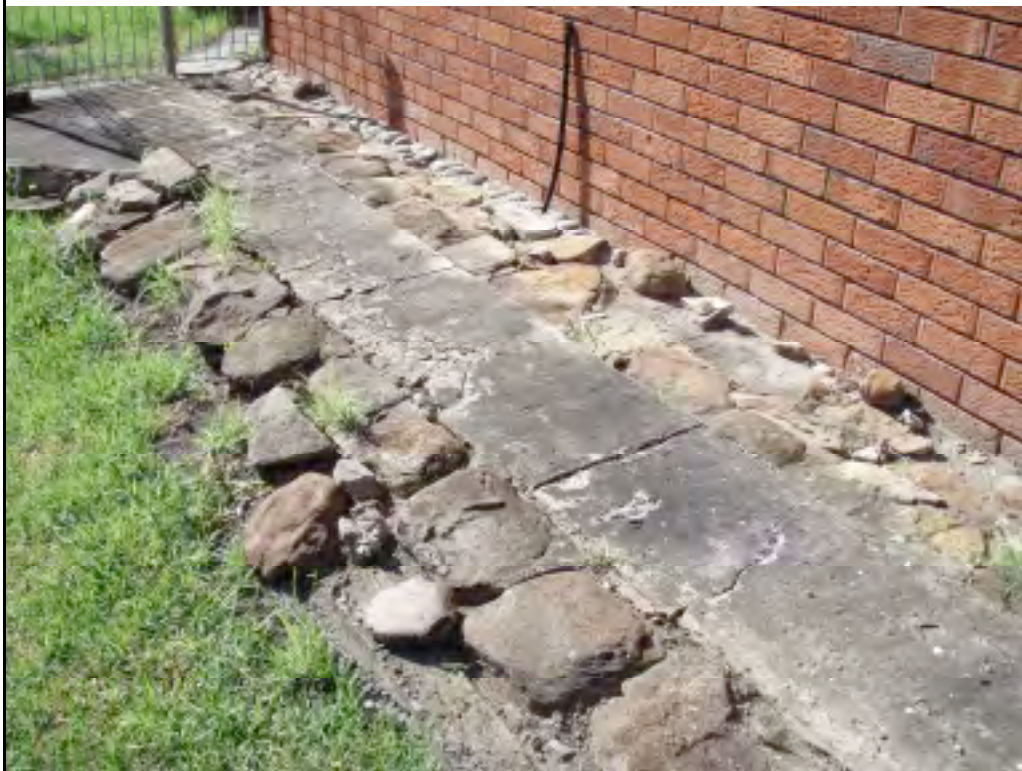
Cracked pathway to the left side.

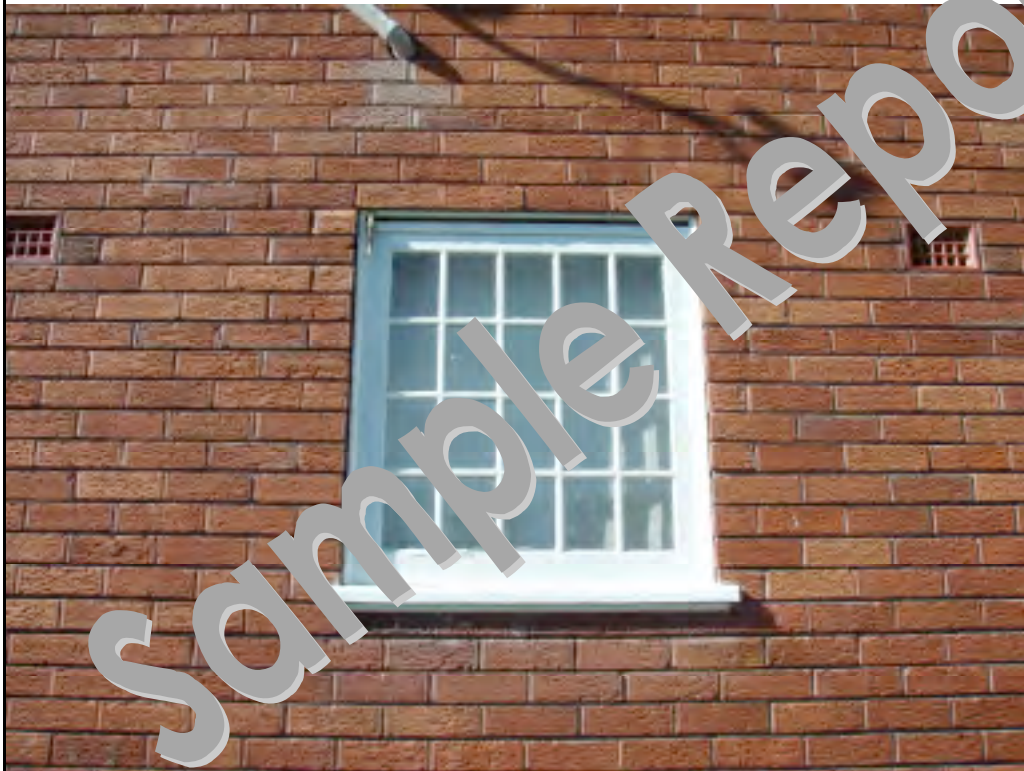
Cracks above and below the left side window to the room at the rear of the garage.

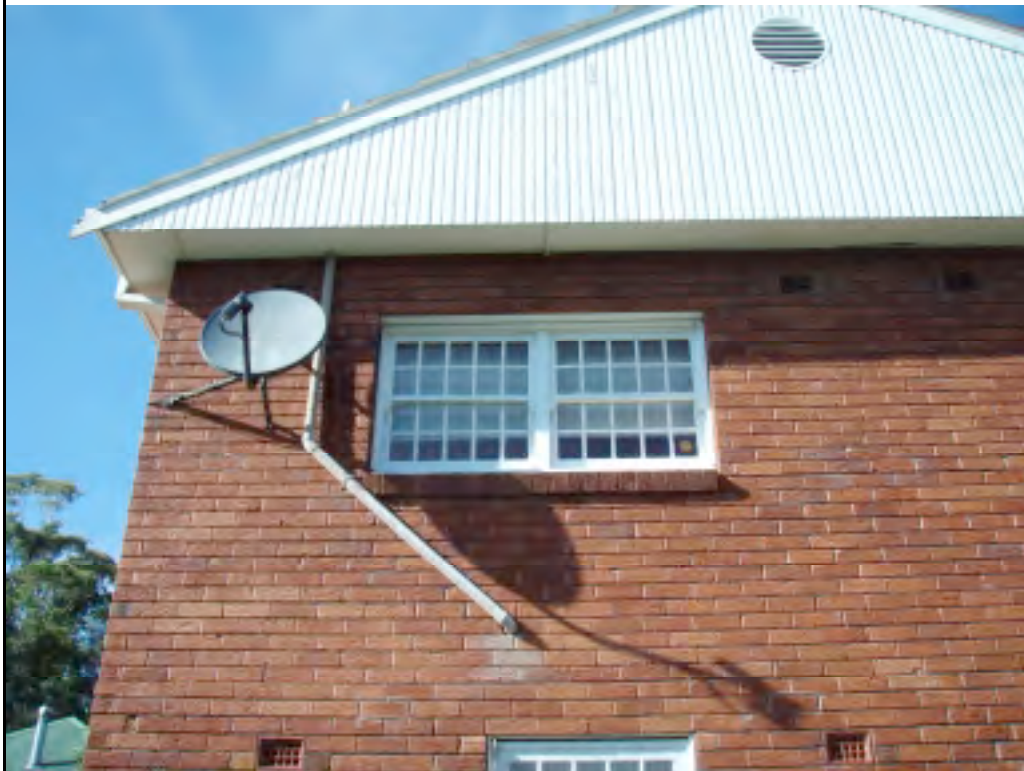
Cracks noted to the brickwork above and below the left side upper level window.

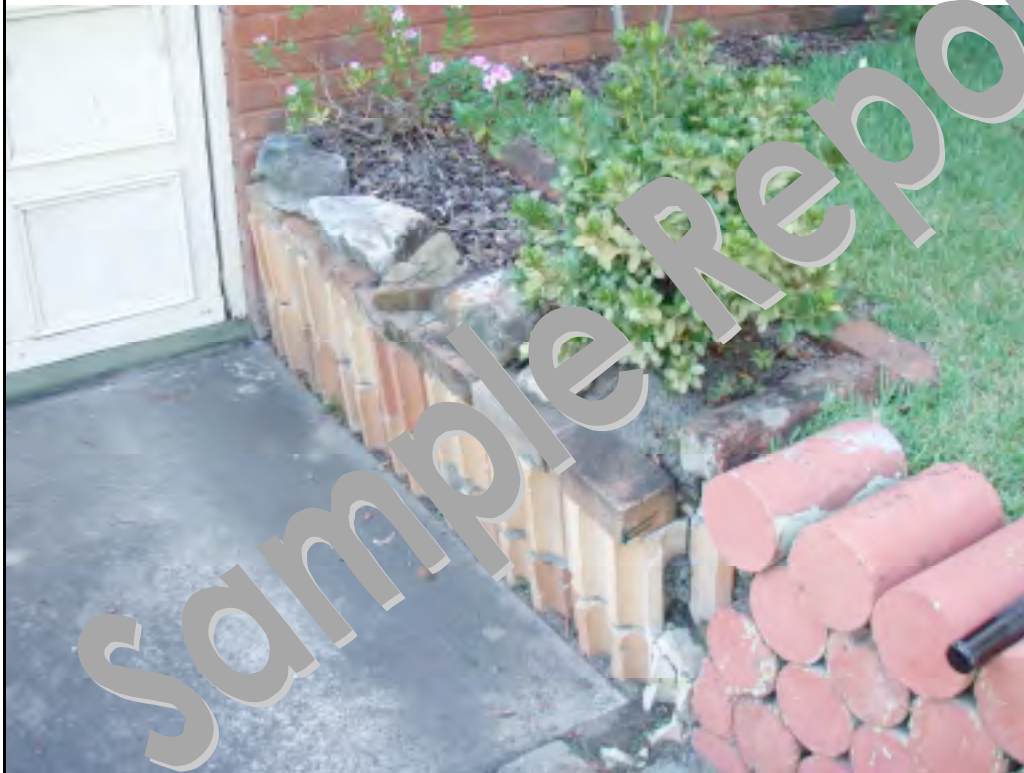
Failing garden retaining wall to the right side of the garage entrance.

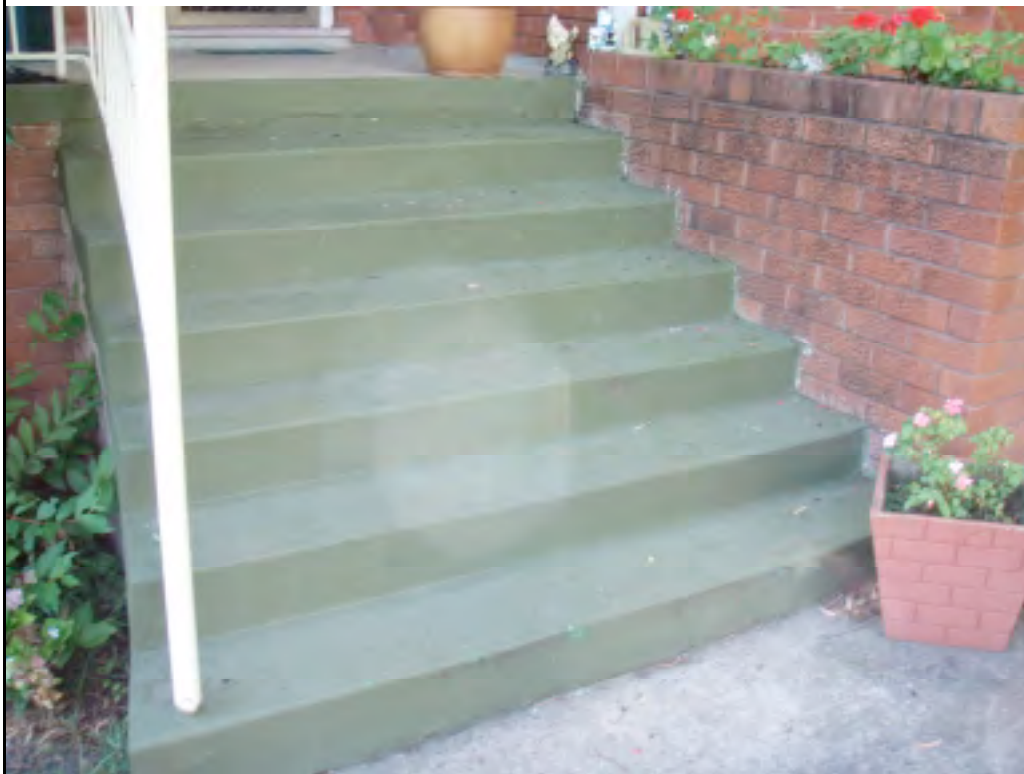
Cracks to the front steps top riser and bottom riser and tread to the right side.

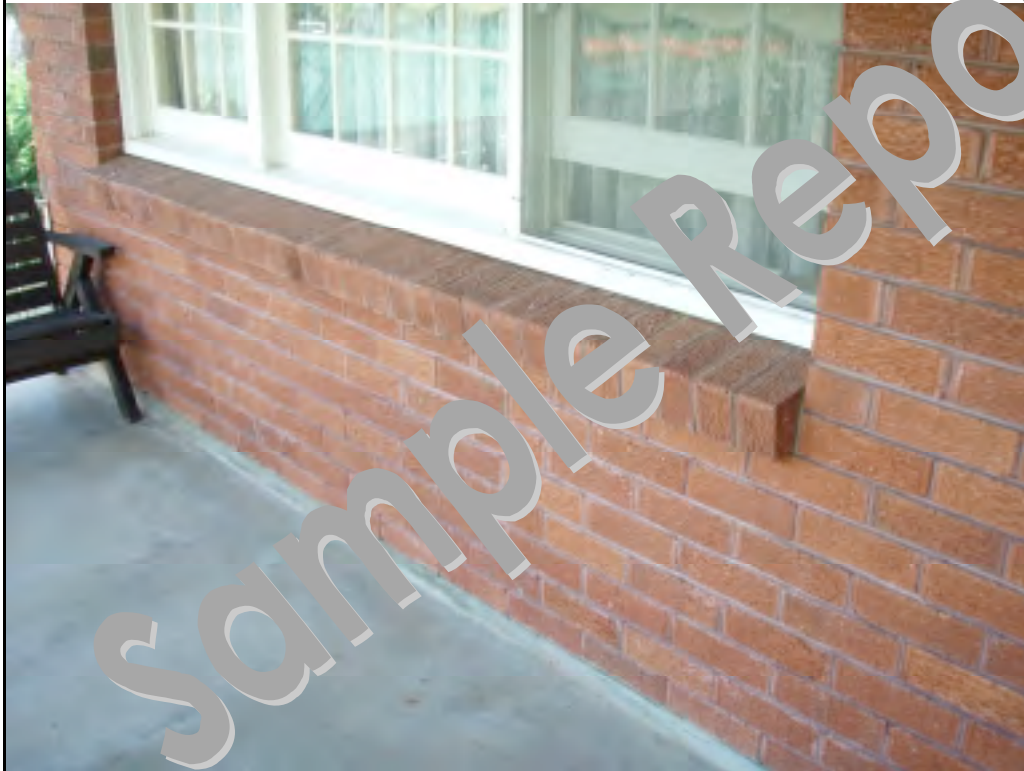
Cracks below the front left side window.

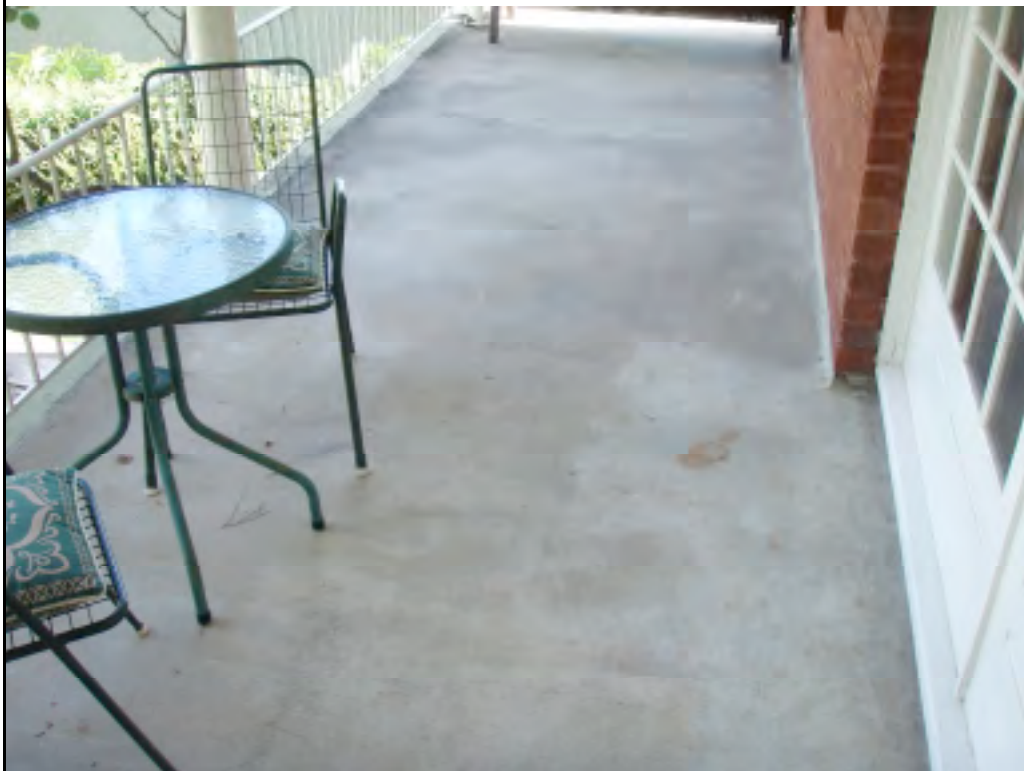
Hairline cracking to the verandah slab.

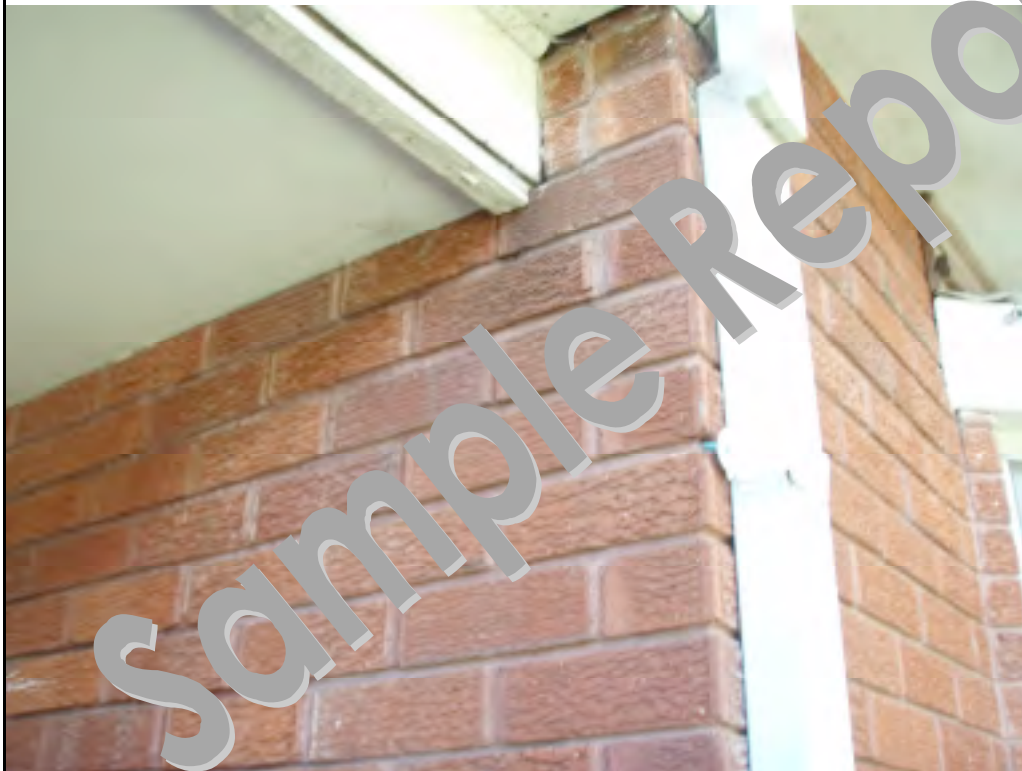
Crack to the front verandah area above the steps.

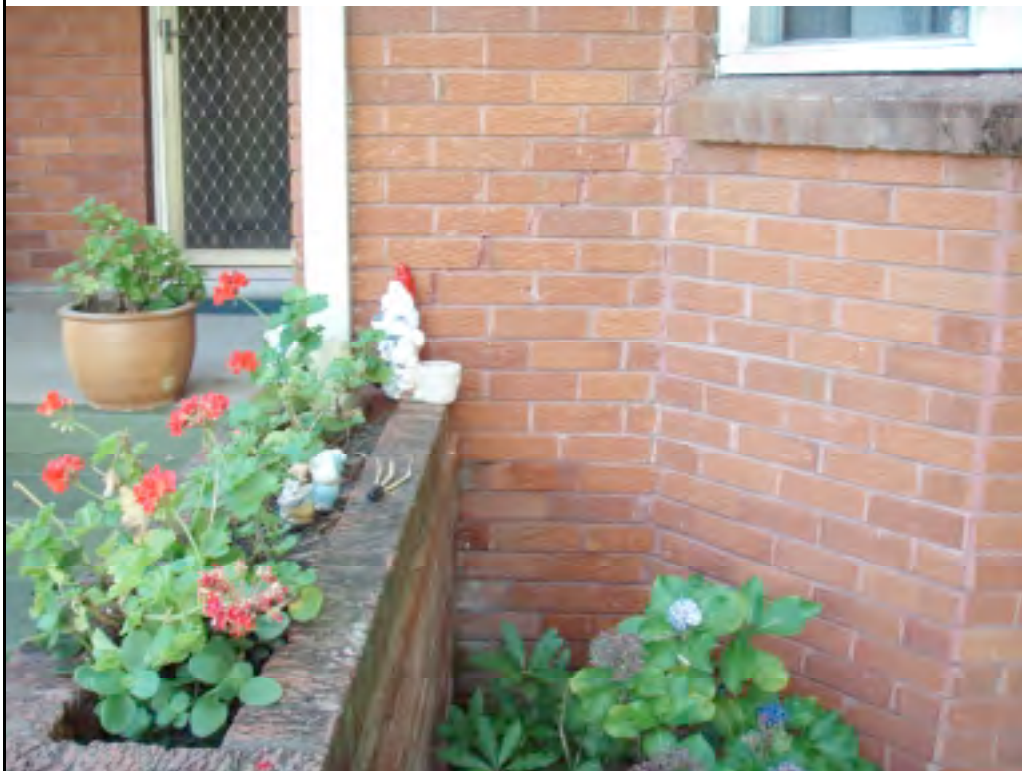
Cracks to the right side of the front verandah steps.

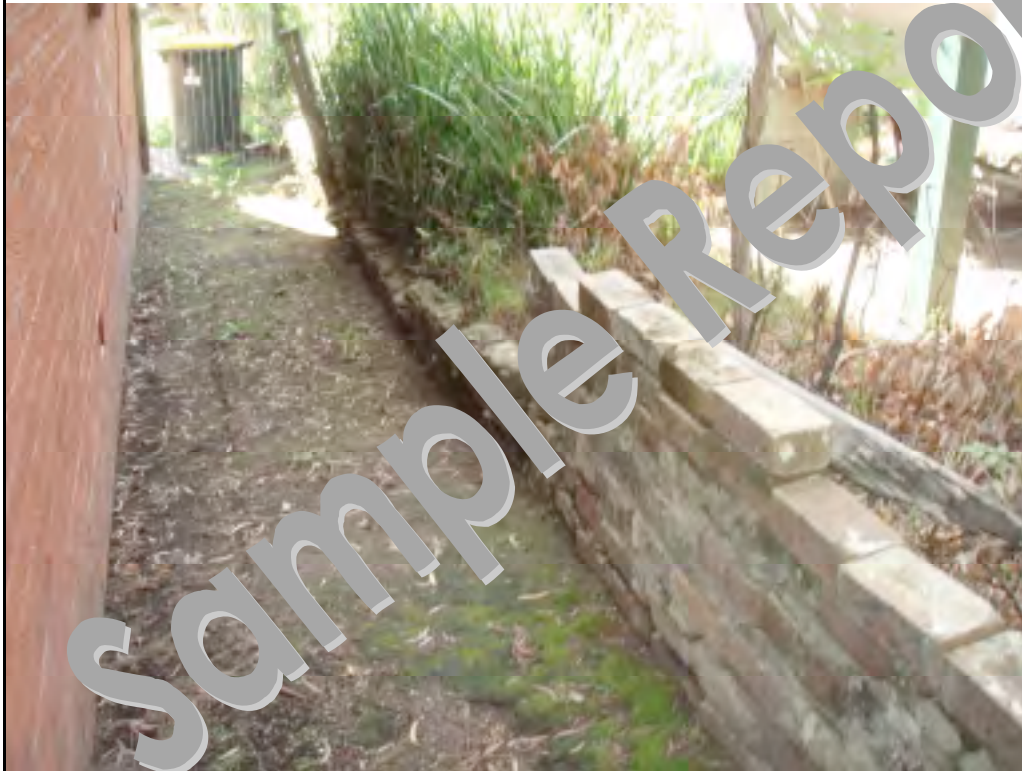
Failing garden wall to the right side.

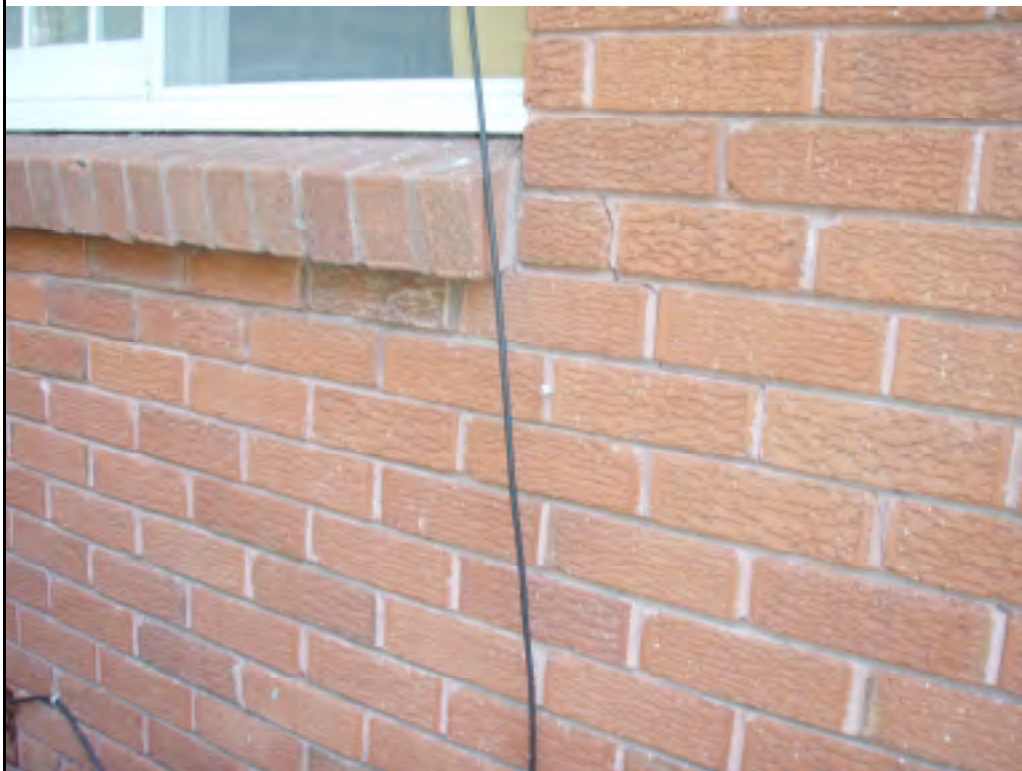
Cracks above and below the window to the right side.

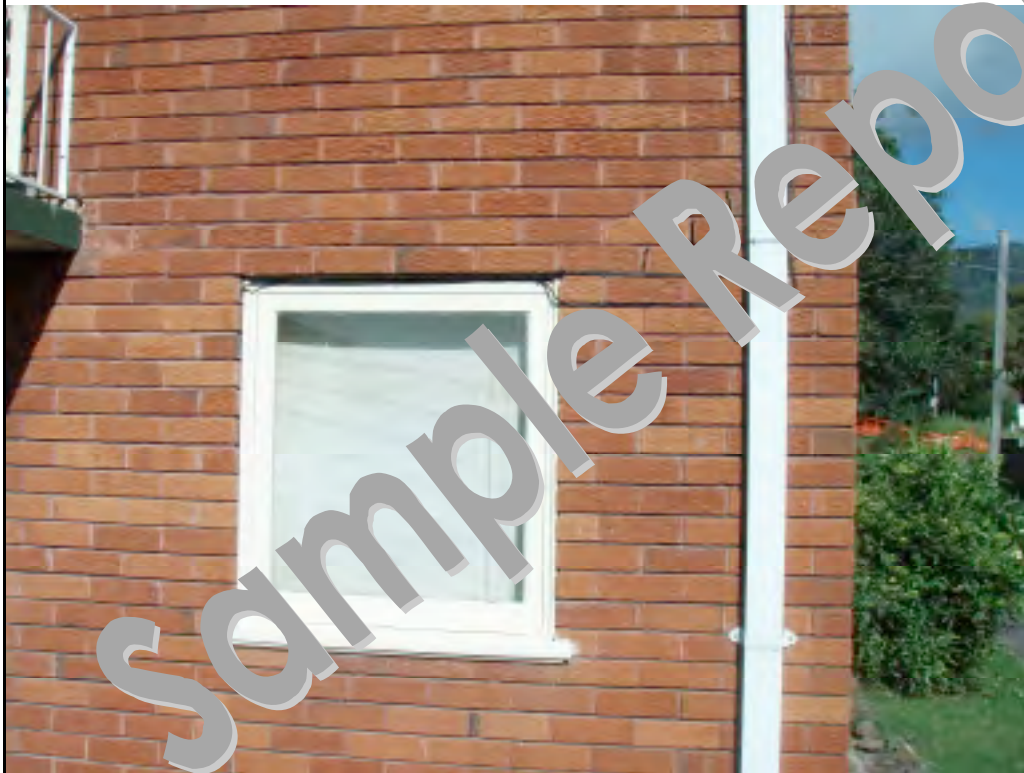
Cracked brickwork to the window area to the rear of the garage.

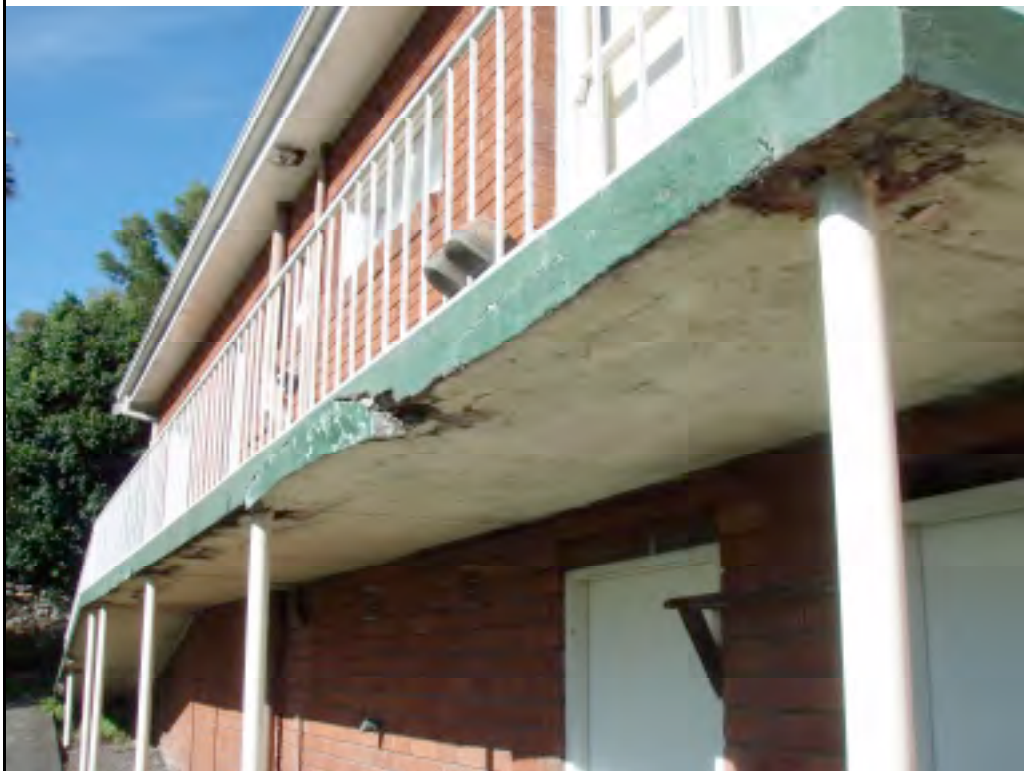
Spalling concrete to the rear verandah.

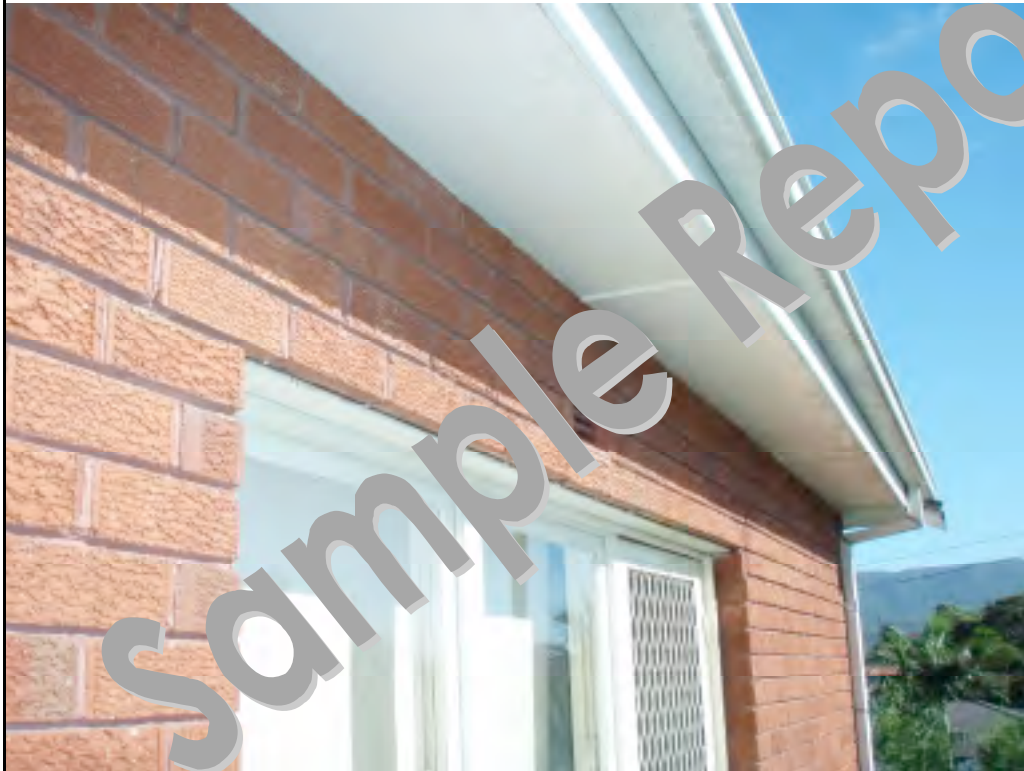
Cracks above the rear upper level door and window.

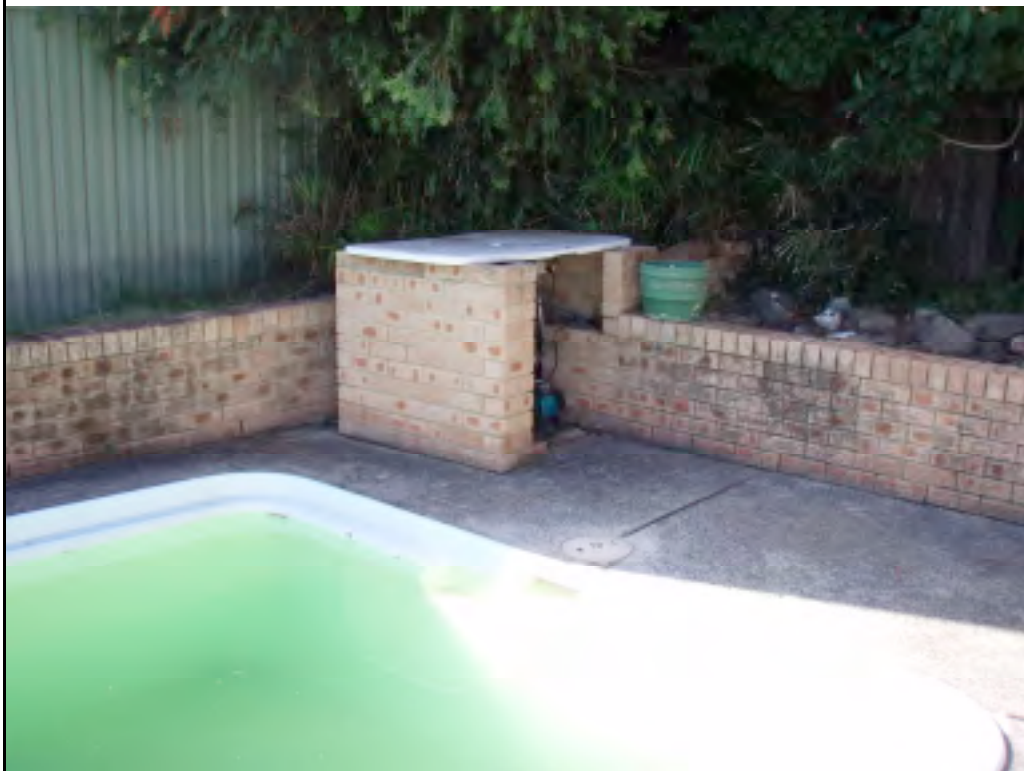
Cracked and failing retaining walls around the pool area.

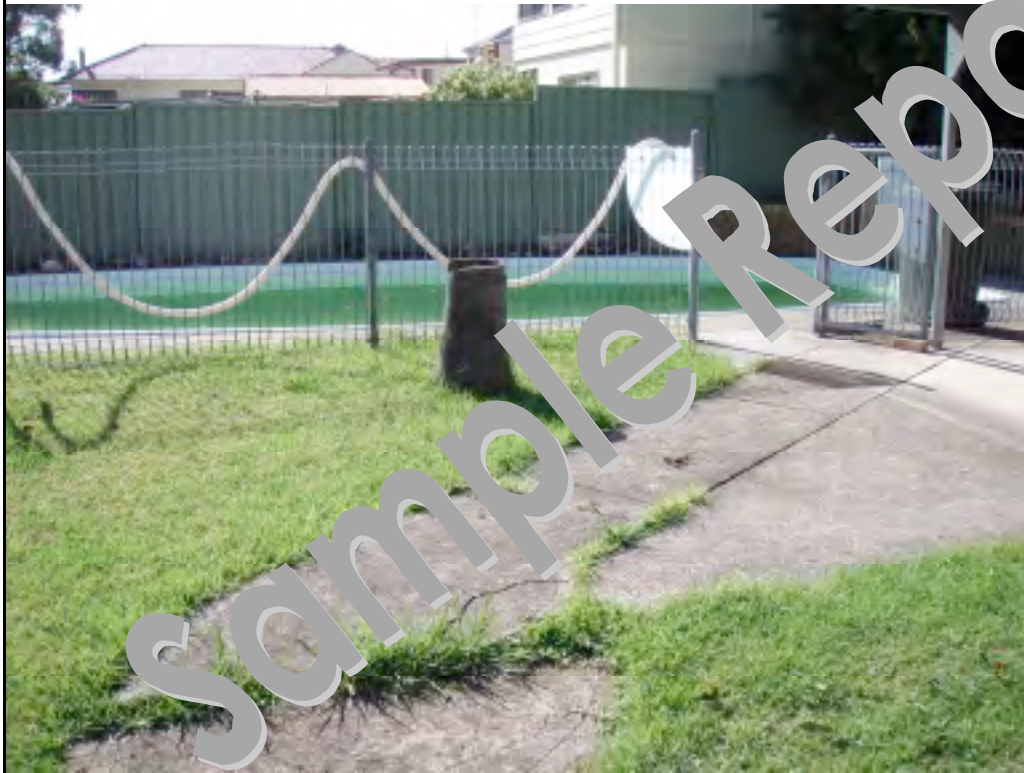
Settlement cracks developed in the concrete paths surrounding and near the pool area.

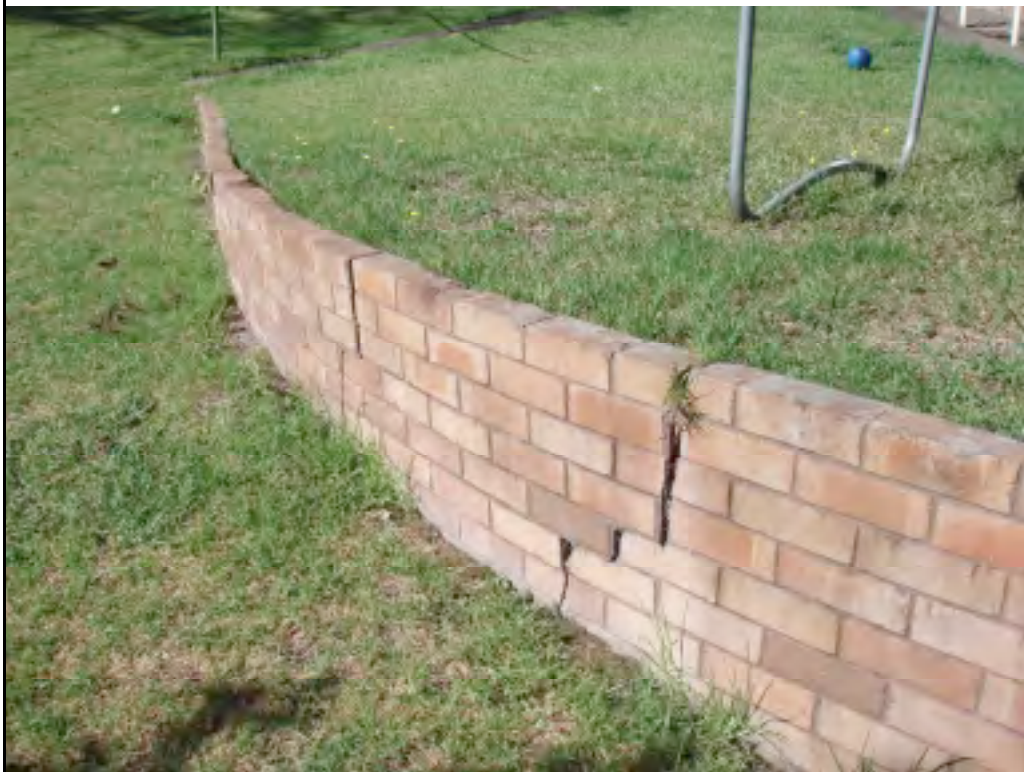
Cracked and failing rear yard retaining wall brickwork.

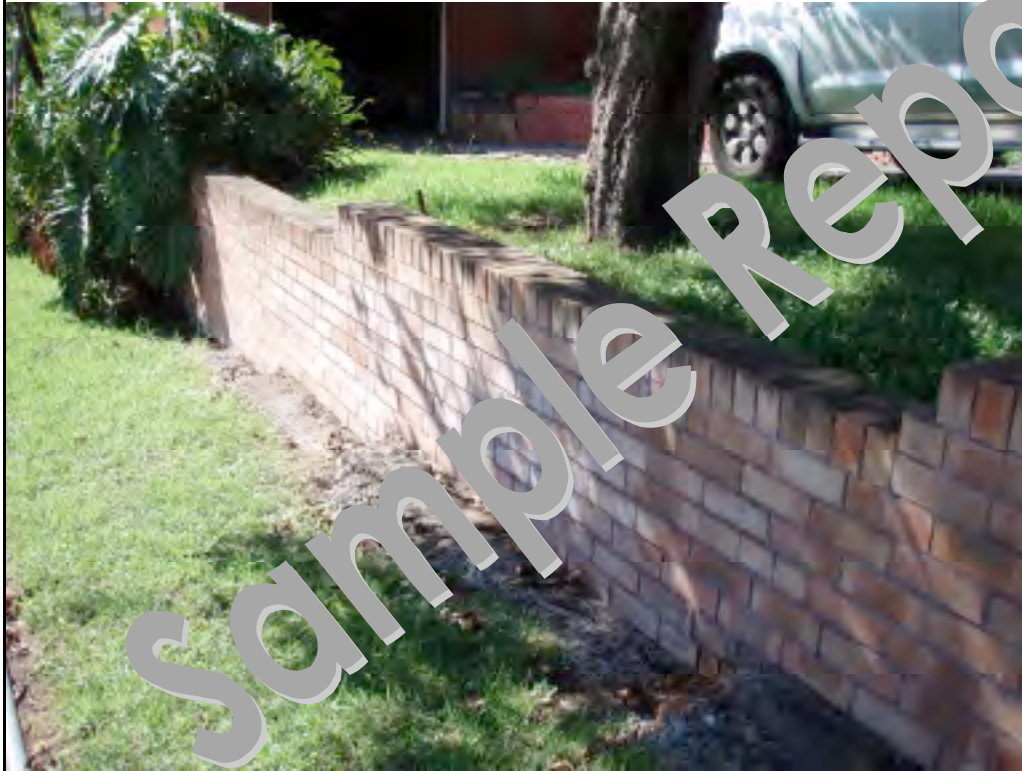
Several cracks noted to the brick retaining wall to the left side of the property.
