BUILDING DILAPIDATION REPORT

The following inspection has been carried out to check and report on the current structural condition of the property prior to construction commencing on the Northern Distributor freeway extension.

Sample Report

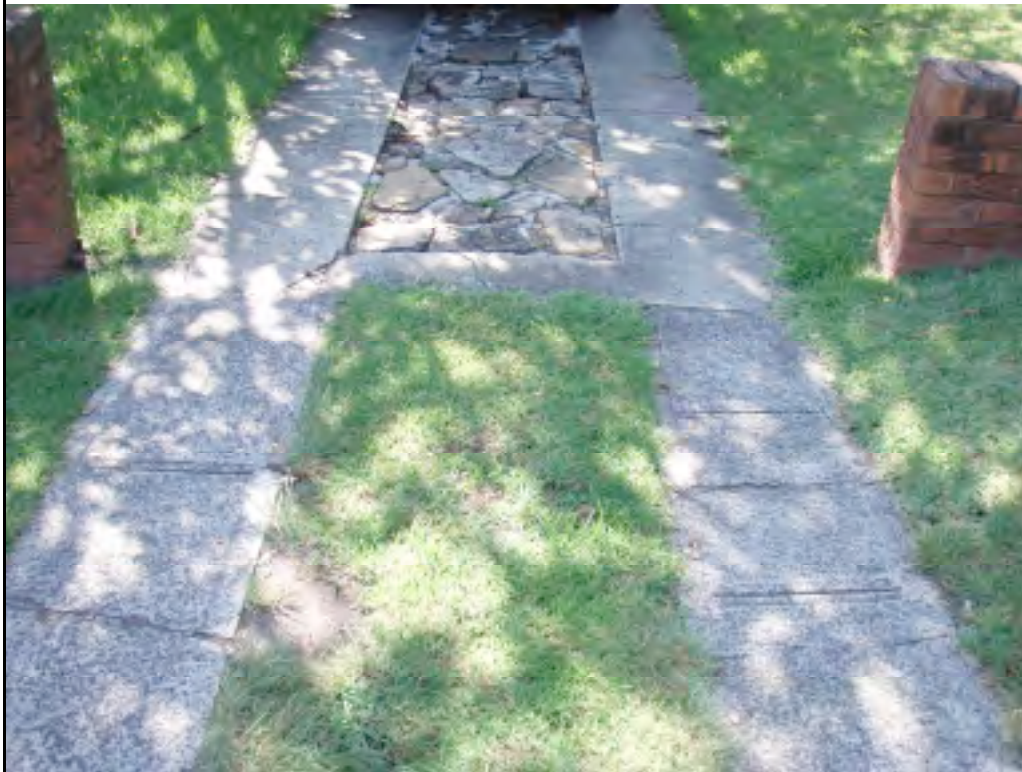
Cracking noted to the concrete driveway along the entire length.

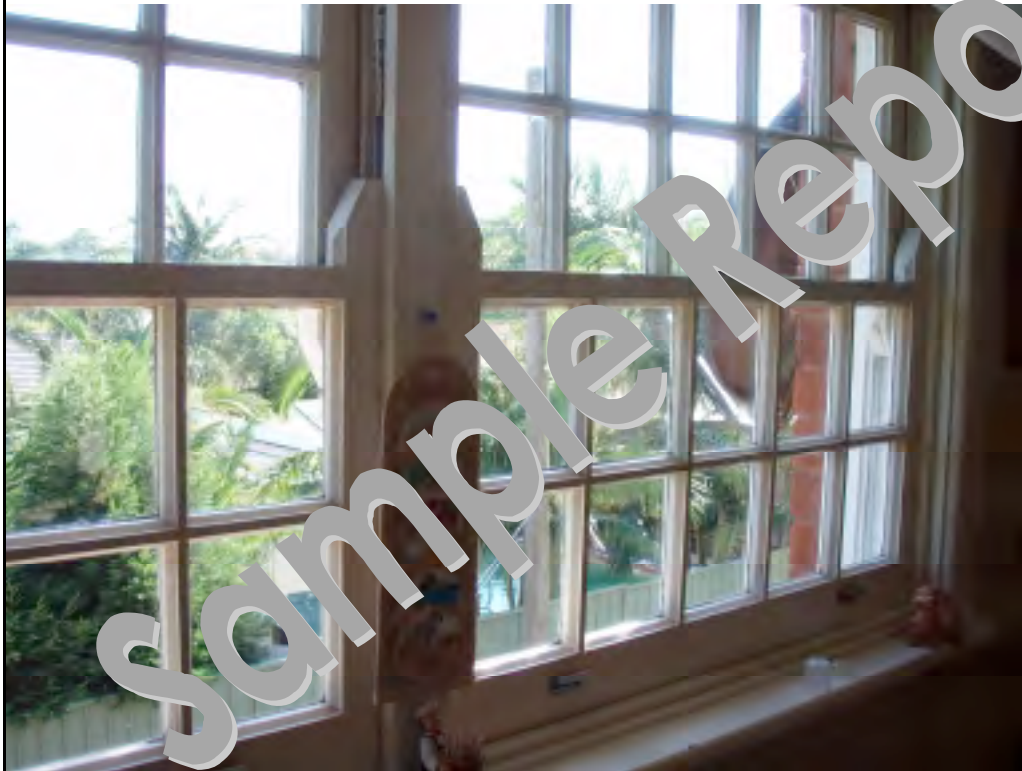
Cracked glazing to the kitchen window.

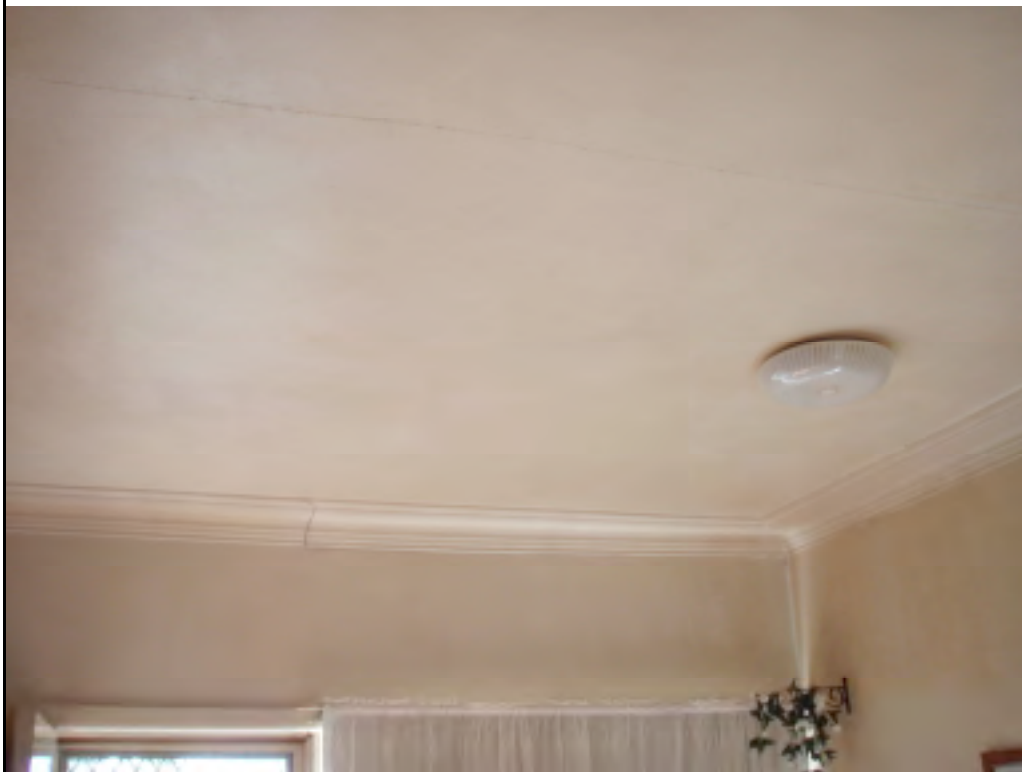
Cracked ceilings to the kitchen.

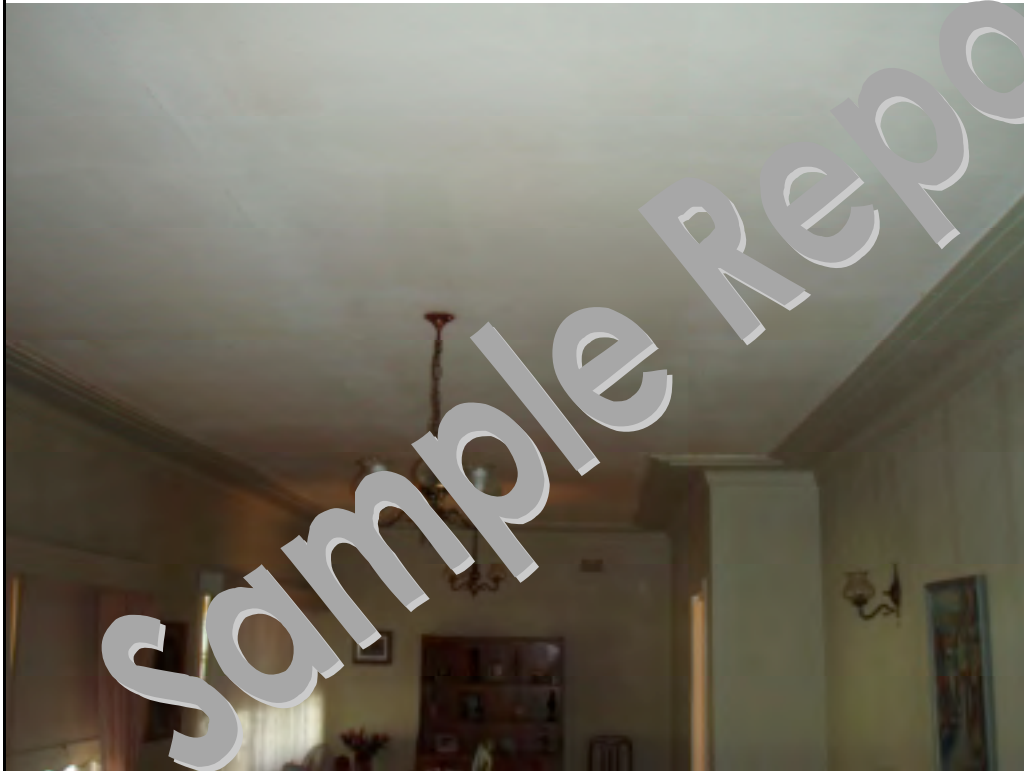
Cracked ceilings and cornices to the living room.

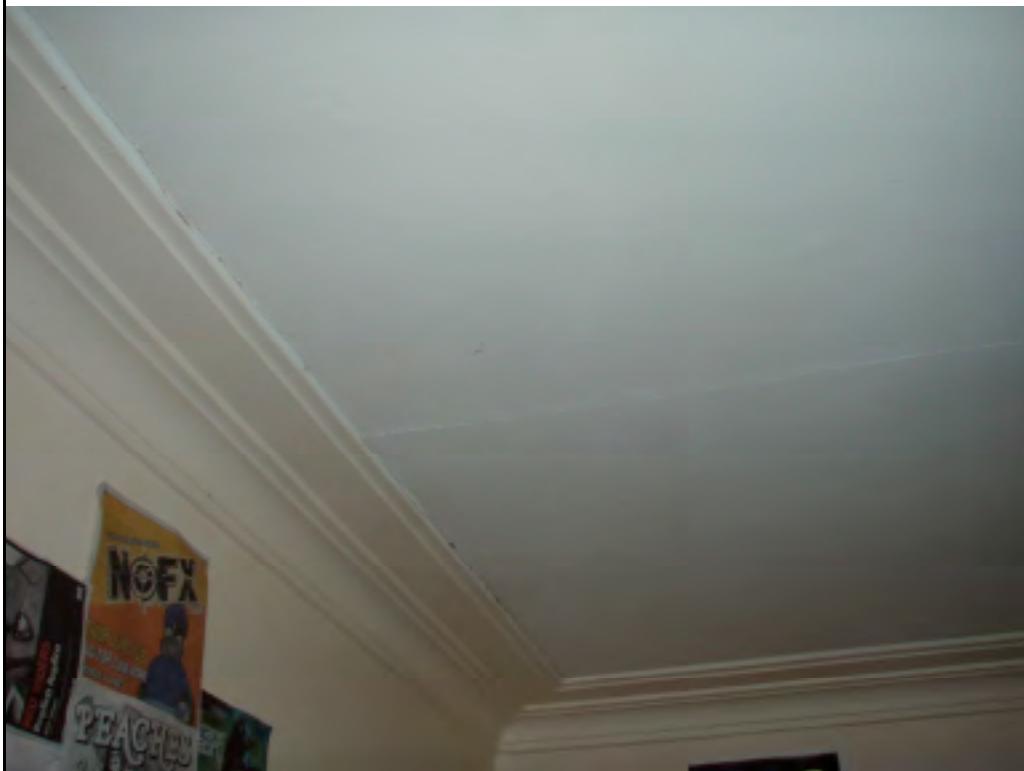
Cracked ceiling to bedroom 3.

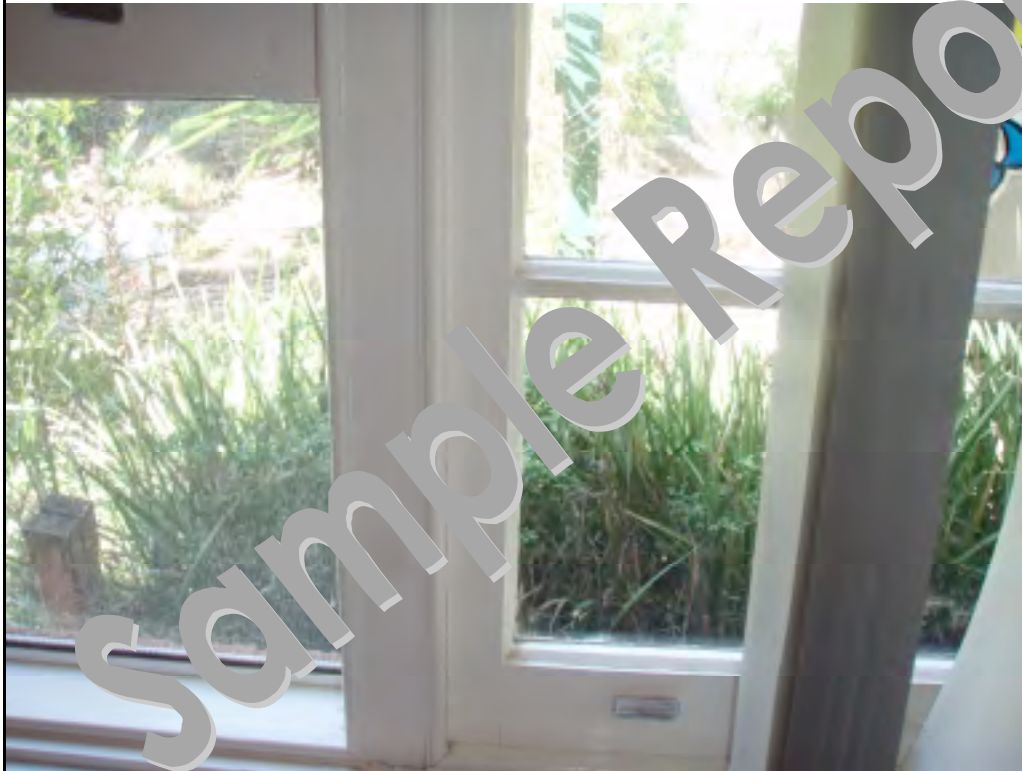
Cracked glazing to bedroom 2.

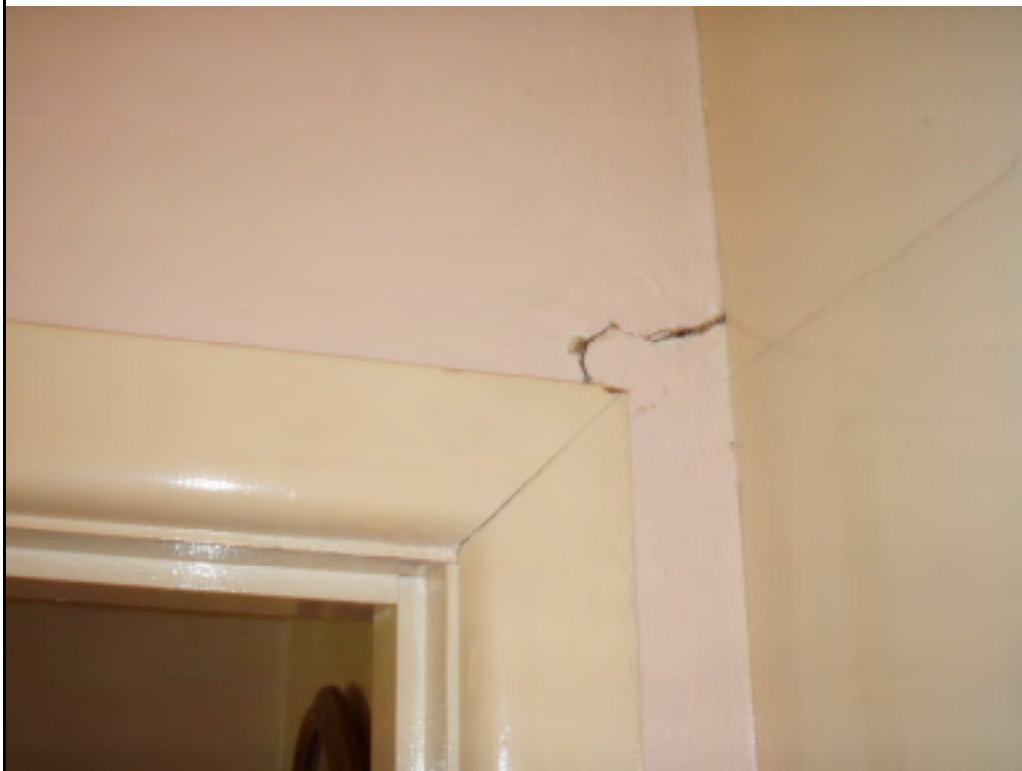
Crack above the door in bedroom 1.

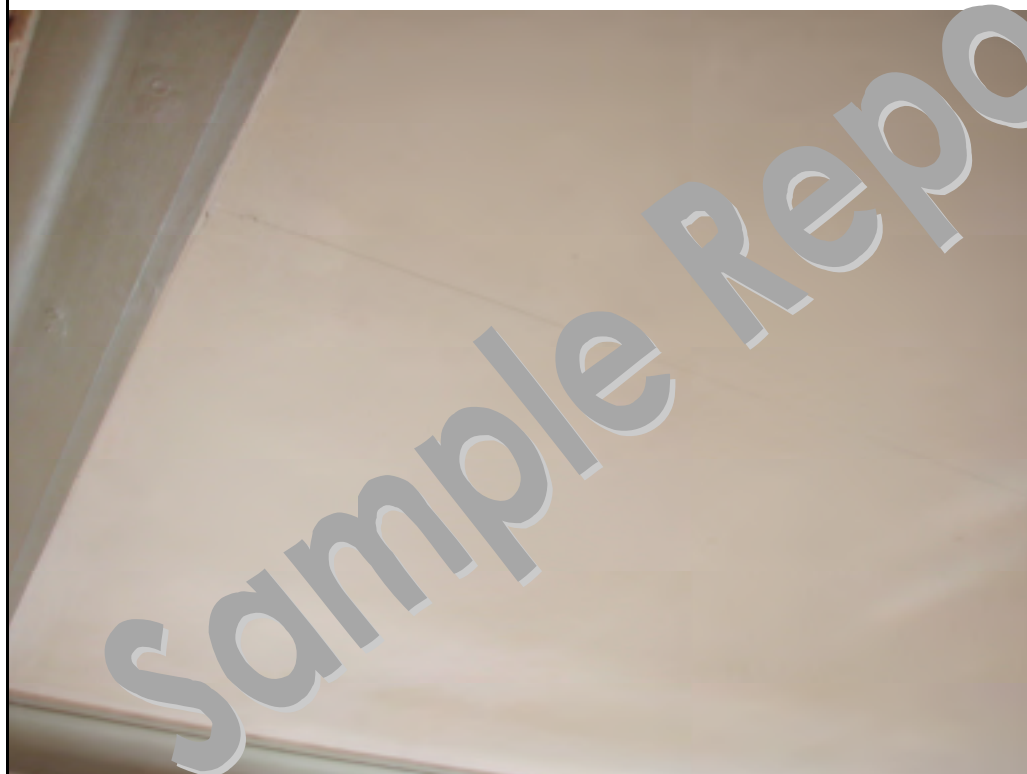
Cracked ceiling to bedroom 1.

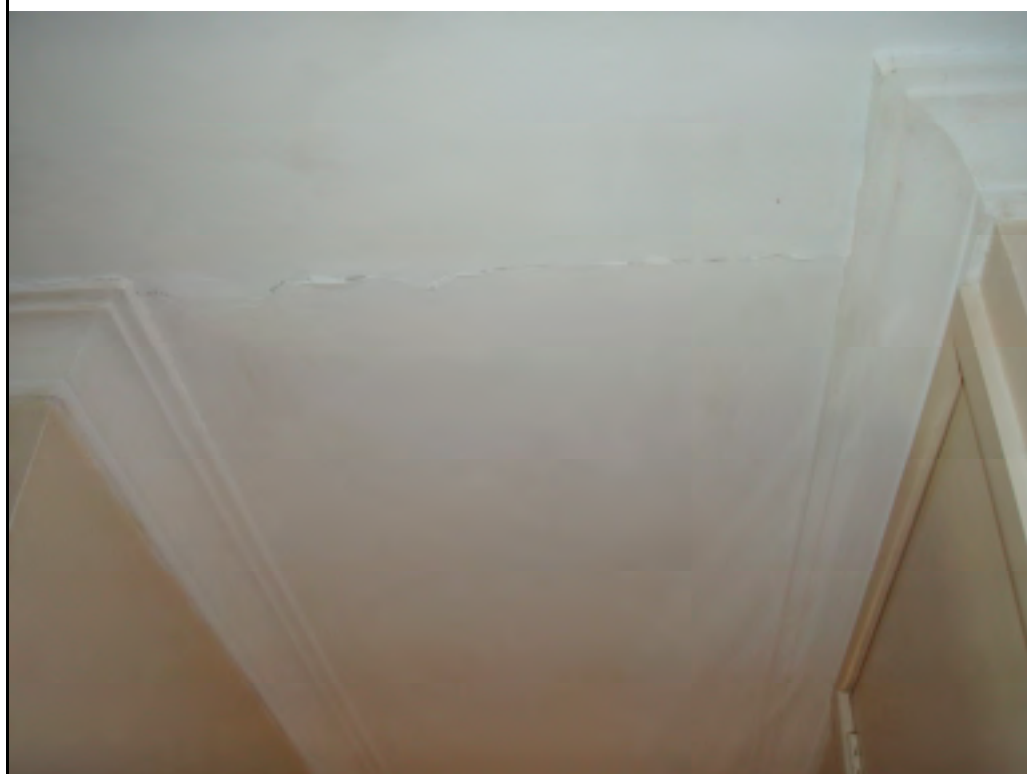
Cracked ceiling in the hallway.

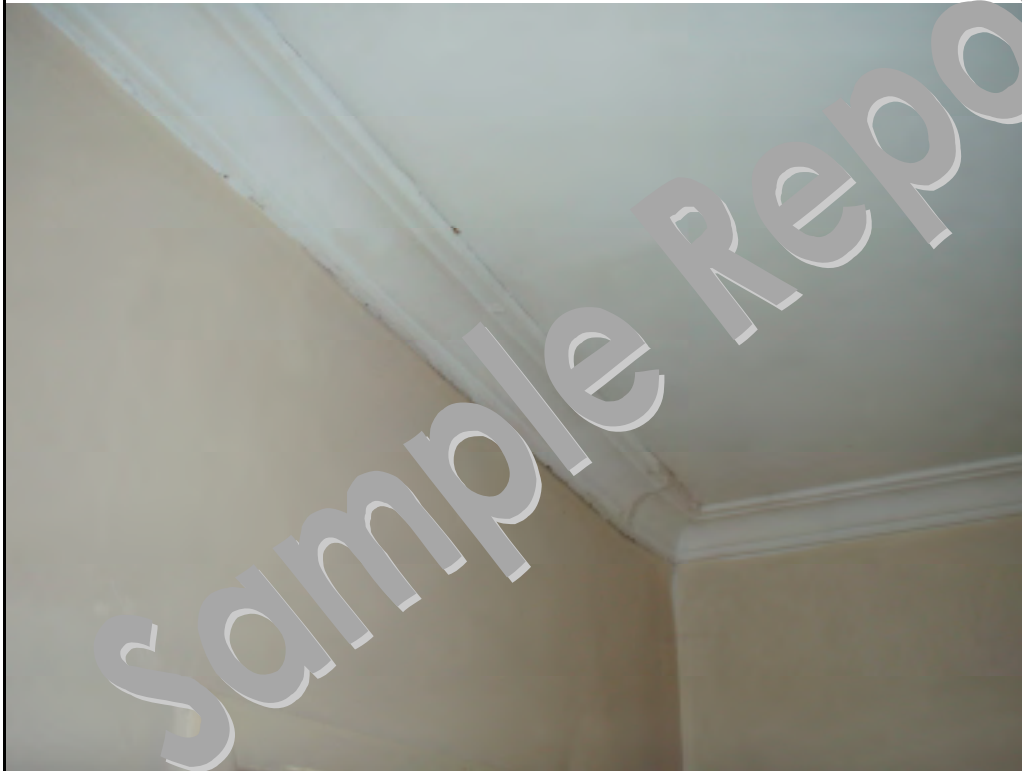
Cracked ceiling above the front door.

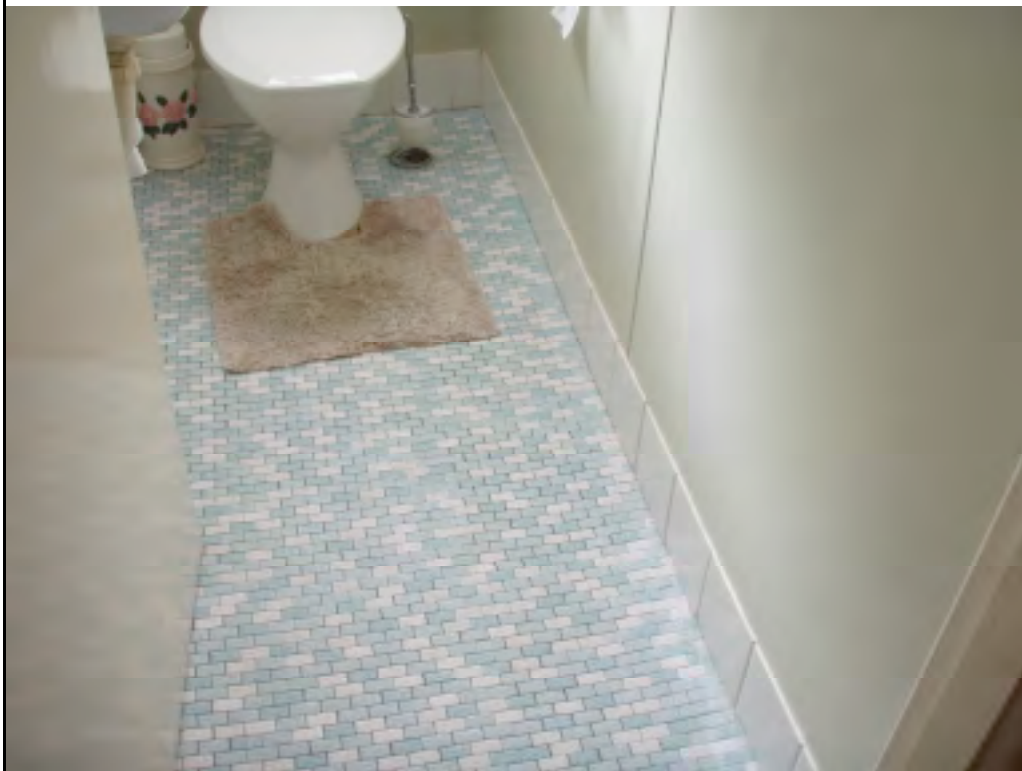
Drummy and loose skirting tiles to the toilet.

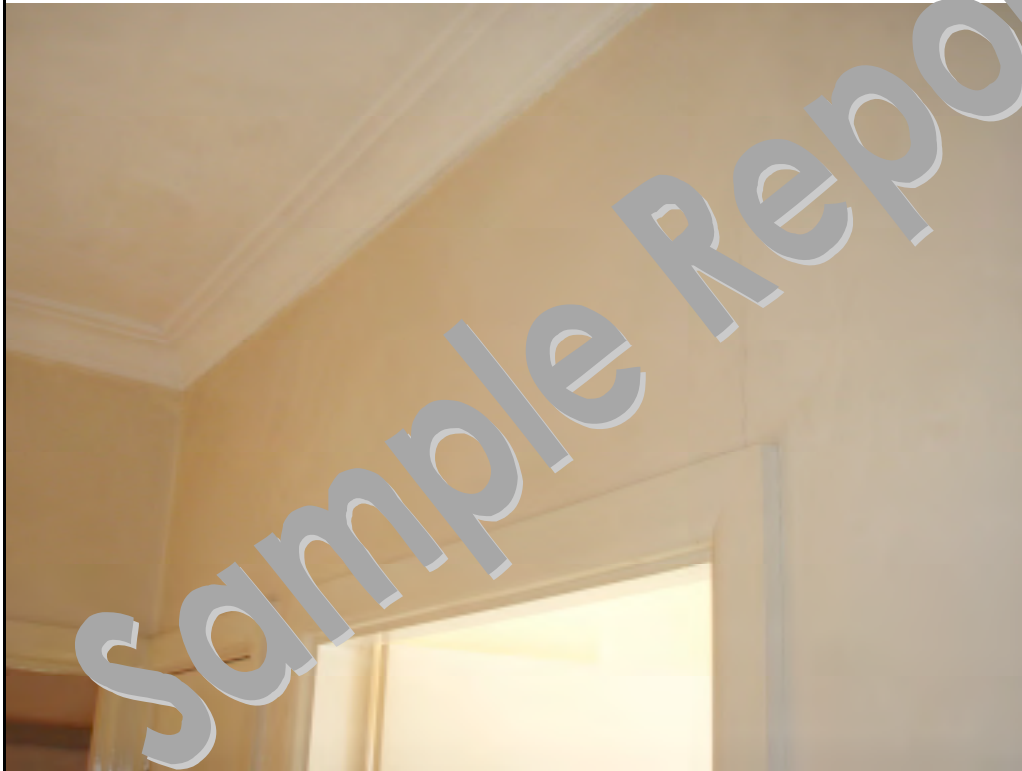
Cracks above the bathroom and hallway cupboard door.

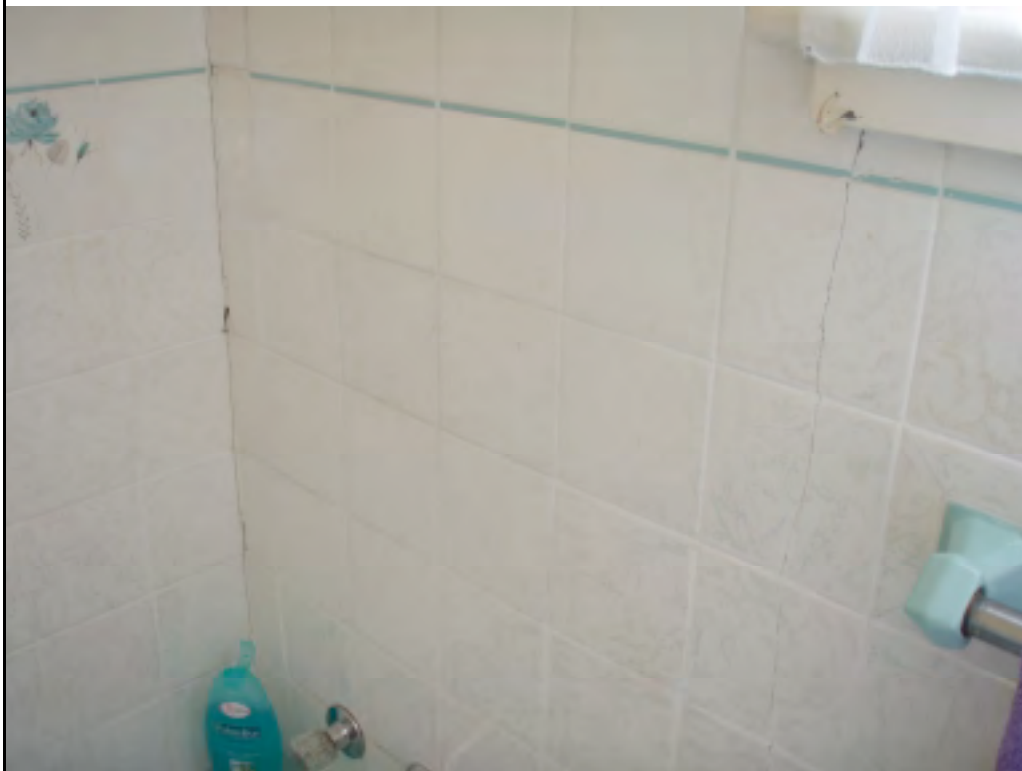
Cracks to the wall above the bath.

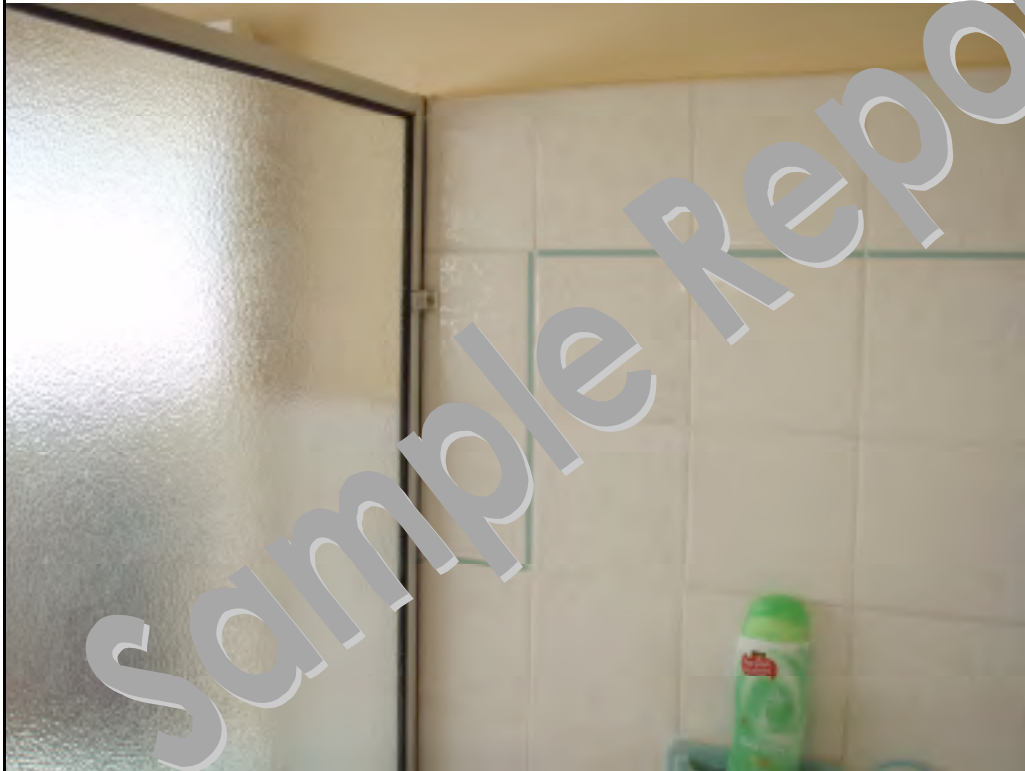
Loose tiles to the shower area wall.

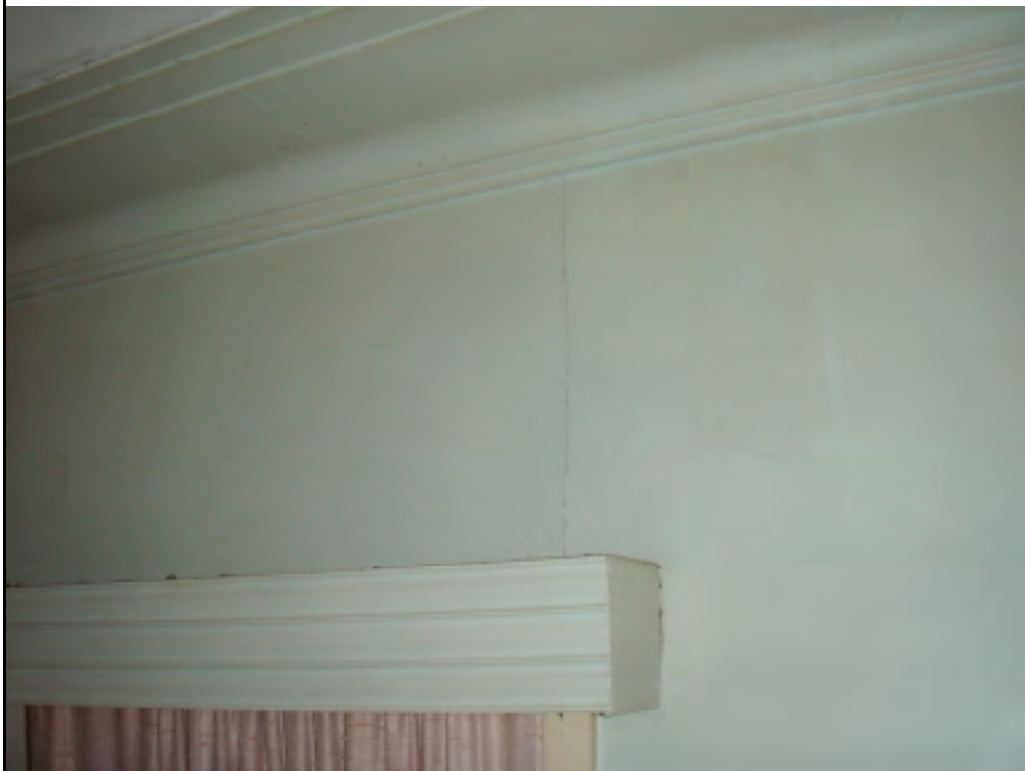
Cracks to the walls in the living room.

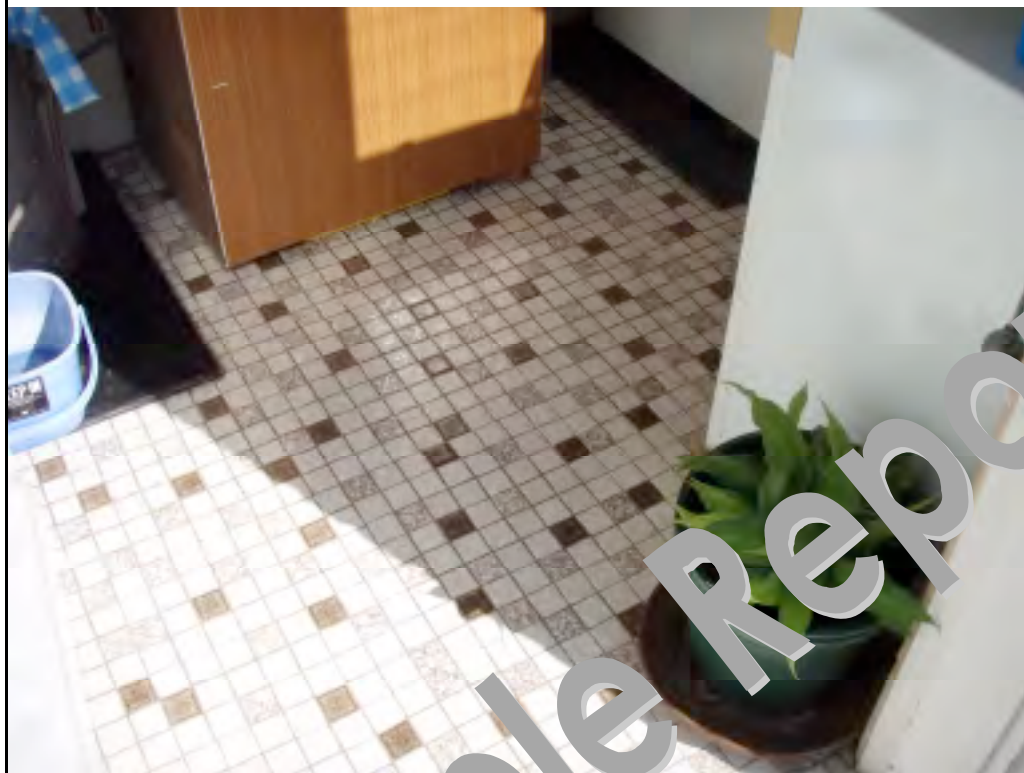
Drummy tiles to 60% of the laundry floor.
