**PROPERTY
INSPECTIONS**

PRE-PURCHASE BUILDING REPORT

The property inspected is a single storey, semi detached building of full masonry construction. This structure is on pier and strip and concrete slab footings, with a skillion roof covered in corrugated steel.

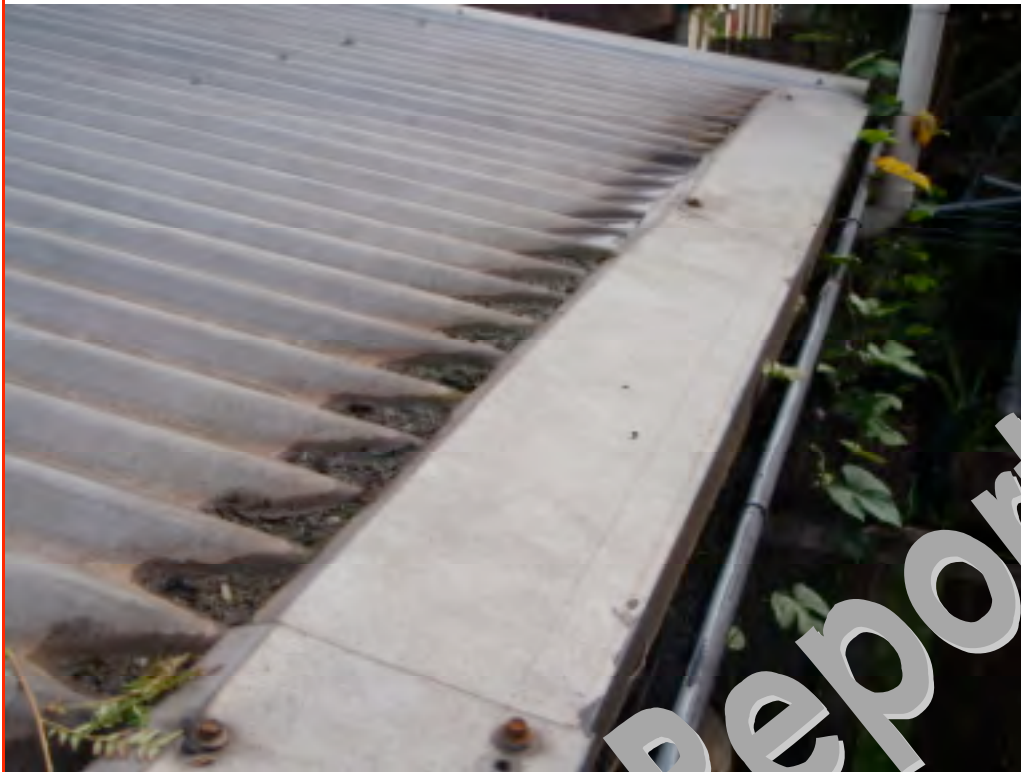
Remove the flashing to the gutter area at the rear of the home to allow stormwater to enter the gutter.

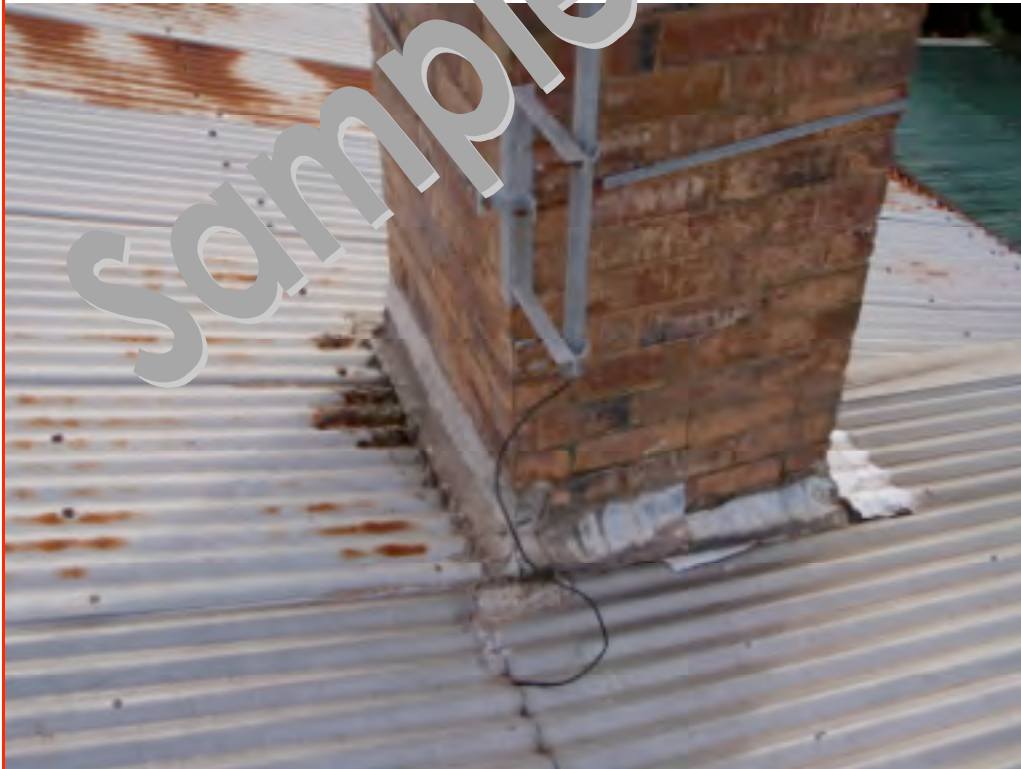
Cracked tiling was noted to the rear courtyard. Replacement is not essential at this stage.

Replace the inadequate and deteriorated flashing to the chimney area.

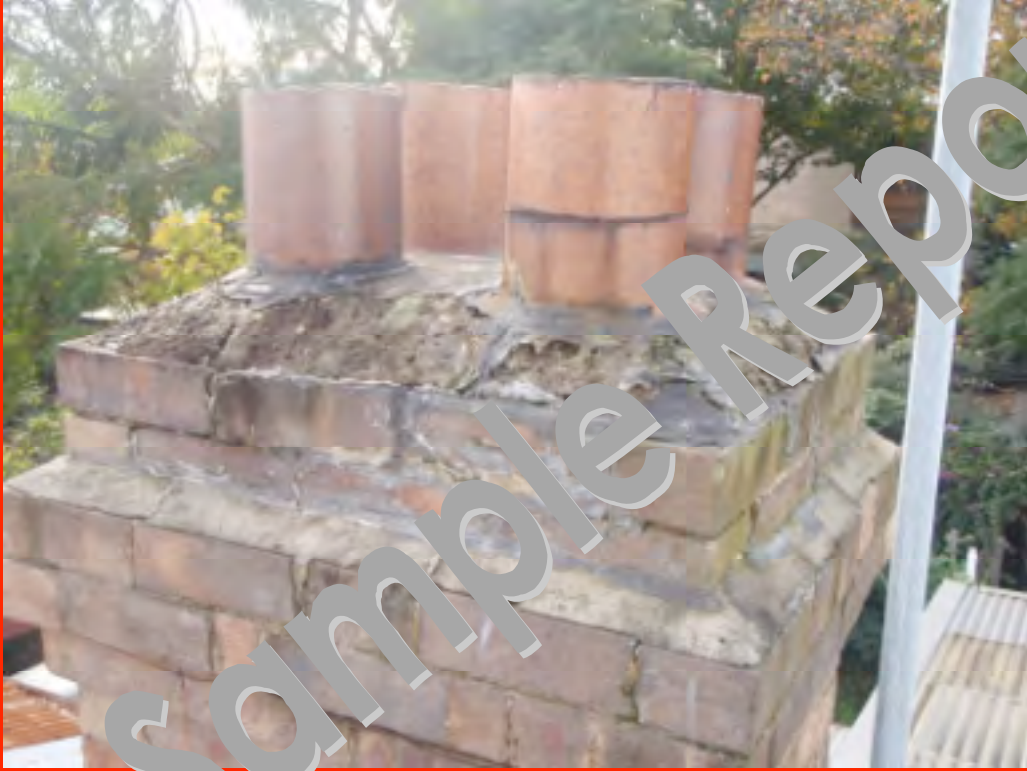
| Replace the damaged chimney pots and seal the capping to this area. | \$400.00 |

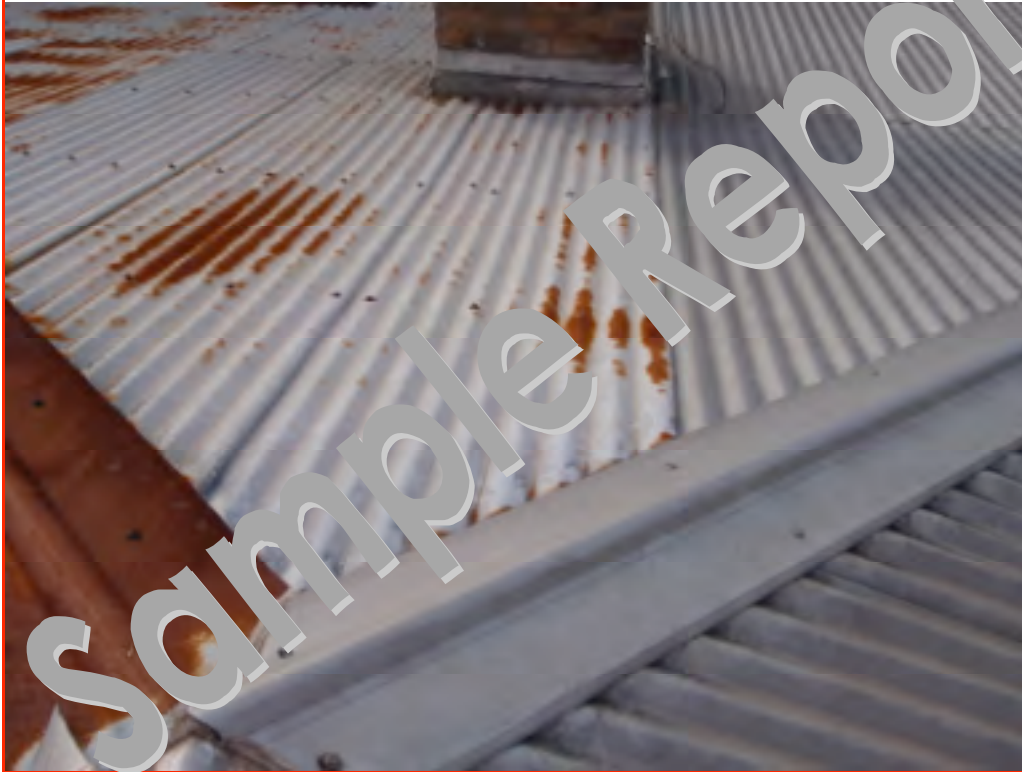
Replace part of the rear roof sheeting where it has rusted.

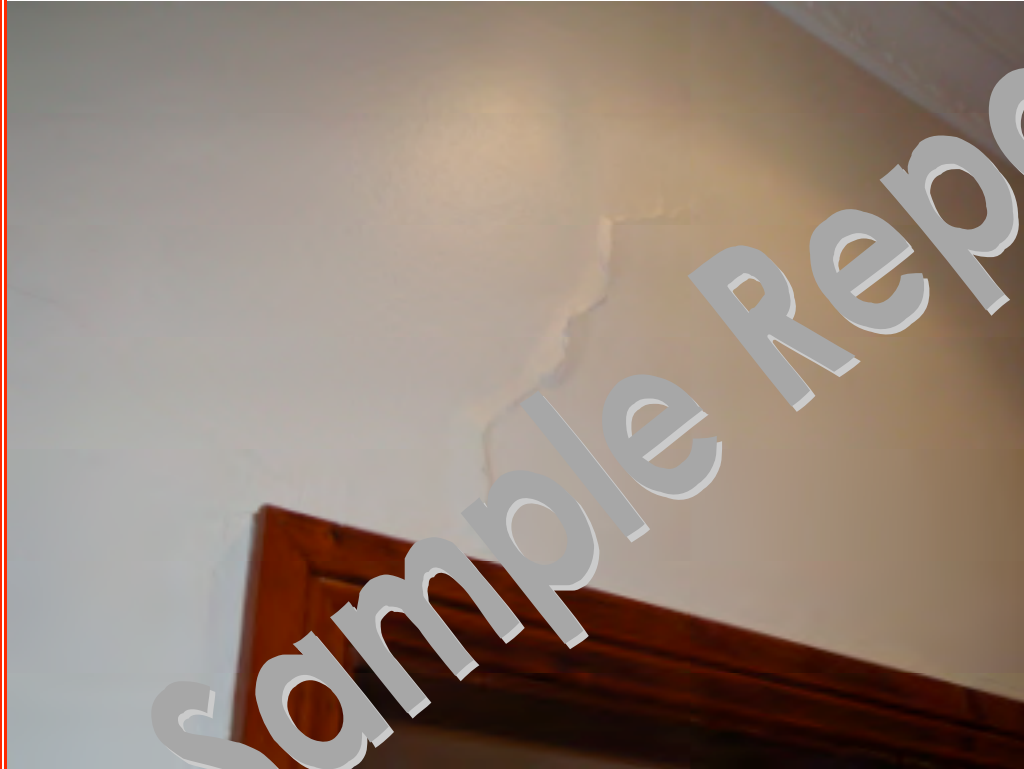
Settlement cracks have developed to the internal walls in several areas.

Generally minor hairline cracks of up to 1mm will occur in the early settlement stage and then cease. Similar to masonry cracks, however these cracks will need to be monitored by a structural engineer over time to determine if further movement is occurring.

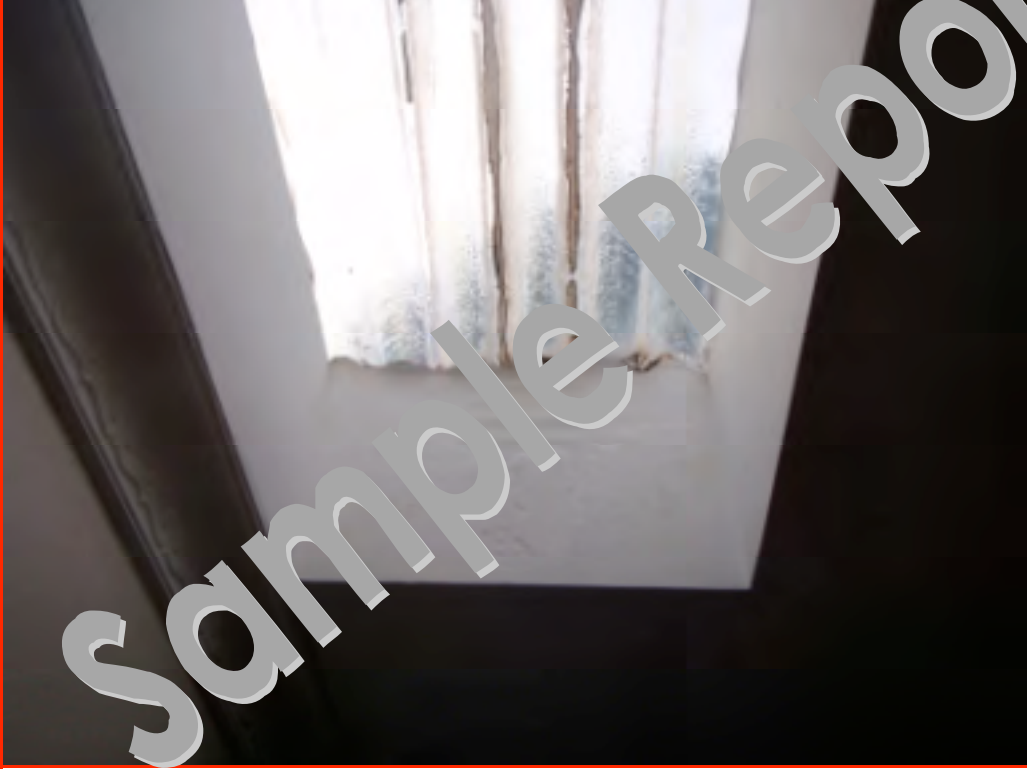
| Replace the polycarbonate sheeting to the bathroom skylight with a properly constructed unit with vents. Moisture is damaging the surrounding linings. | \$1,000.00 |

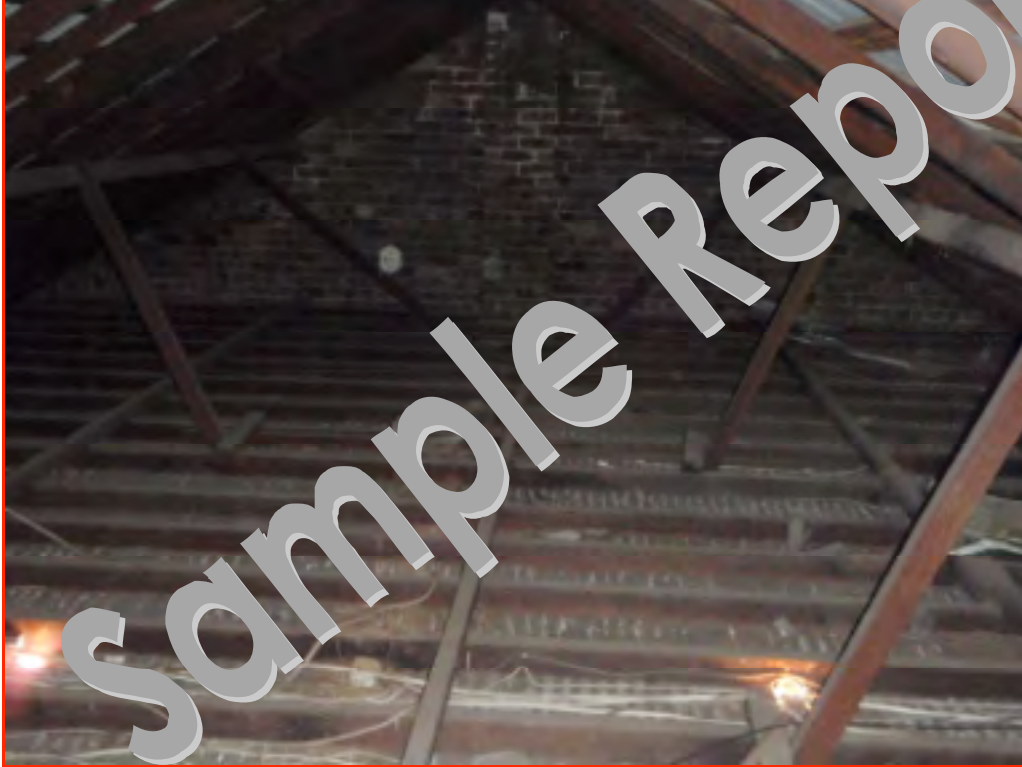
Inadequate party walls are provided between this property and neighbouring properties. Party walls should be installed for security reasons and to meet with fire rating requirements.

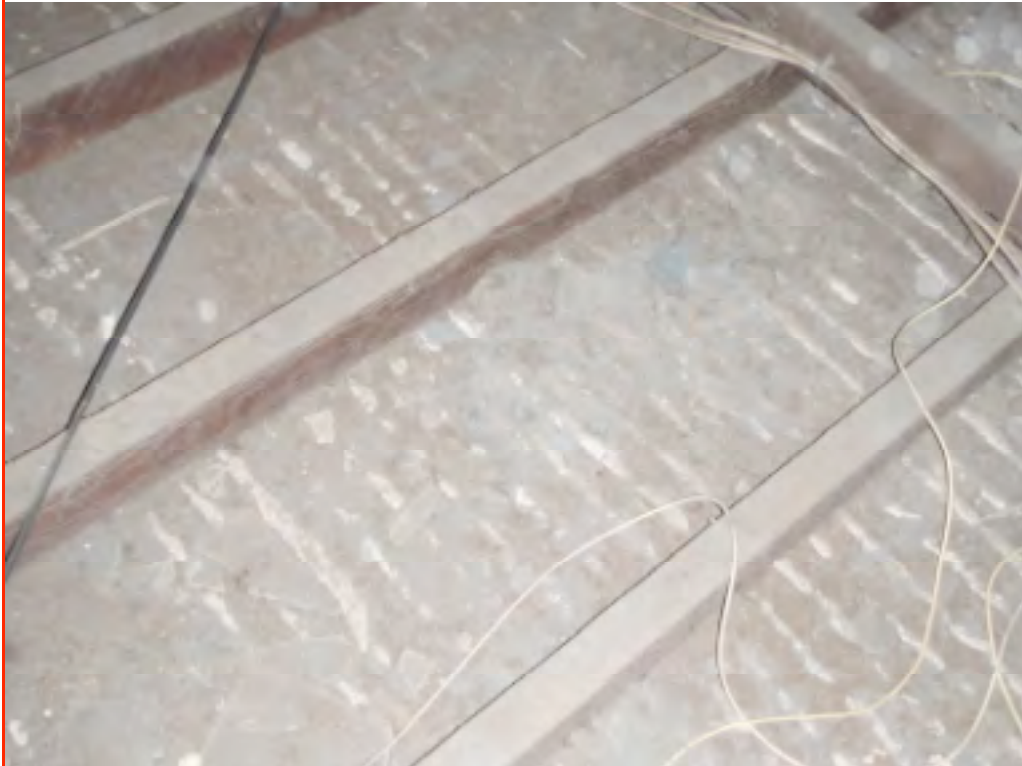
An excessive build-up of dust and debris was noted to the roof void area. This material is potentially a health hazard and should be removed.

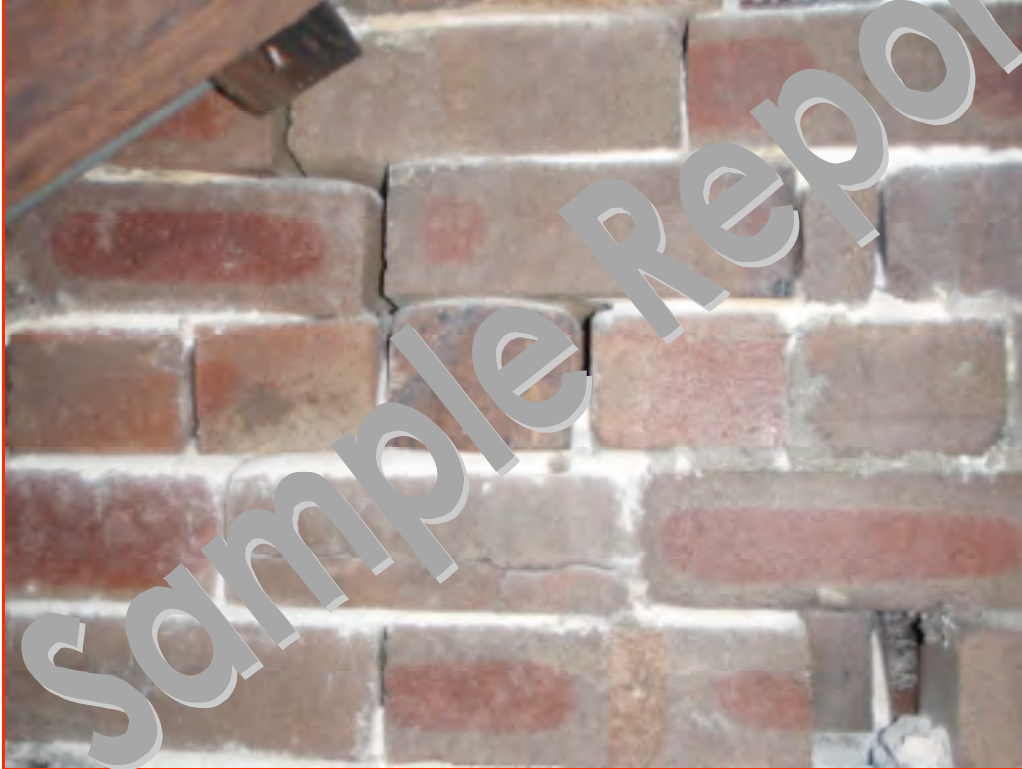
Re-point the deteriorating mortar joints to the eastern gable end brickwork.

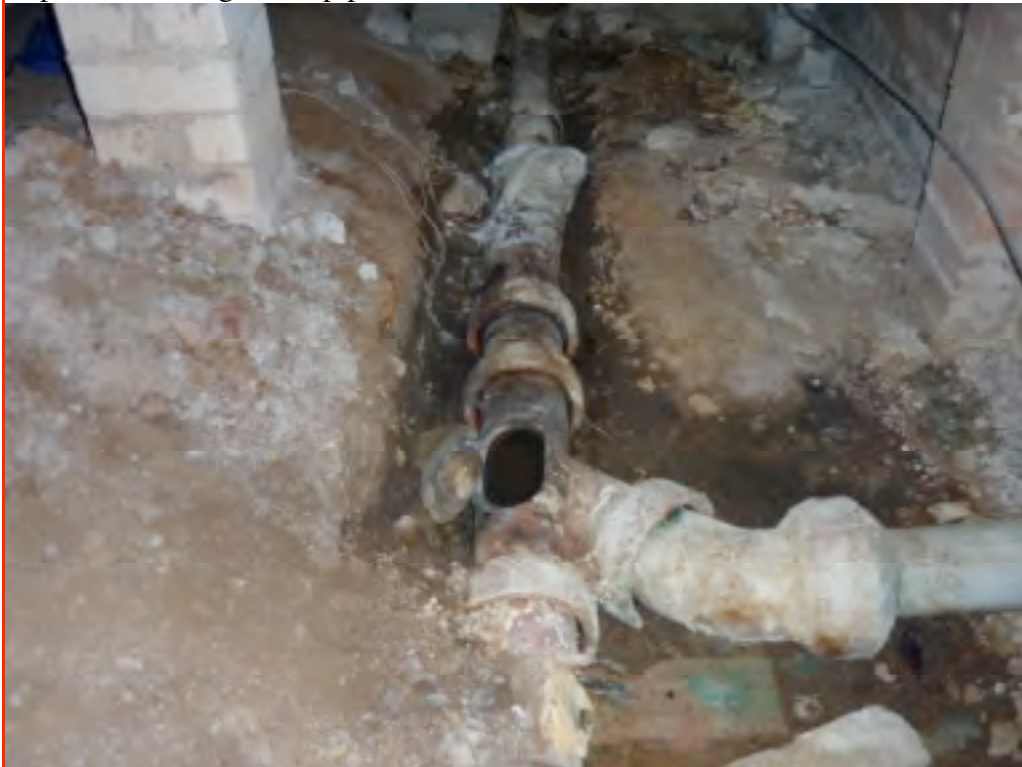
Ventilation to the sub-floor space was observed to be inadequate. To help protect against the degradation of timber, caused by fungal decay and/or insect attack, sub-floor ventilation should be improved.

We recommend the removal of forming timbers in place below suspended concrete floors, as these timbers predispose the property to subterranean termite attack.

Repair the leaking sewer pipe in the subfloor.

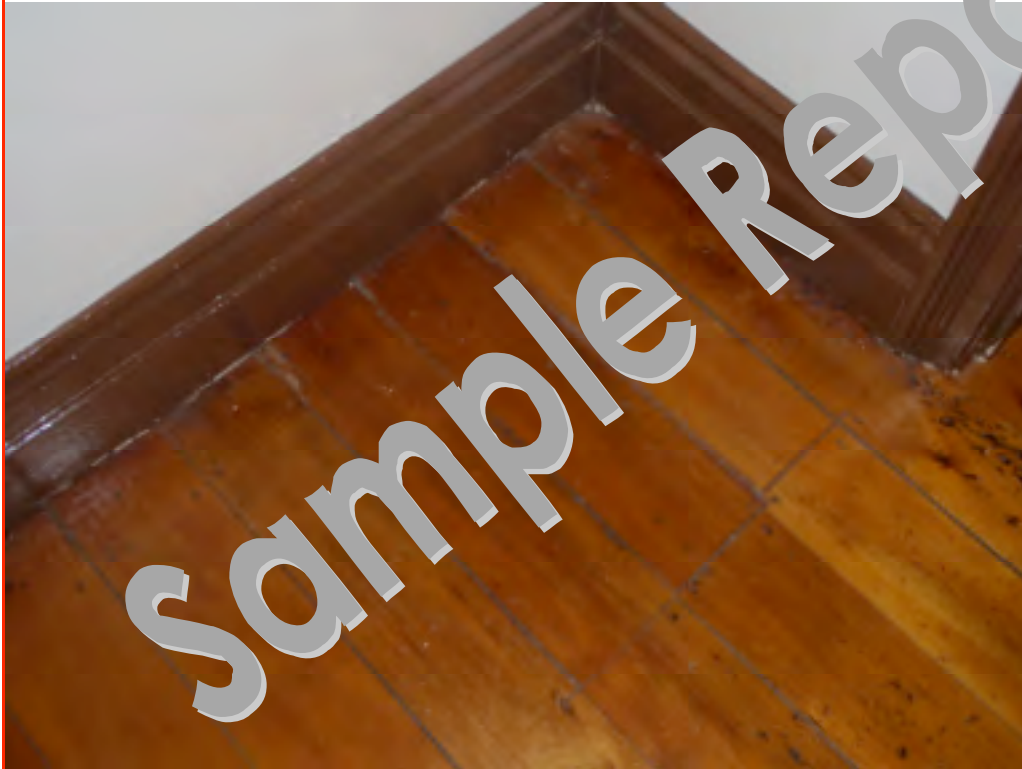
An inspection of the sub-floor area to the rear dining area was not possible due to the manhole being fixed shut.

An inspection of this area is necessary to inspect the sub-floor ventilation, to adequately check for shower leaks, footings problems and to check for timber decay or termite damage.

It is highly recommended that access be made and an inspection be carried out prior to purchasing this property.
