COMPLETION BUILDING REPORT

REPORT NUMBER: 110195

Childs Property Inspections was commissioned by Ryan Death to carry out a completion report on the above property. The purpose of this report is to provide a list of incomplete or defective works to the builder for rectification prior to occupation.

This report is limited to an inspection of apartment 272 only.

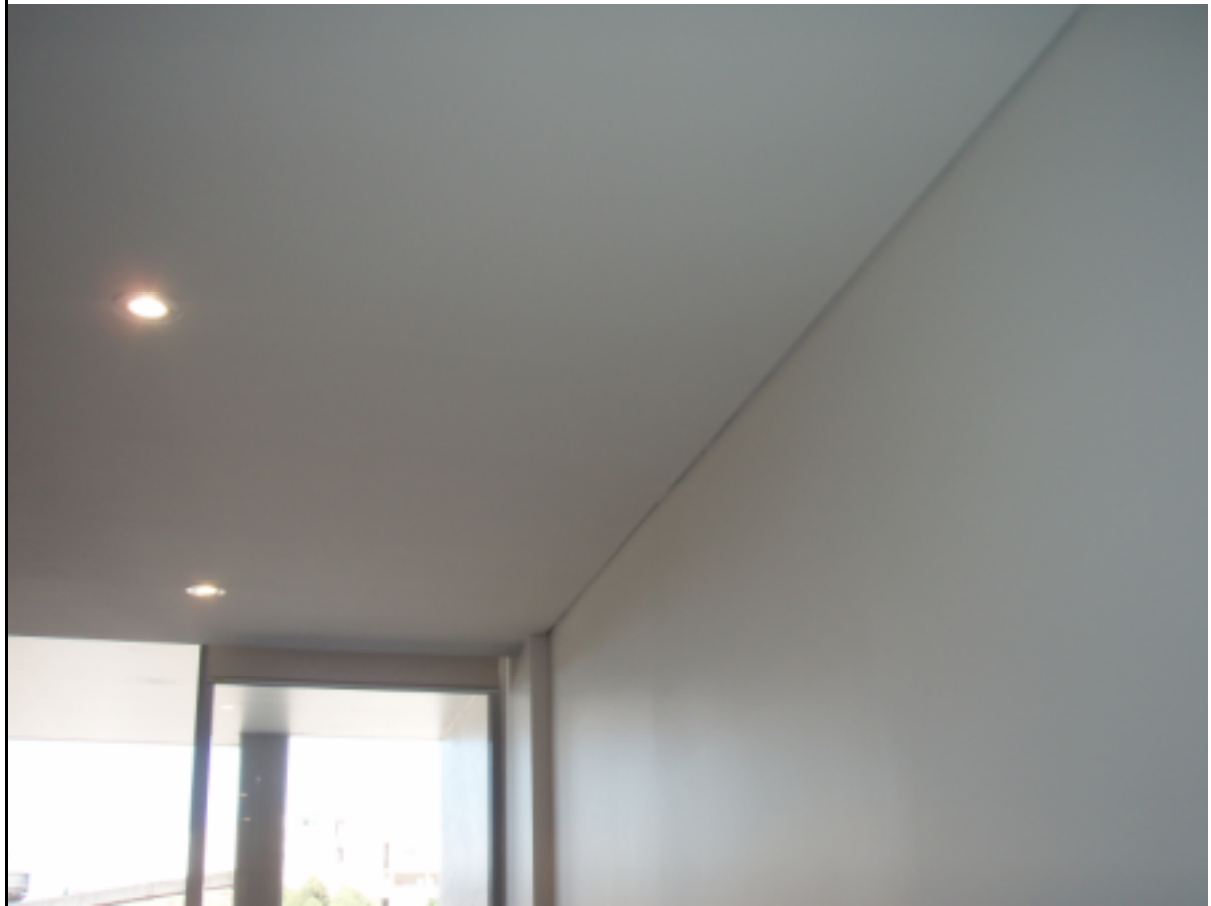
Repair the poorly finished ceiling surface to the south side of the living room.

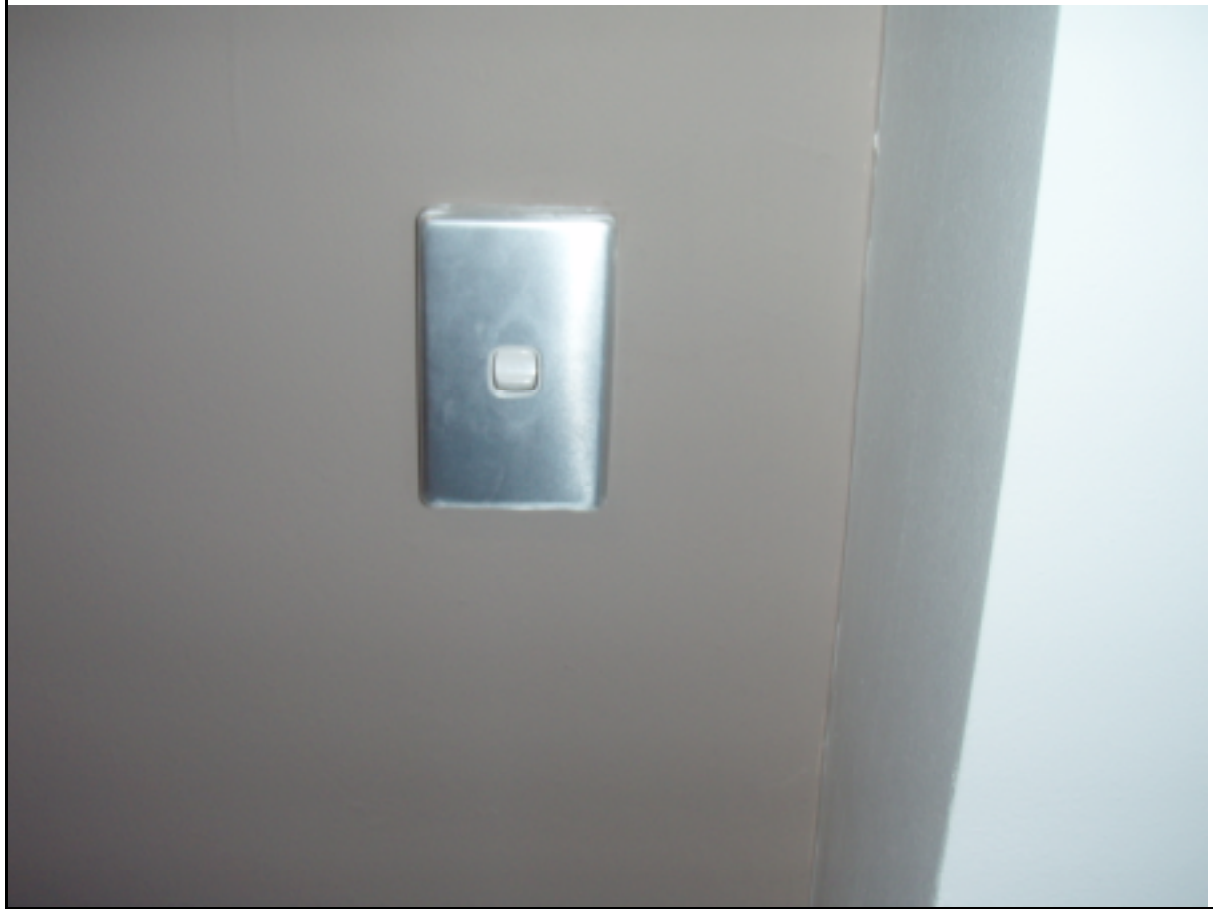
Re-fit the balcony light switch so that it is plumb with the wall.

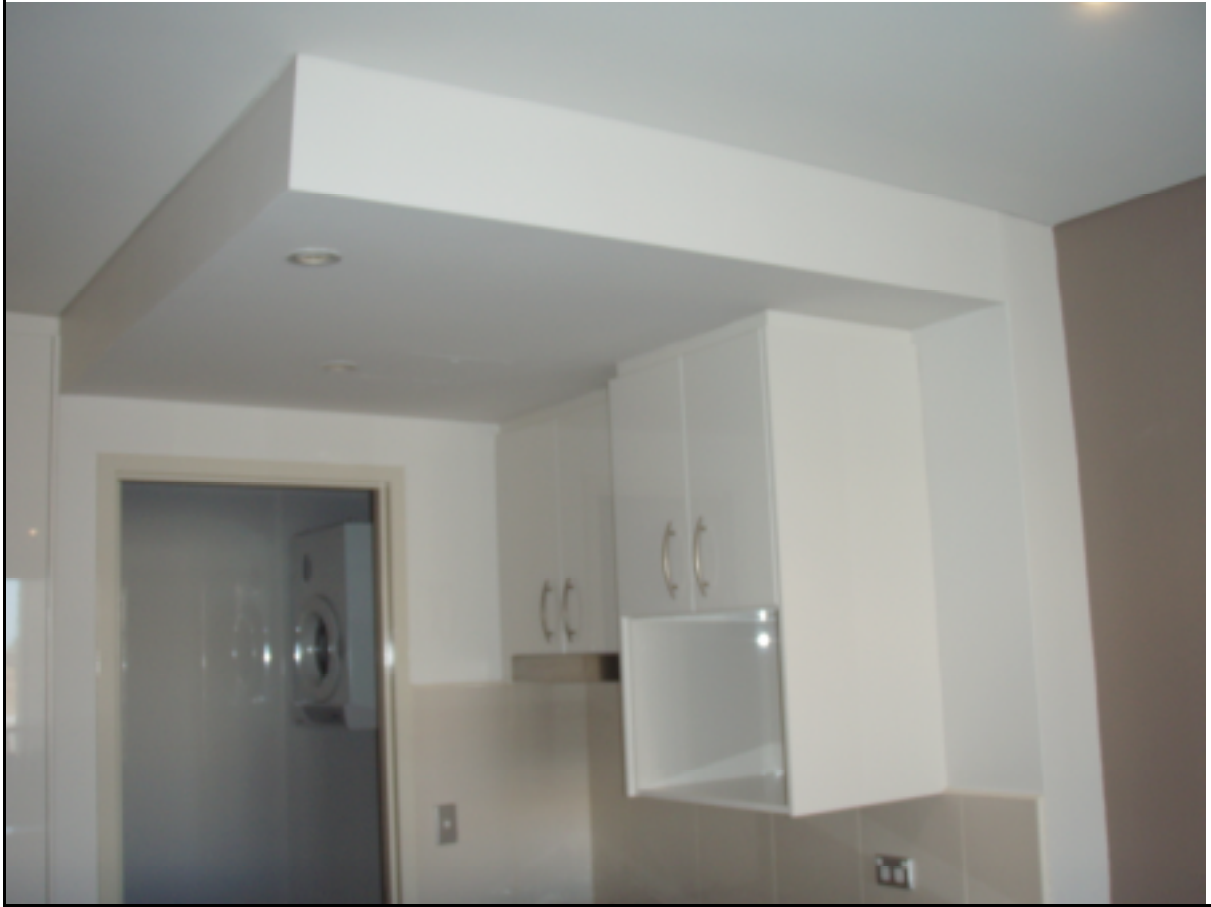
The kitchen ceiling bulkhead and plumbing riser have been installed out of level and out of square.

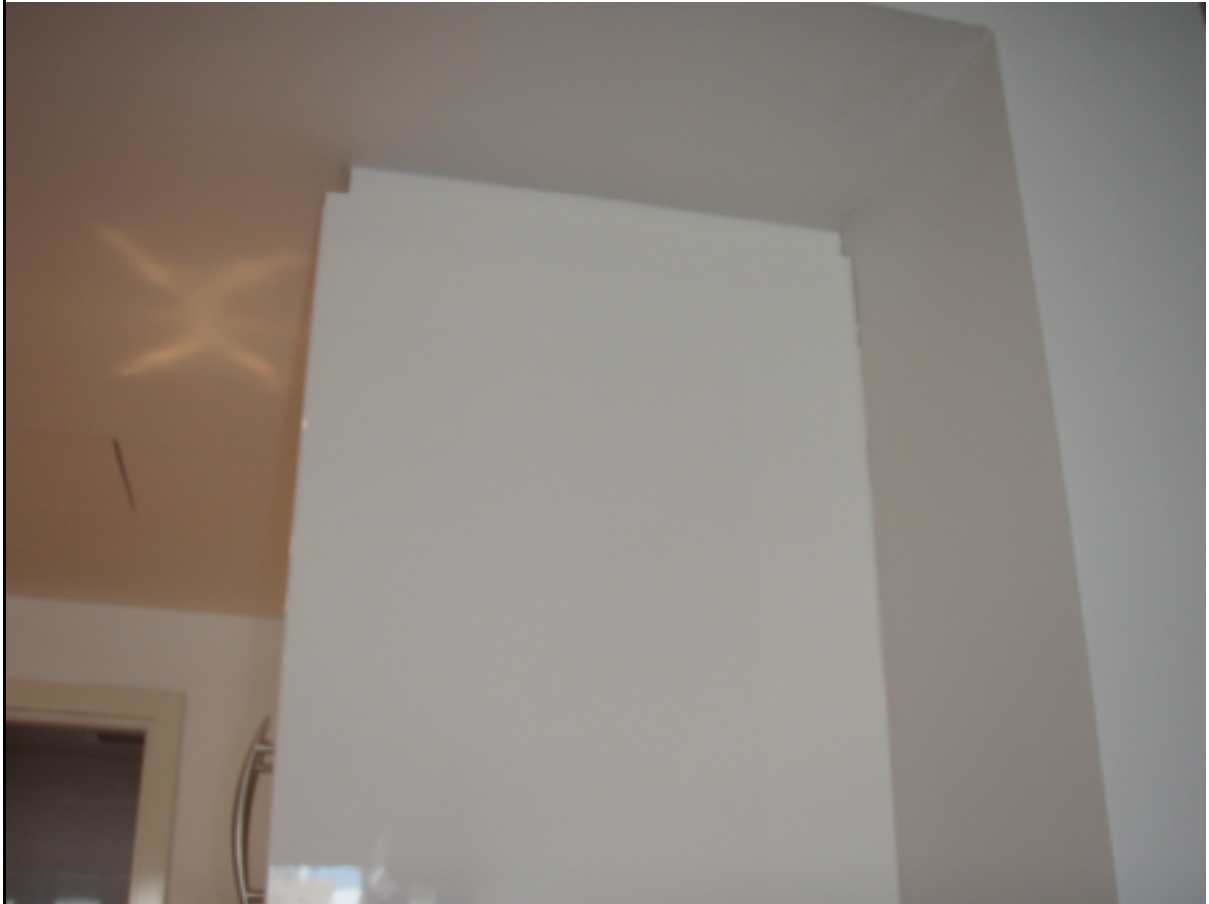
Seal the join between the kitchen wall cupboard and the wall lining above the microwave oven shelf.

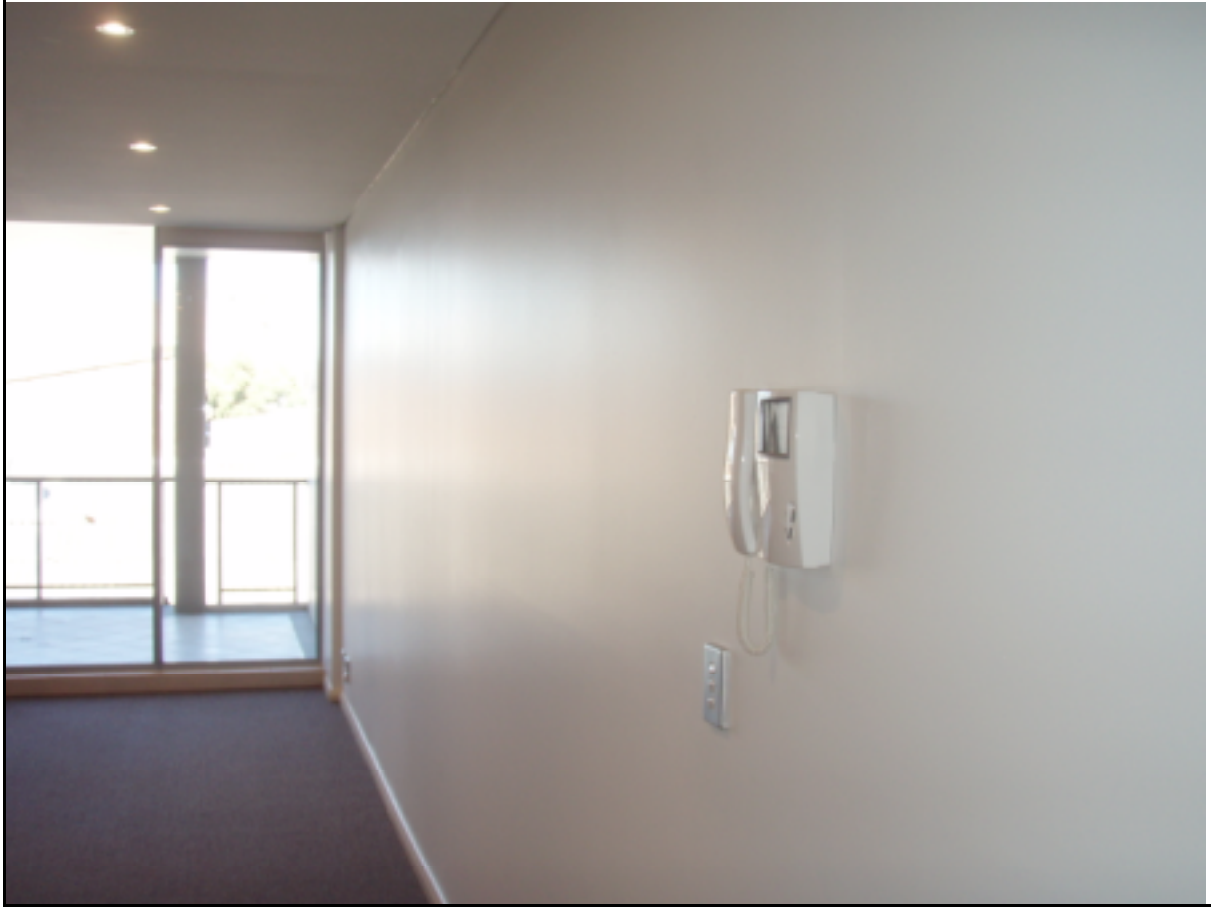
The wall linings throughout the apartment have been poorly finished. This is most notable in the living room.

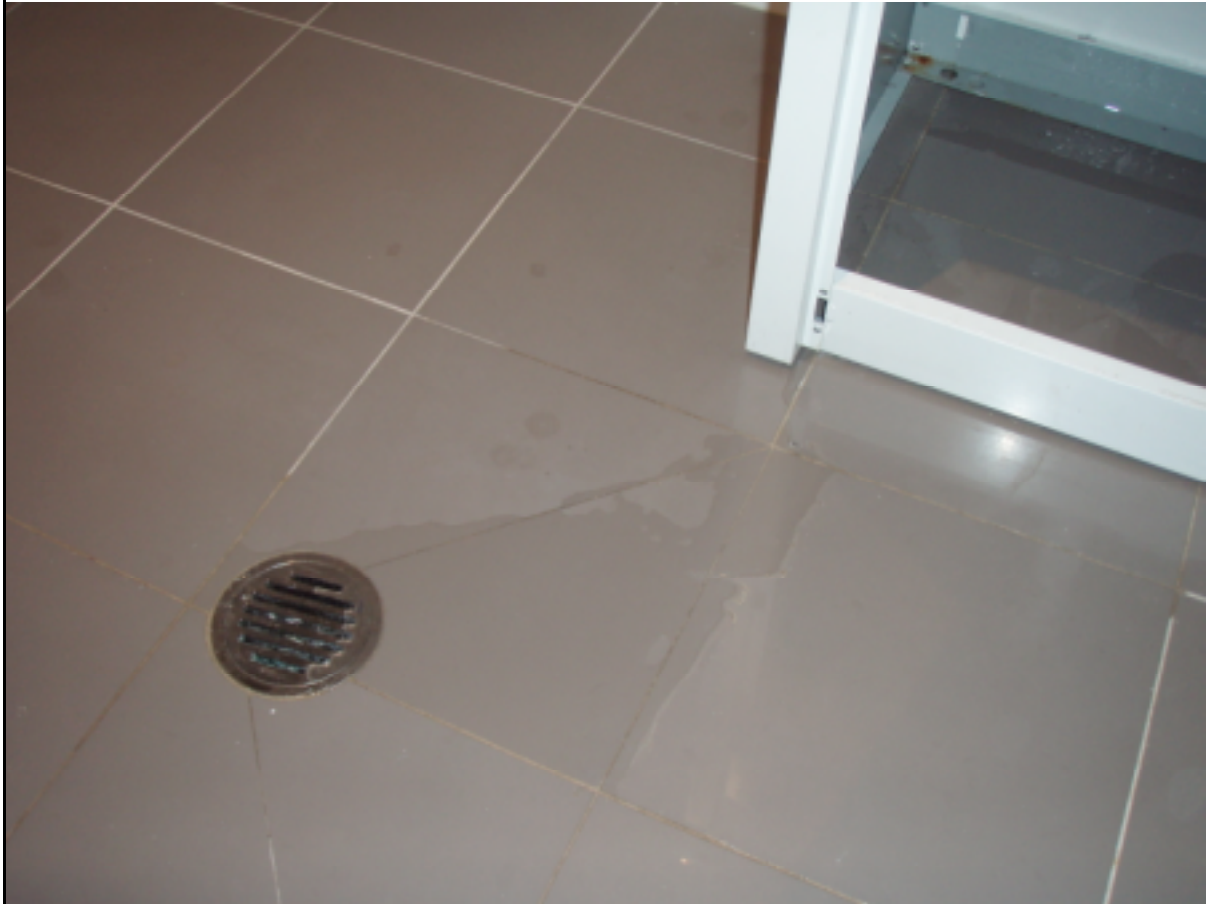
Water was found ponding on the floor tiles near the laundry tub. No leaks were noted at the time of the inspection, however this should be monitored.

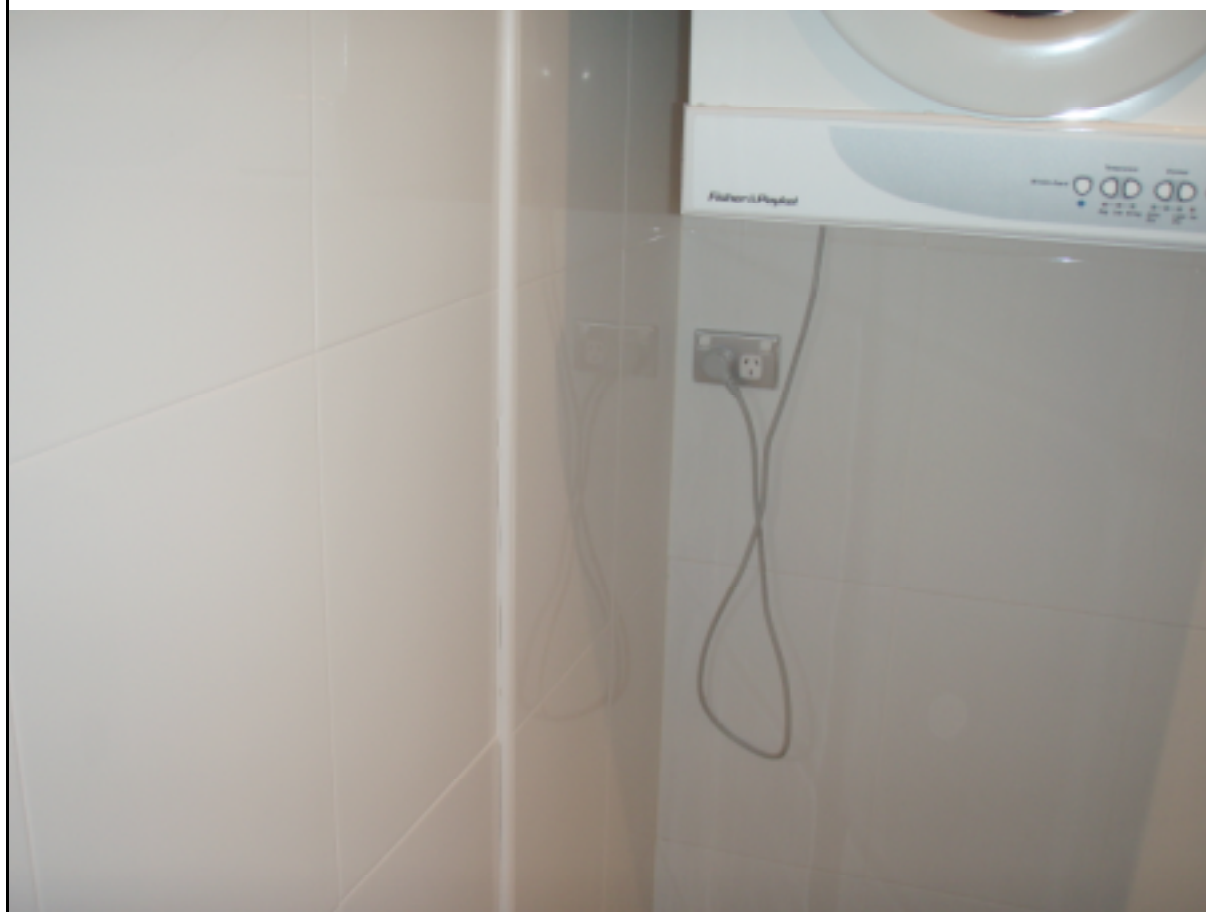
Re-grout the wall tiling at the wall step on the laundry west wall.

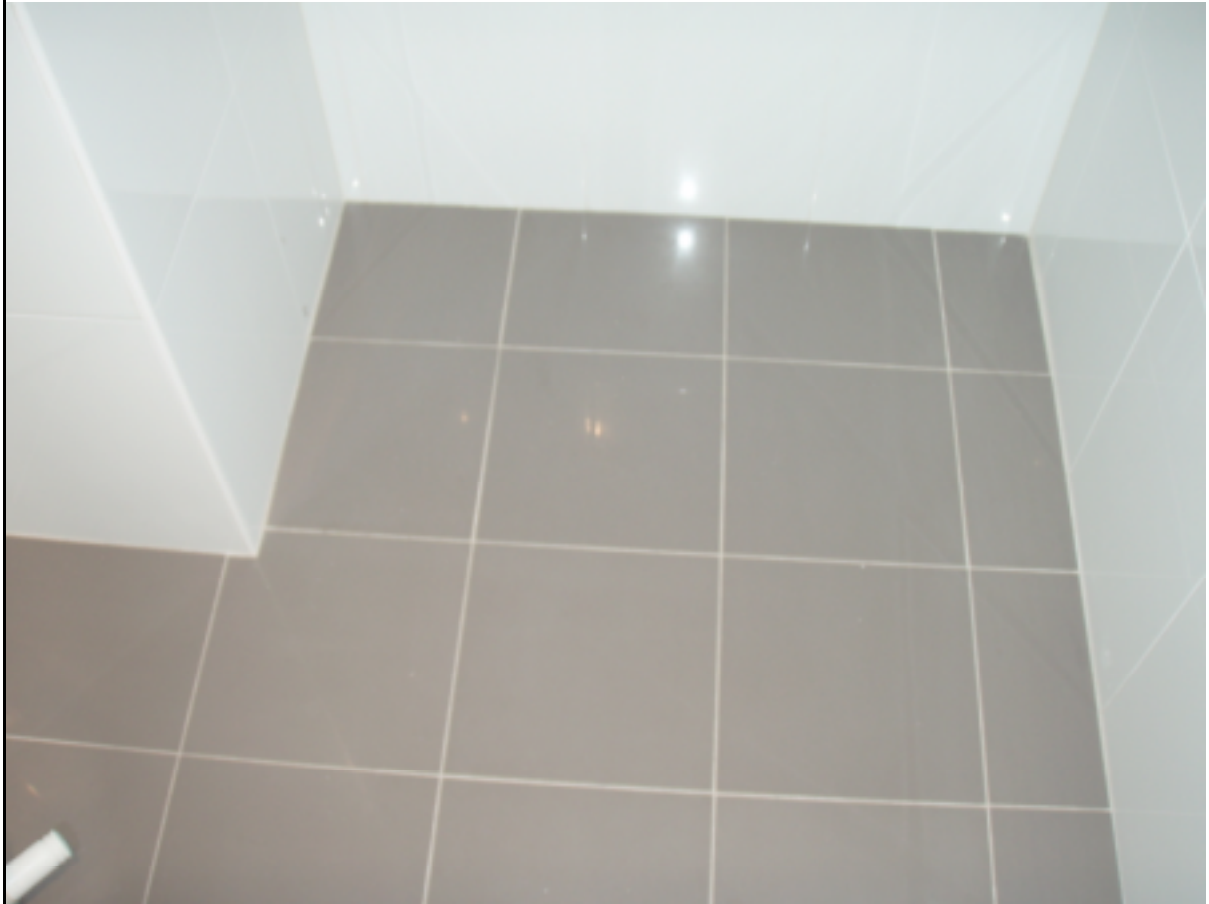
Replace approximately 5 drummy tiles to the laundry floor. This drummy sound is NOT due to acoustic underlay.

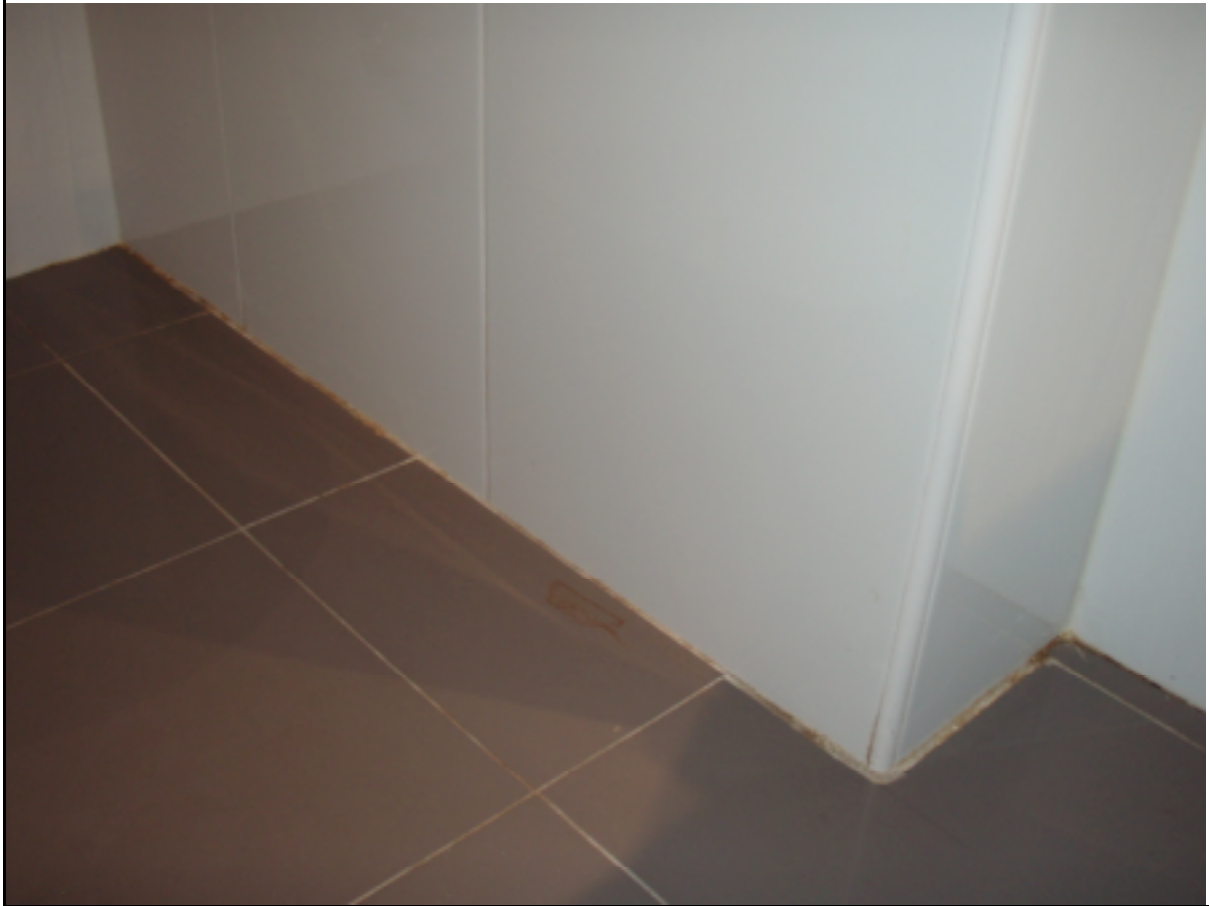
Leaks have occurred from the bathroom vanity unit in the past as water staining was noted to the floor tile grout and slight swelling due to moisture was noted to the vanity bottom shelf. This area should be monitored and the shelf replaced.

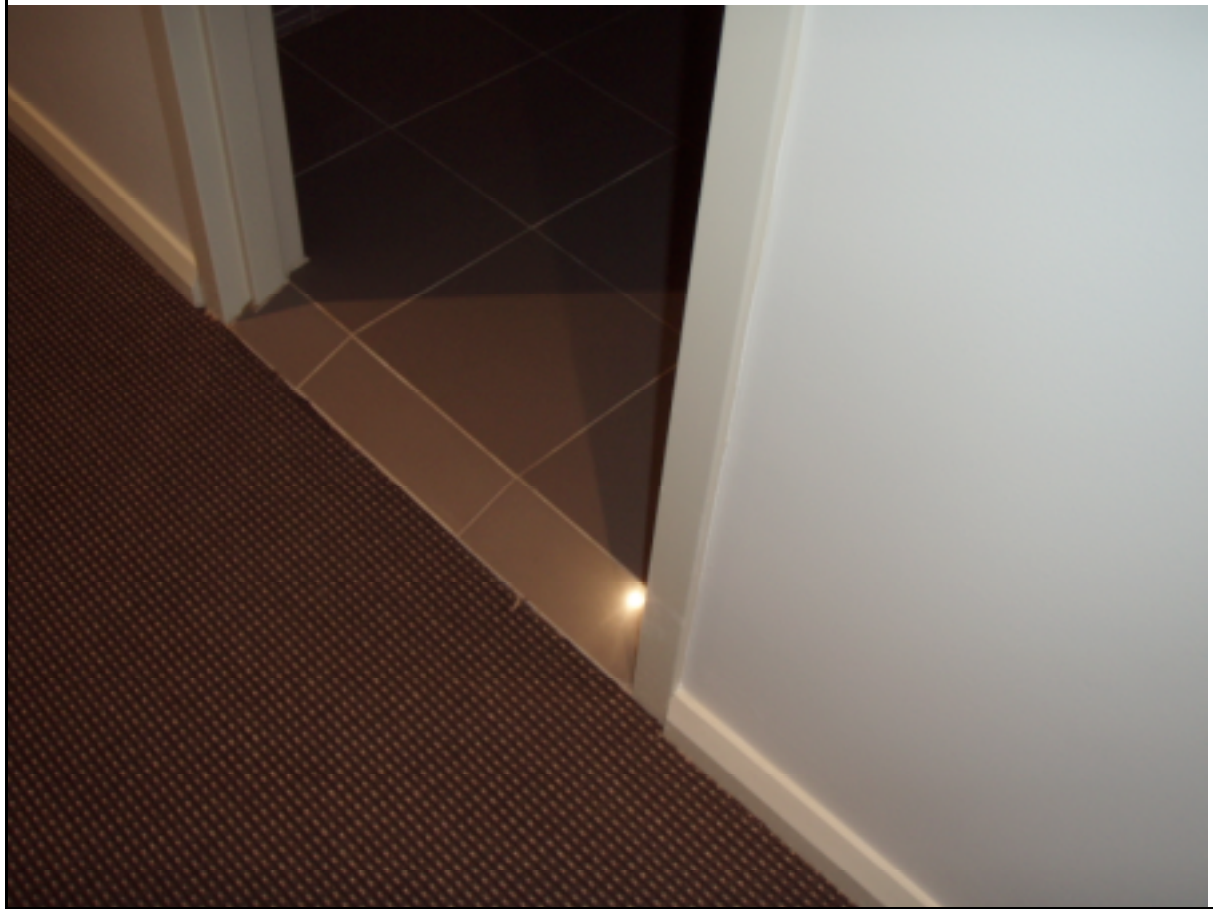
Repaint the bathroom doorjamb.

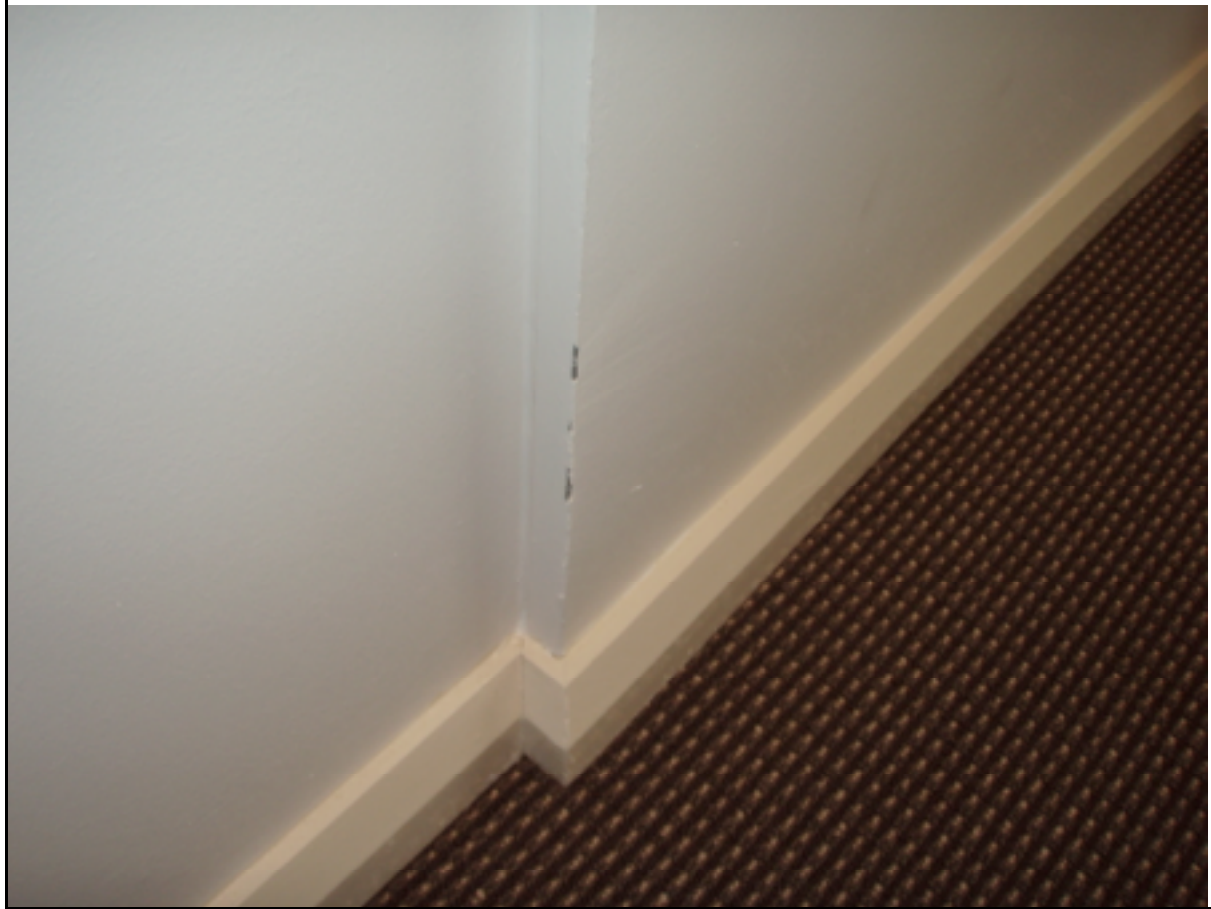
Repaint the wall at the step near the rear bedroom door.

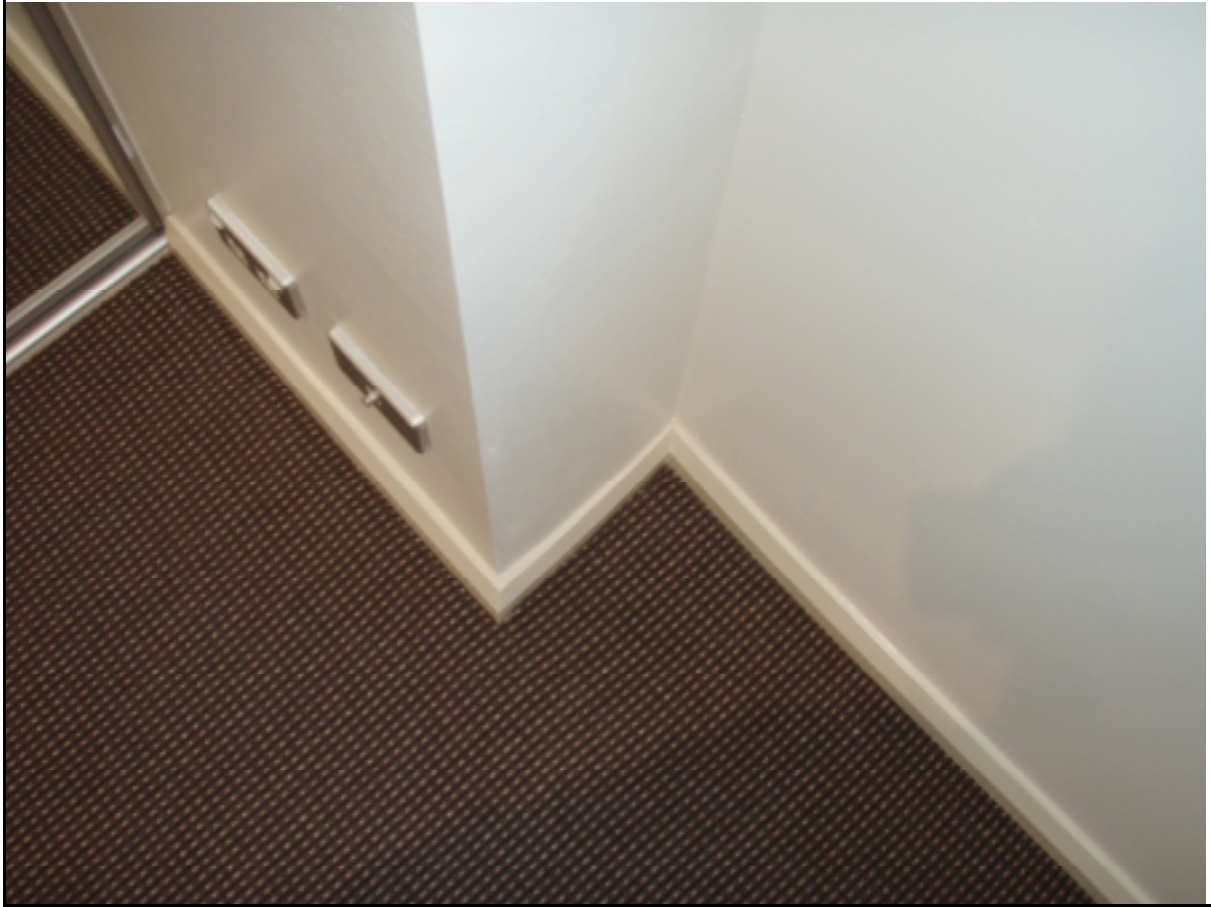
Repair the poorly finished, out of square wall lining and skirting board to the rear upper bedroom.

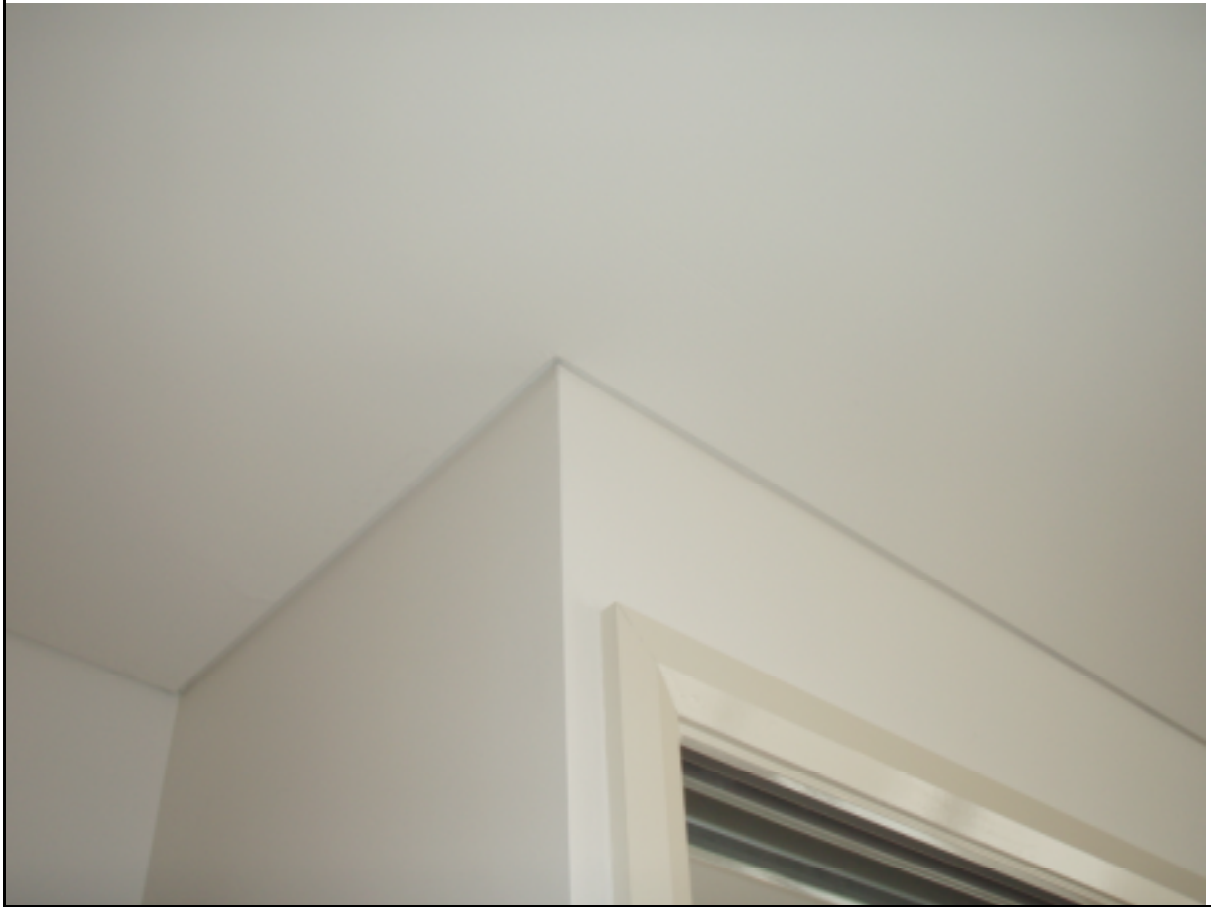
Repair the poorly finished ceiling near the wardrobe in bedroom 1.

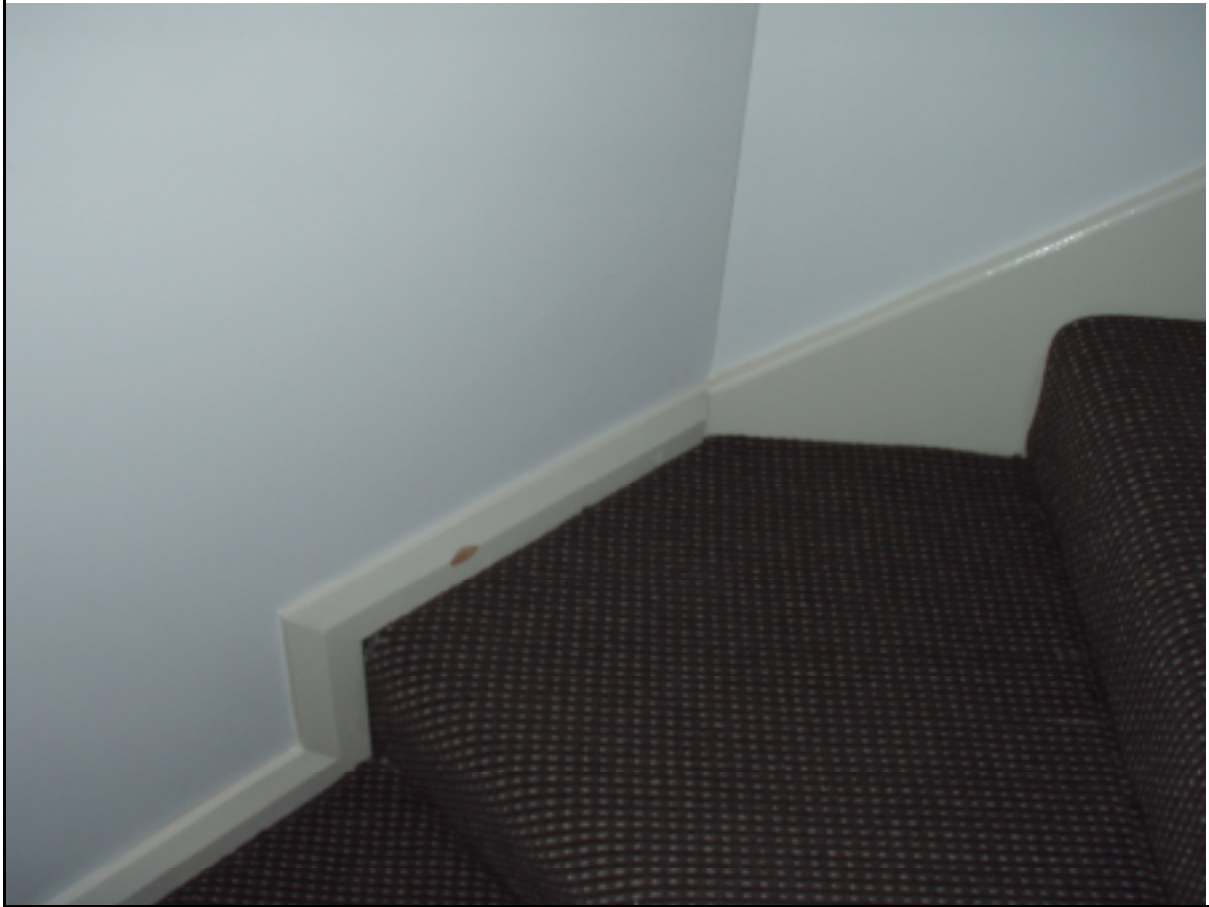
Repair the skirting damage to the stairwell.

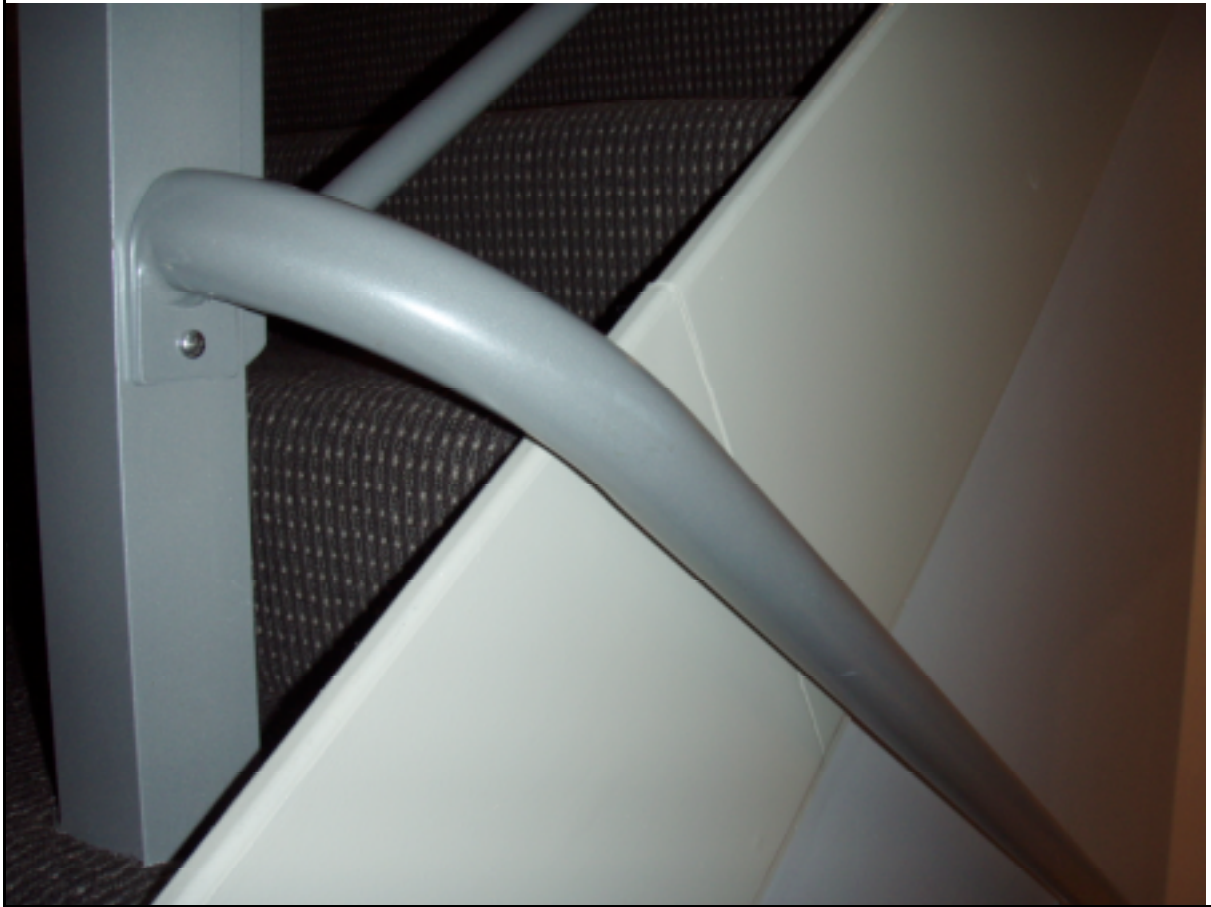
Improve the stair stringer finish at the join.

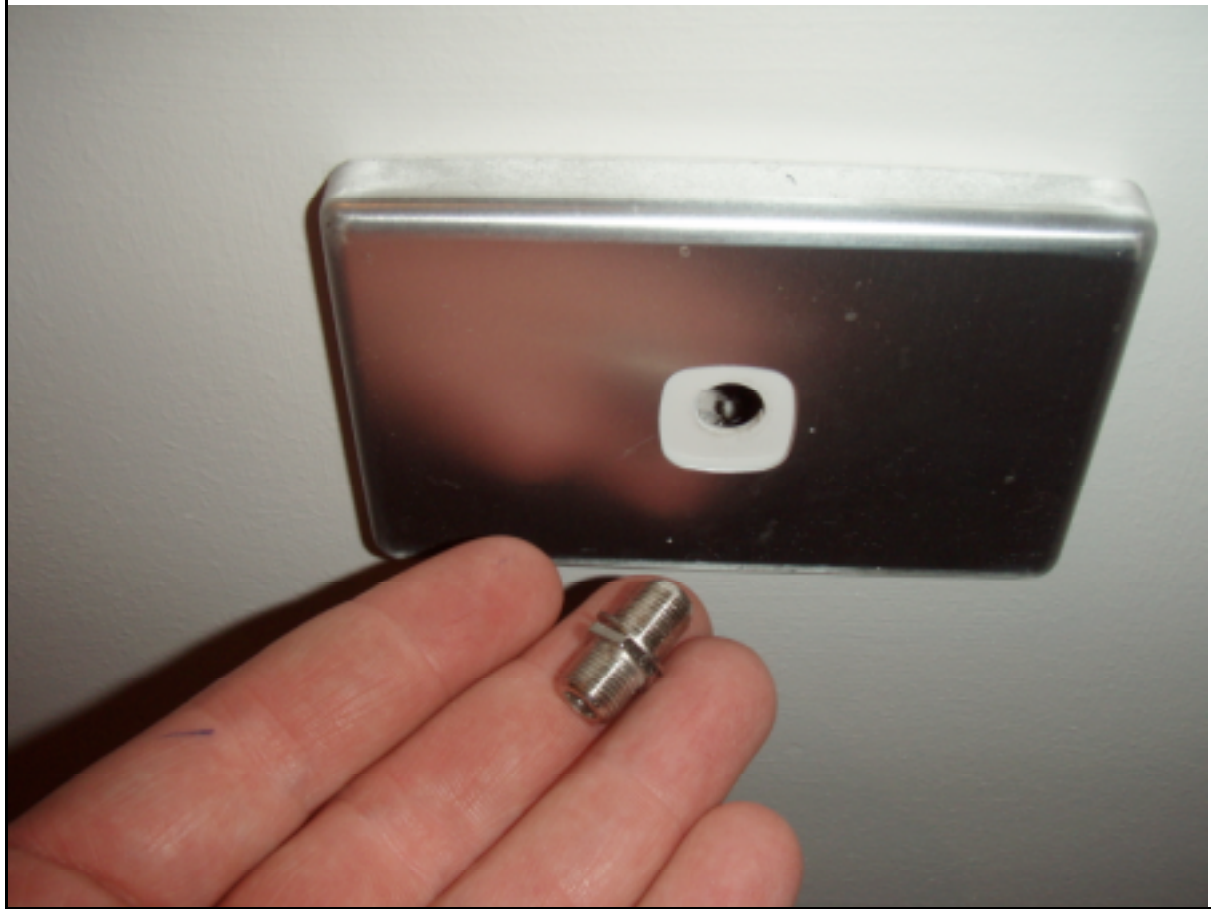
Complete the installation of the main bedroom TV aerial.

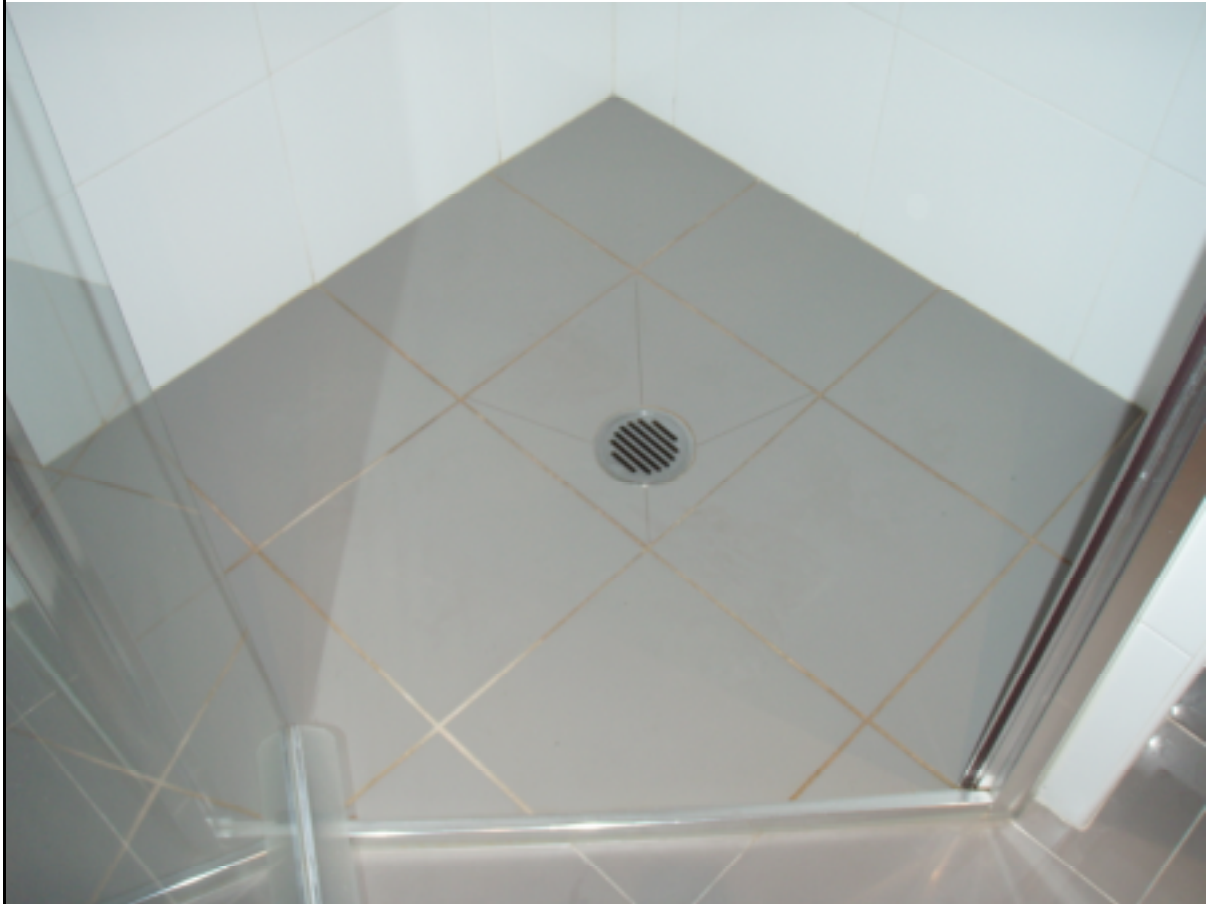
Replace the stained grout to the ensuite shower floor tiles. This shower has been used many times to have grout staining to this extent.

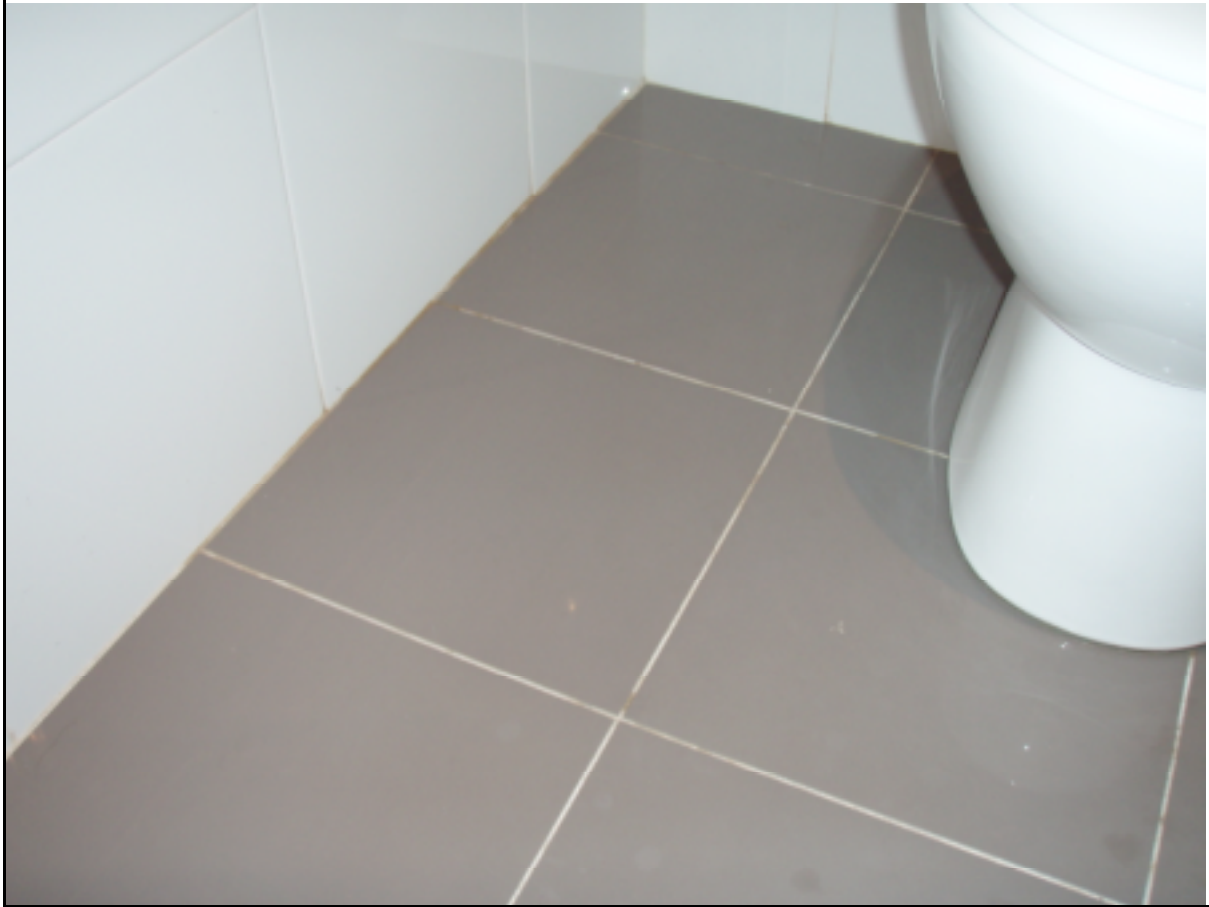
Monitor staining to the tile grout around the ensuite toilet.
