# PRE-PURCHASE BUILDING REPORT

sample Report

The property inspected is a single storey, semi detached building of full masonry construction. This structure is on pier and strip and concrete slab footings, with a skillion roof covered in corrugated steel.

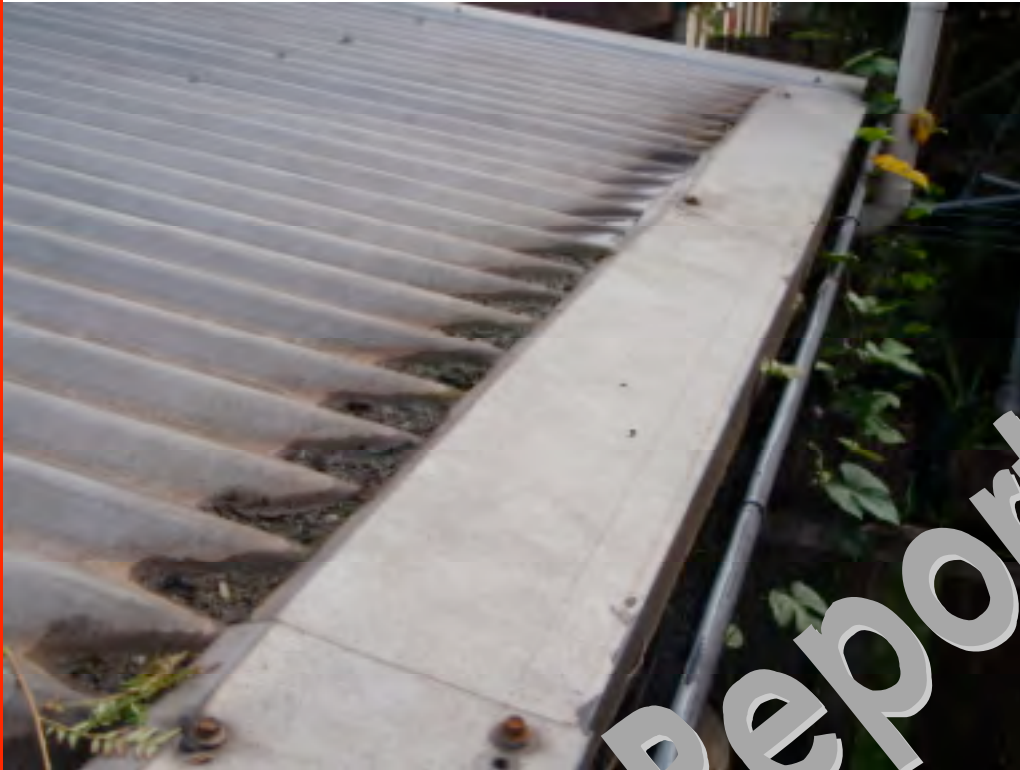
The gutters to the front, rear and right side are rusting and will need to be replaced.	\$1,200.00
Repair the leaning fence to the front boundary.	\$350.00

Remove the flashing to the gutter area at the rear of the home to allow stormwater to enter the gutter. \$2,000.00

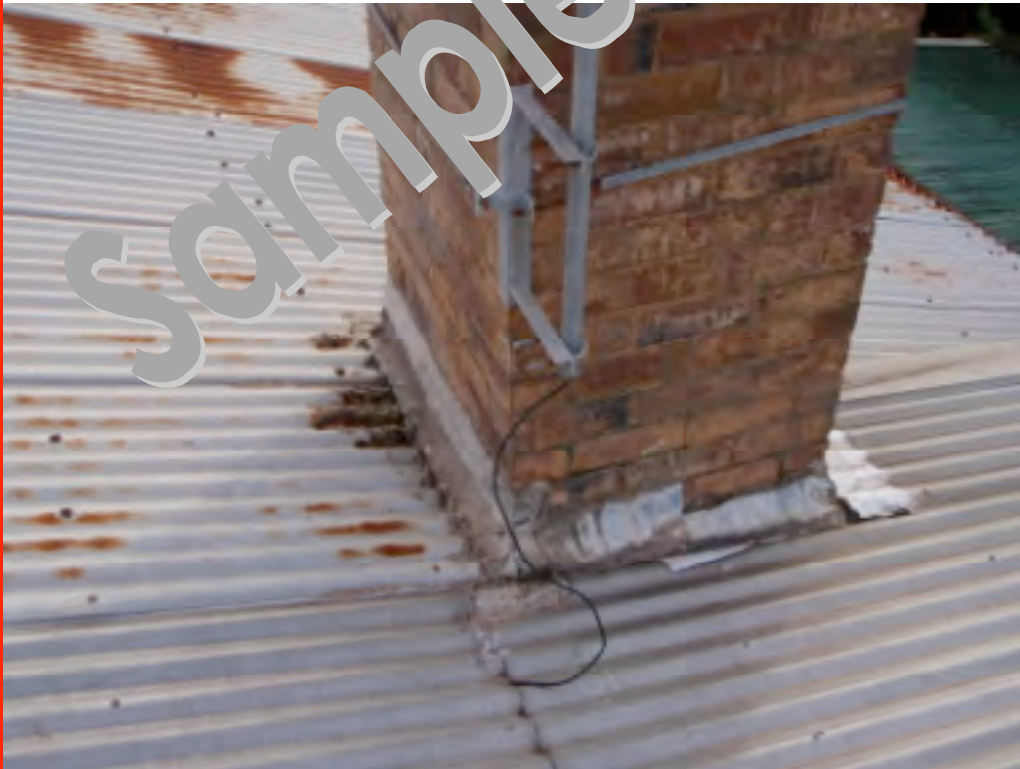
Cracked tiling was noted to the rear courtyard. Replacement is not essential at this stage.

Replace the inadequate and deteriorated flashing to the chimney area. \$650.00

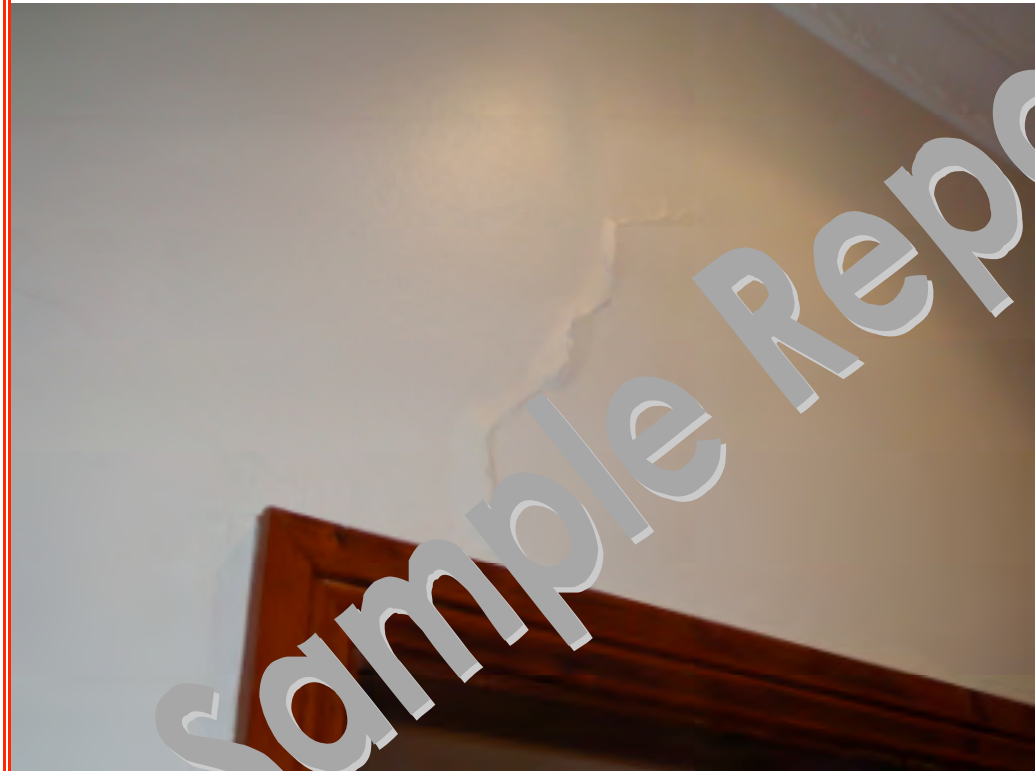
<p>Settlement cracks have developed to the internal walls in several areas.</p> <p>Generally minor hairline cracks of up to 1mm will occur in the early settlement stage and then cease. Similar to masonry cracks, however these cracks will need to be monitored by a structural engineer over time to determine if further movement is occurring.</p>

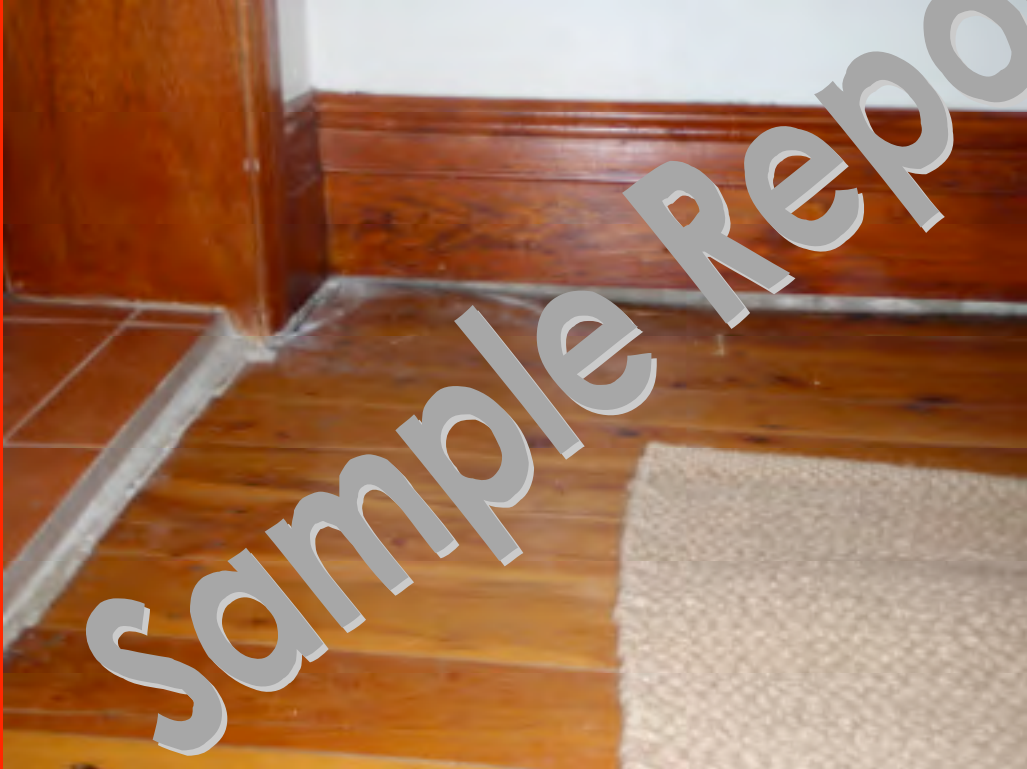
The join between the kitchen bench and the wall splashback should be re-sealed with a silicon sealant to prevent moisture entering into the cupboard below.	\$90.00
The doors to the rear and front require easing and adjustment in order for them to operate correctly.	\$200.00
The timber windows in a number of areas require maintenance, including:  Replacement of glazing putty Easing and adjustment Replacement of decayed timbers Replacement of hardware	\$1,200.00
Drummy plaster render was noted in a number of areas due to rising damp, settlement and general age. Repairs will be required as this render becomes loose.	
Replace the damaged shelf panels to the third bedroom cupboard.	\$350.00
The flooring to the corner of the dining room has subsided. Access to the subfloor in this area will be required to determine the cause. A collapsed pier footing and /or moisture damage to the framing is likely	\$5,000.00
