Childs Property  
Inspections

# Pre-Purchase Building Report

## BUILDING DESCRIPTION

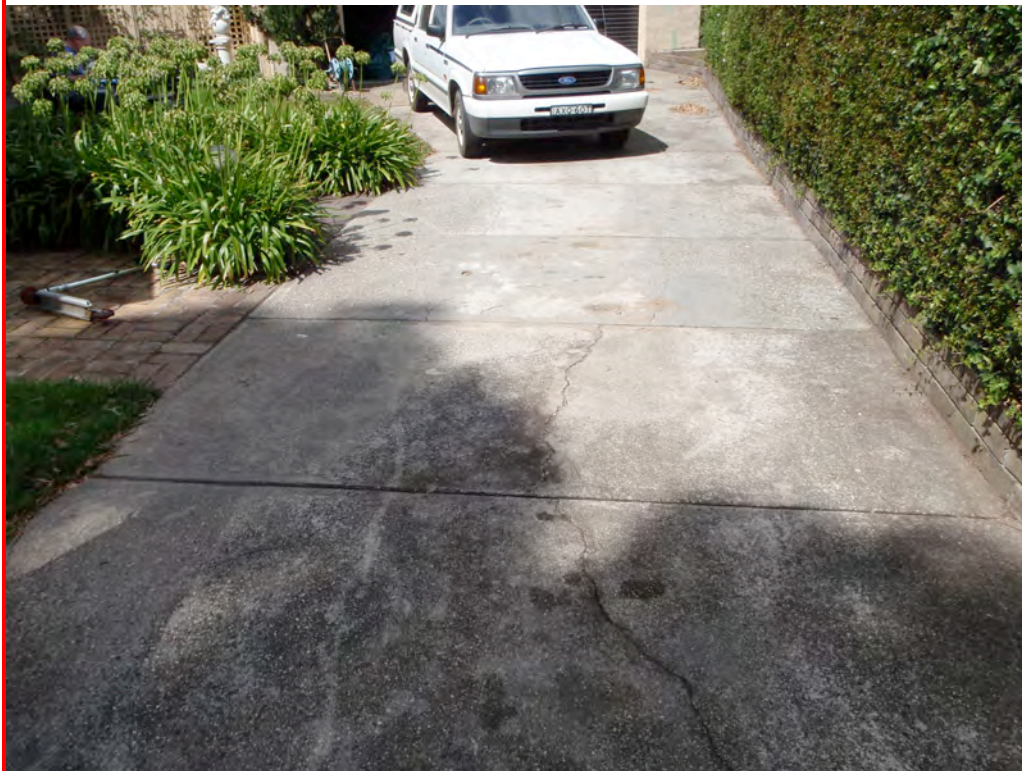
Cracking was noted to the concrete paths and driveway.

These cracks have been caused by the movement of the foundation material below, minimal expansion joints and possibly insufficient re-enforcement and overloading.

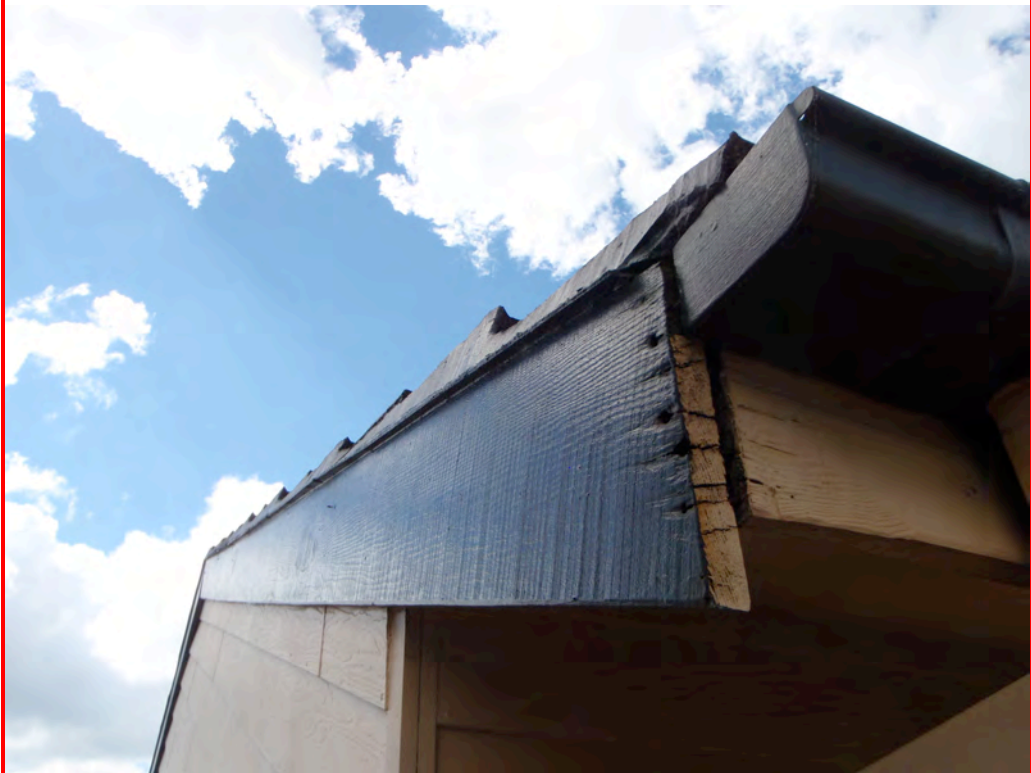
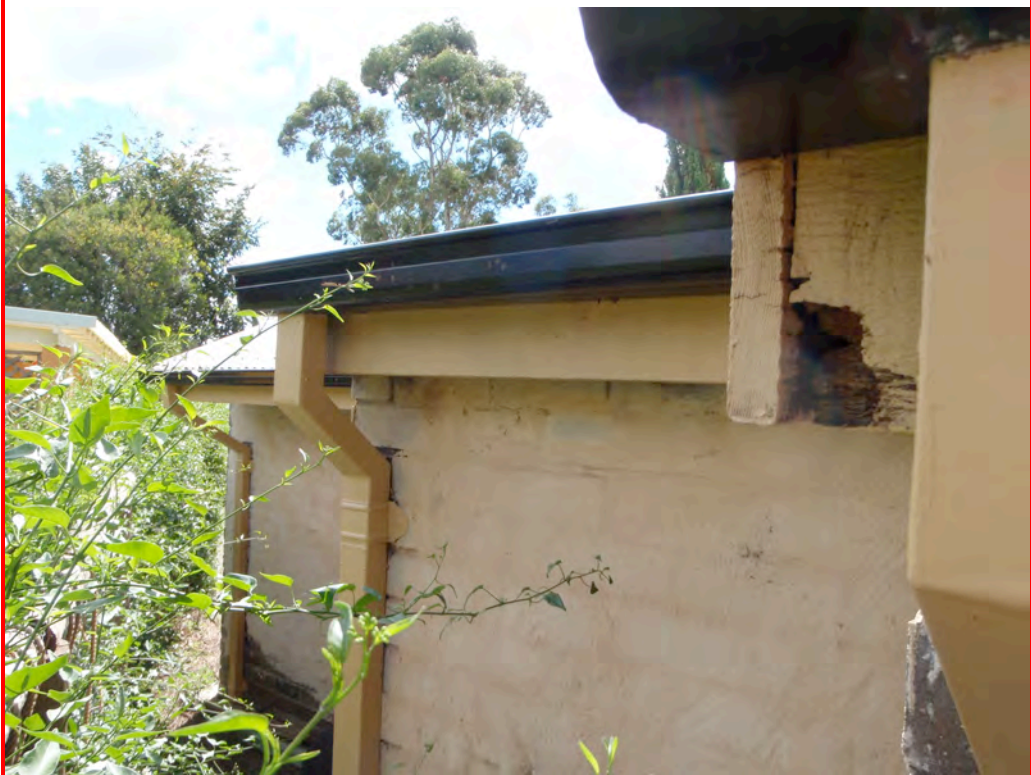
The following external timbers have decayed and will require repair or replacement by a licenced carpenter:

- 1. Barge board ends to the house.
- 2. Fascia board to the garage.
- 3. Screens and BBQ doors.

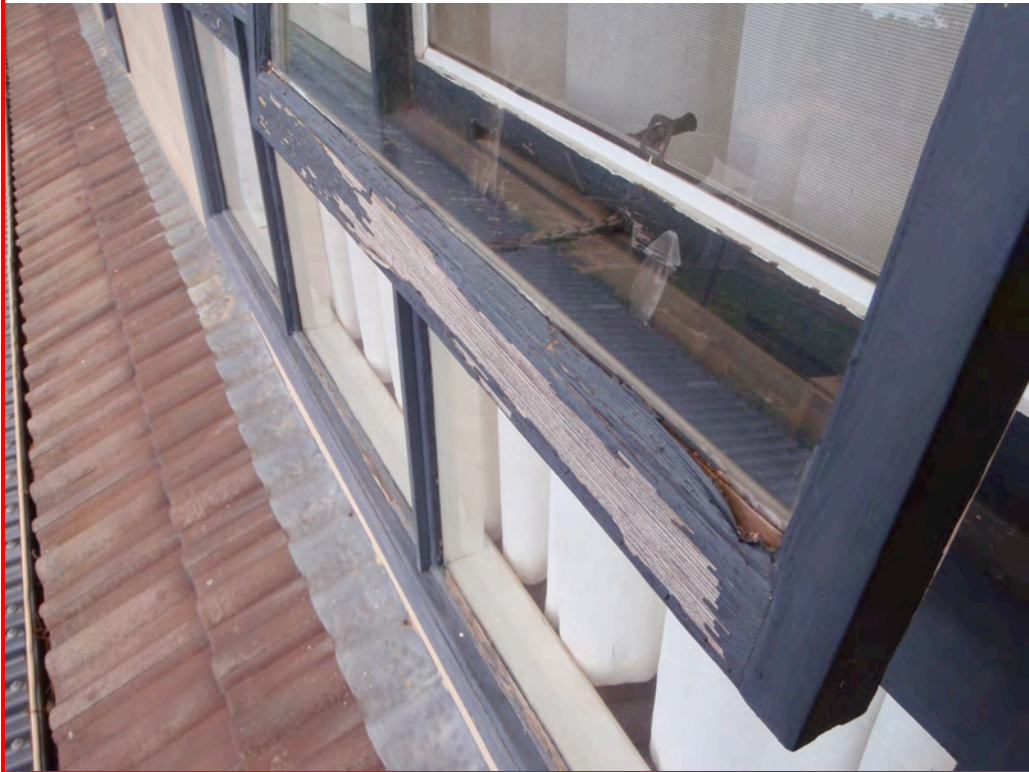
The external timbers to the property have aged and weathered in areas. These timbers should be painted immediately to prevent decay.

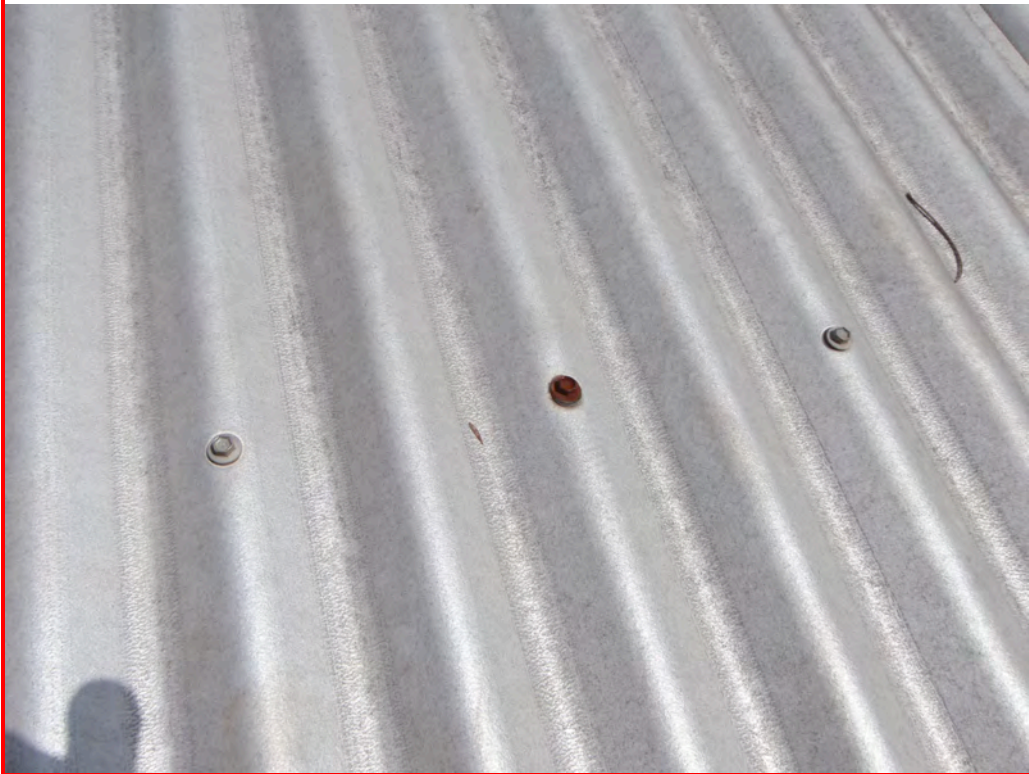
Replace the rusted fixing screws to the garage and kitchen roof.

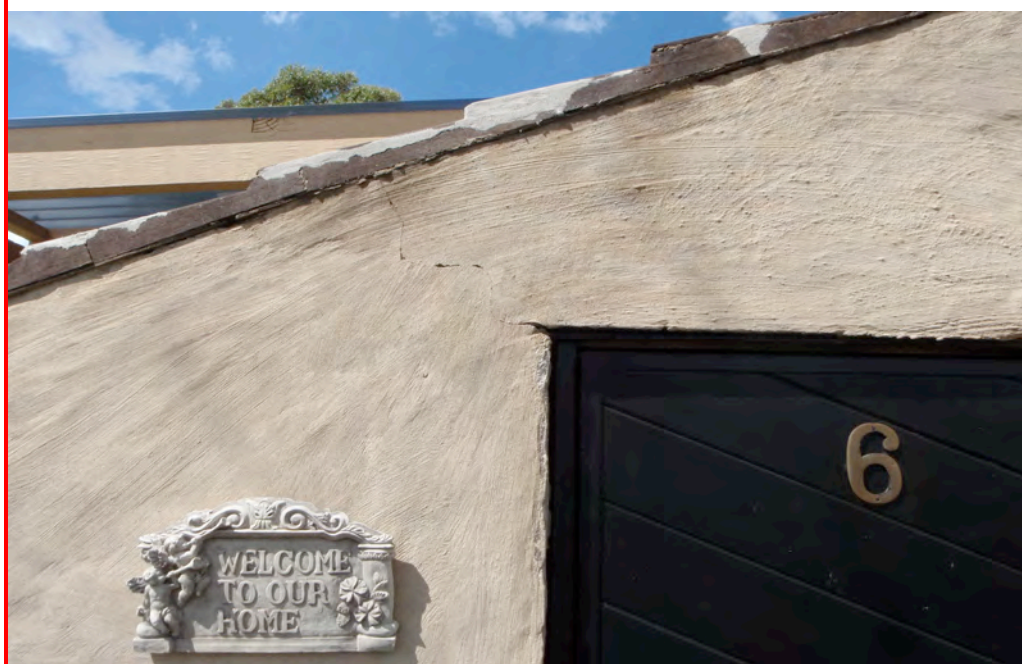
Settlement cracks have developed in the external wall surfaces to various areas.

These types of cracks are caused by differential movement of the building's footings over time on the foundation material.

To properly determine if further movement is occurring, these areas will need to be monitored by a structural engineer during the change in seasons and subsequent change in moisture content of the foundation material.

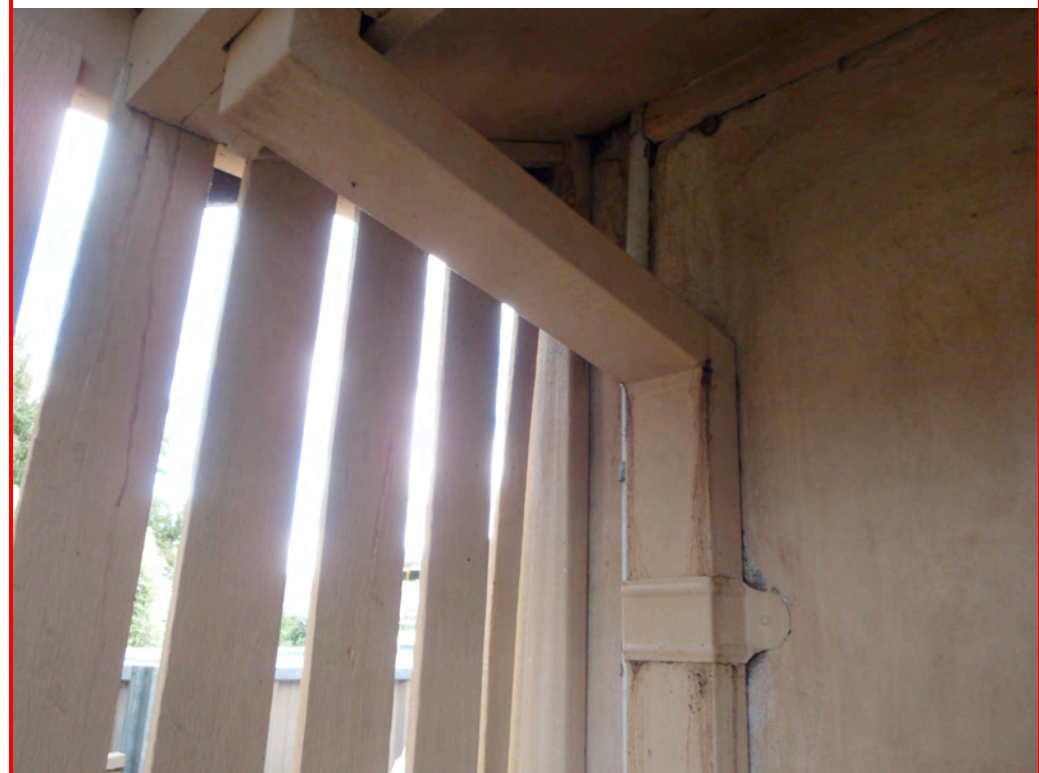
<p>The gutters to the property contain excessive debris. The gutters and downpipes should be regularly cleared of debris to allow stormwater to flow to the dispersal system.</p> <p>Blocked gutters and downpipes will cause water to pond, which in turn may cause water to flow back into the eaves. Ponding of water in gutters will also lead to rust.</p> <p>It is recommended that a stormwater and sewer line camera survey be carried out to check for blockages and breaks in pipes. A survey can be carried out for \$495.00.</p>	<p>\$200.00</p>
<p>Downpipes and gutters were found to be leaking in areas, and will need to be sealed at the joins to prevent leaks.</p> <p>It is recommended that a stormwater and sewer line camera survey be carried out to check for blockages and breaks in the pipes.</p>	<p>\$200.00</p>

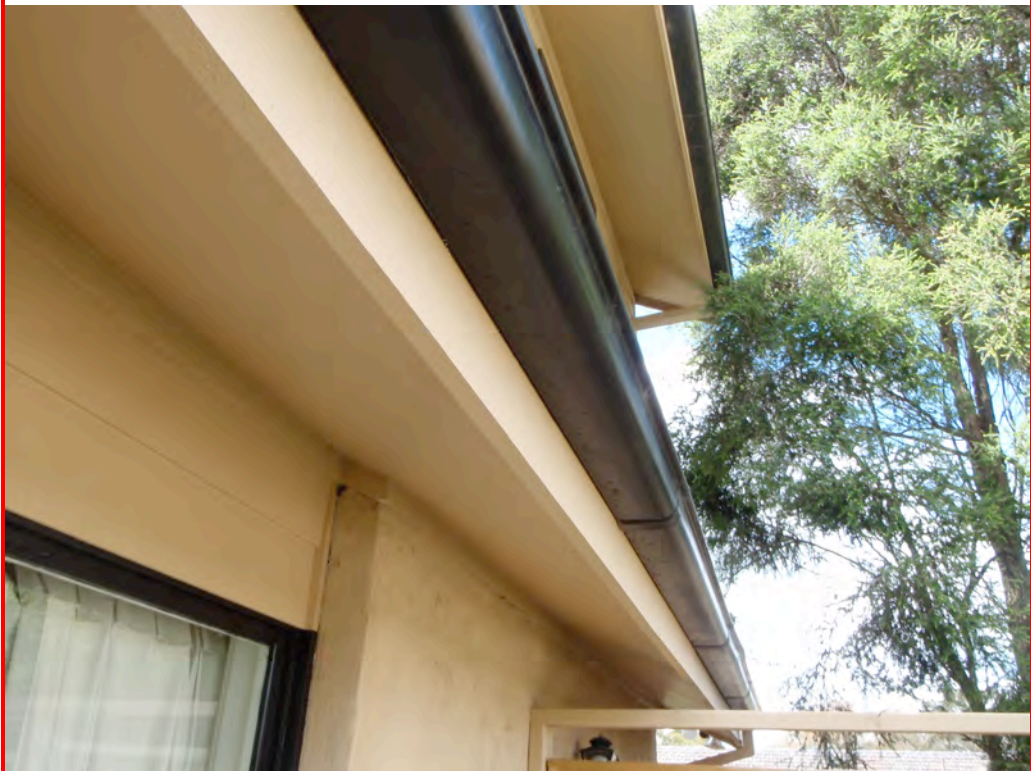
The gutters to the entire lower level roof are rusting and will need to be replaced.

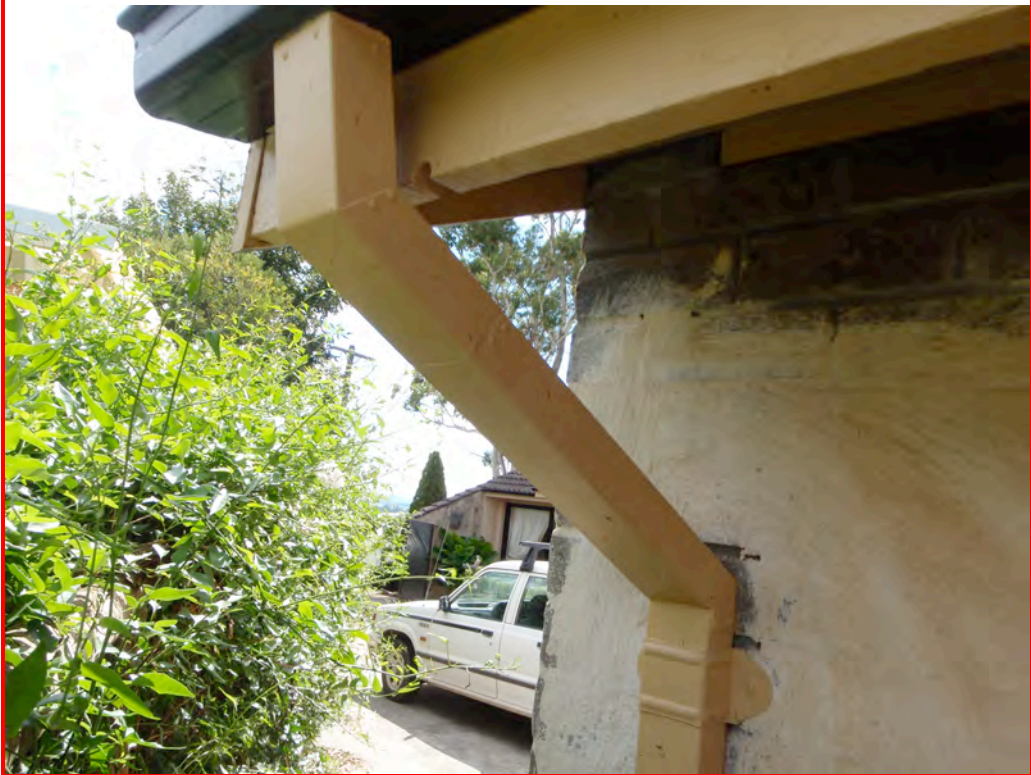
Replace the rusting downpipes to the garage.

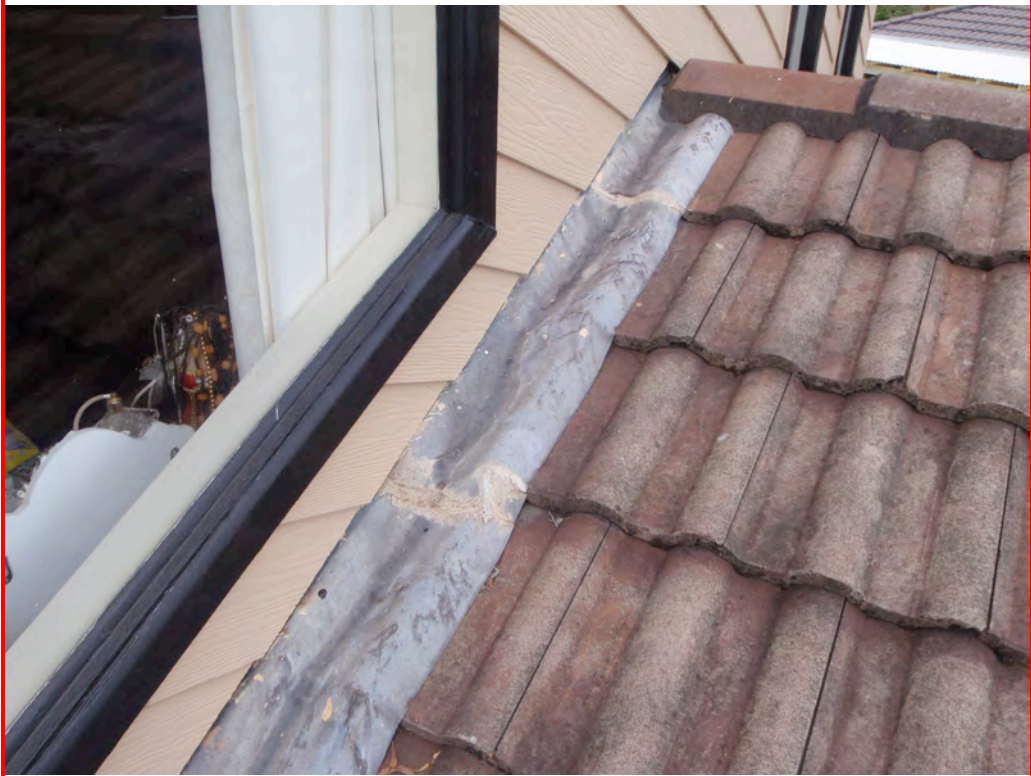
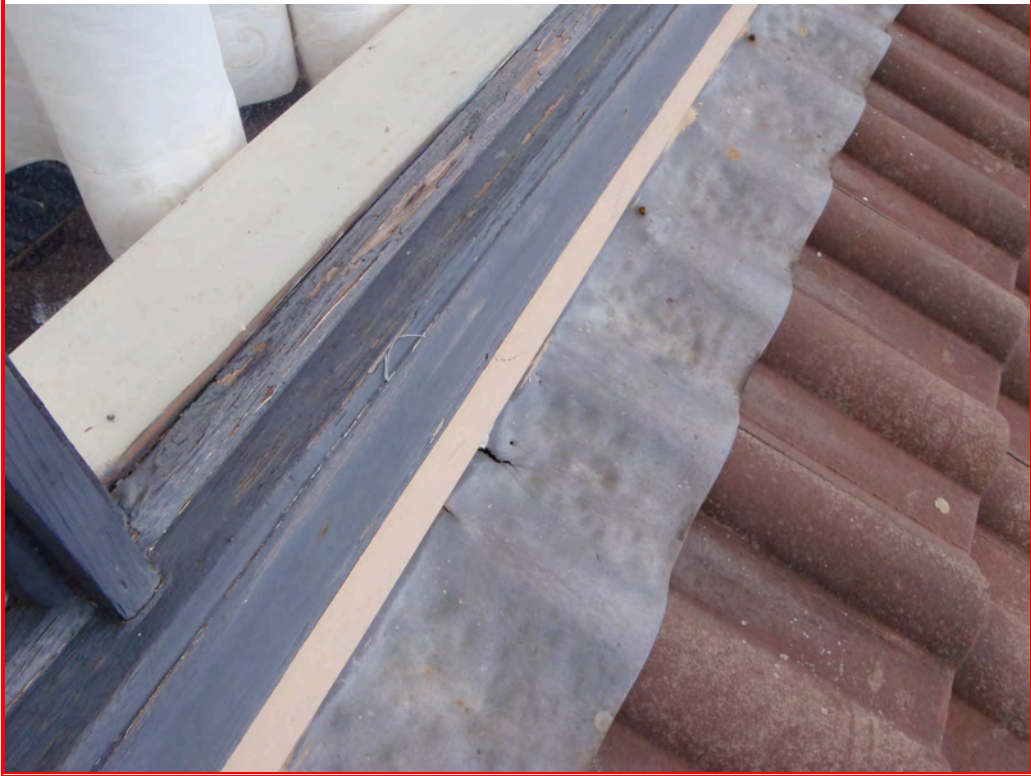
The lead flashing to the junction between the lower and upper level roofs in several areas has split due to metal fatigue.

This flashing will need to be replaced before water entry into the roof space occurs.

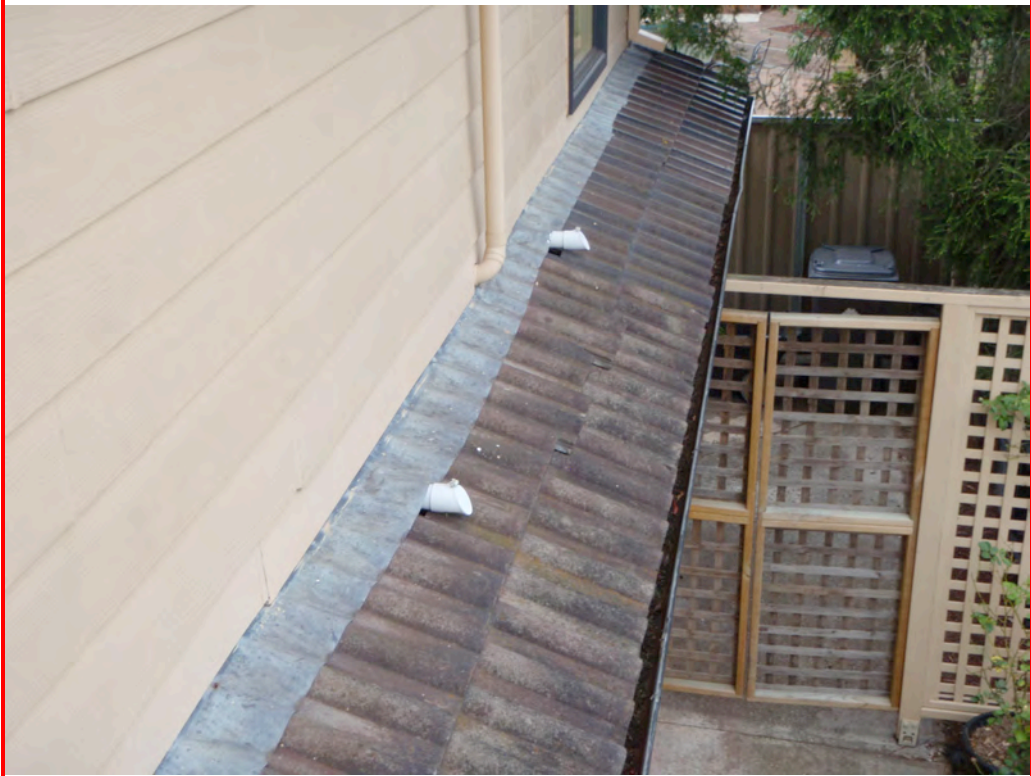
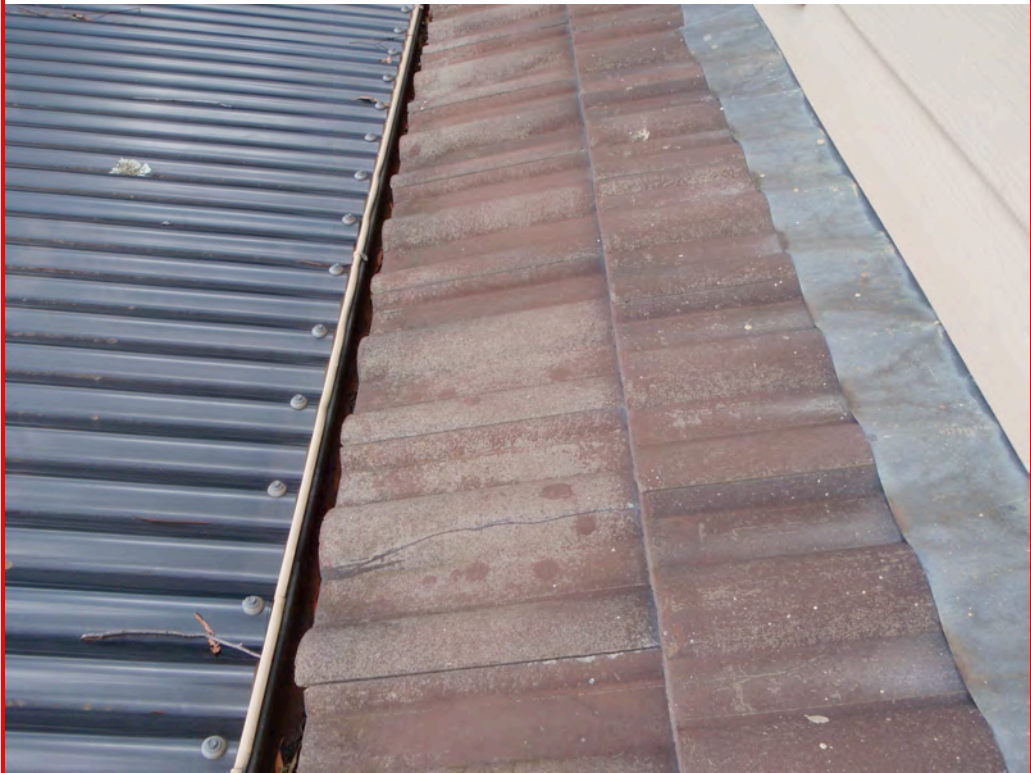
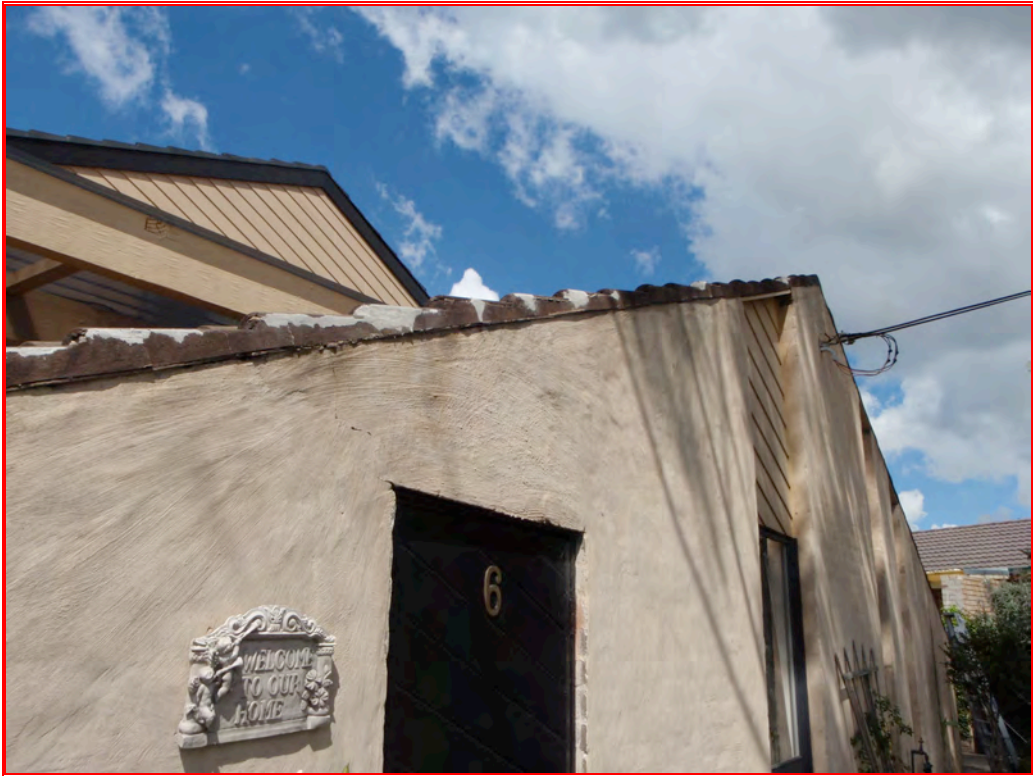
Maintenance will be required to the roof tiling, including: \$1,200.00

- Re-securing the loose tiling.
- Replacement of broken tiles.
- Repairing the cracked mortar bed to the capping tiles.

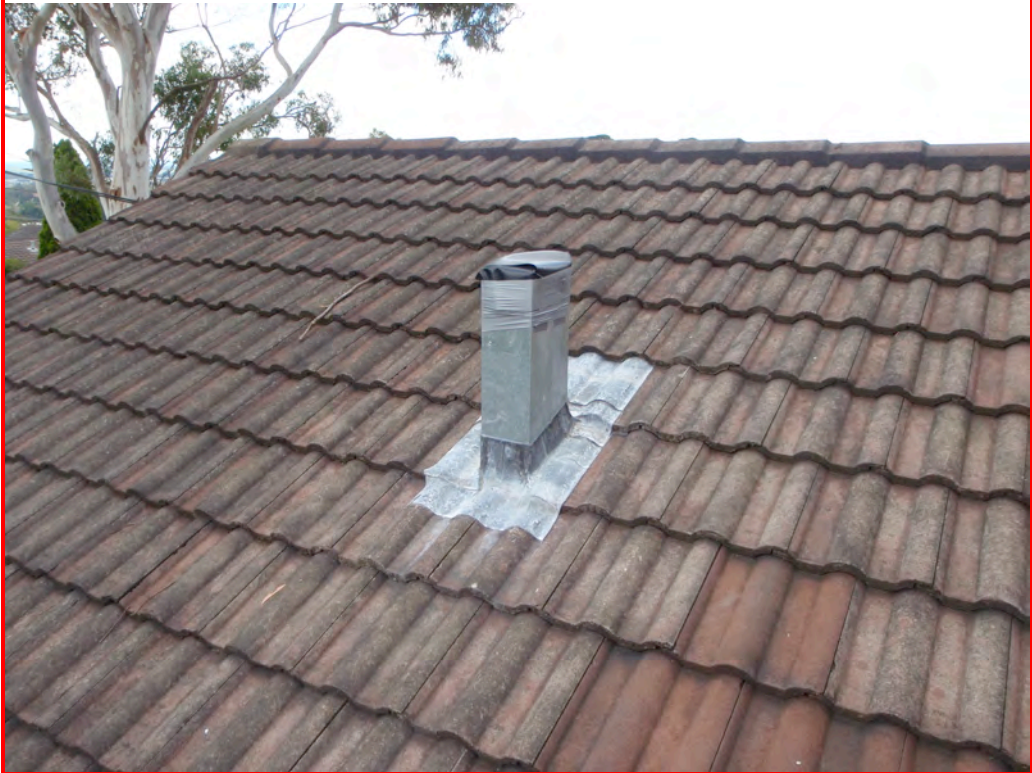
Replace the missing cap to the chimney flue above the kitchen.

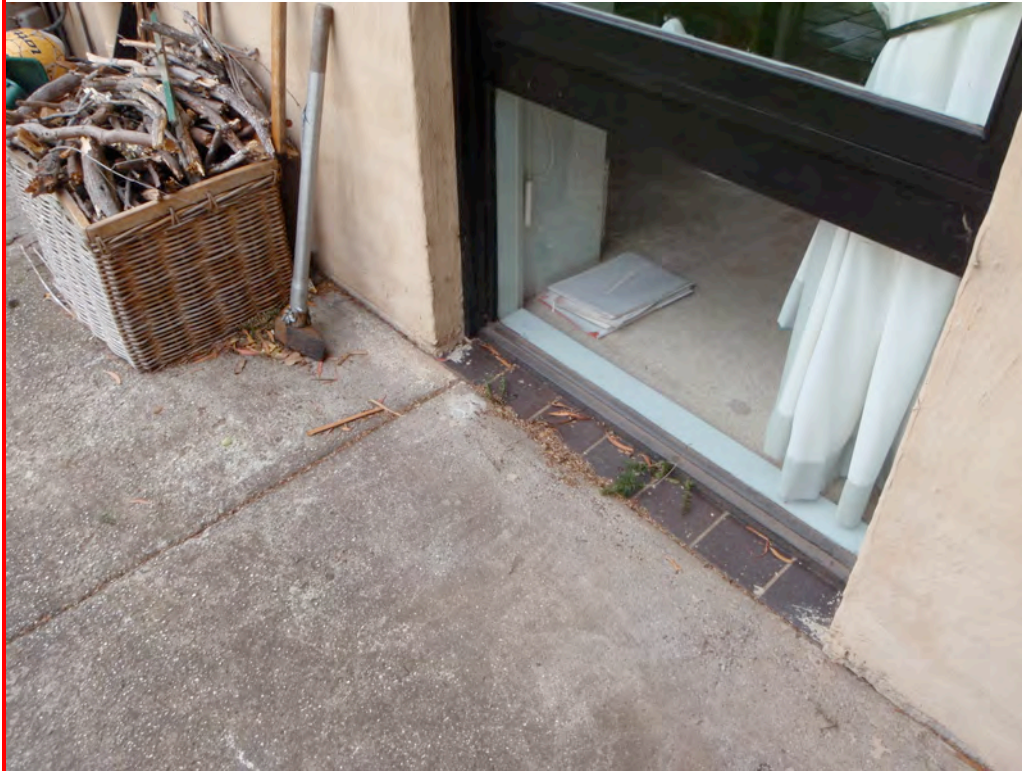
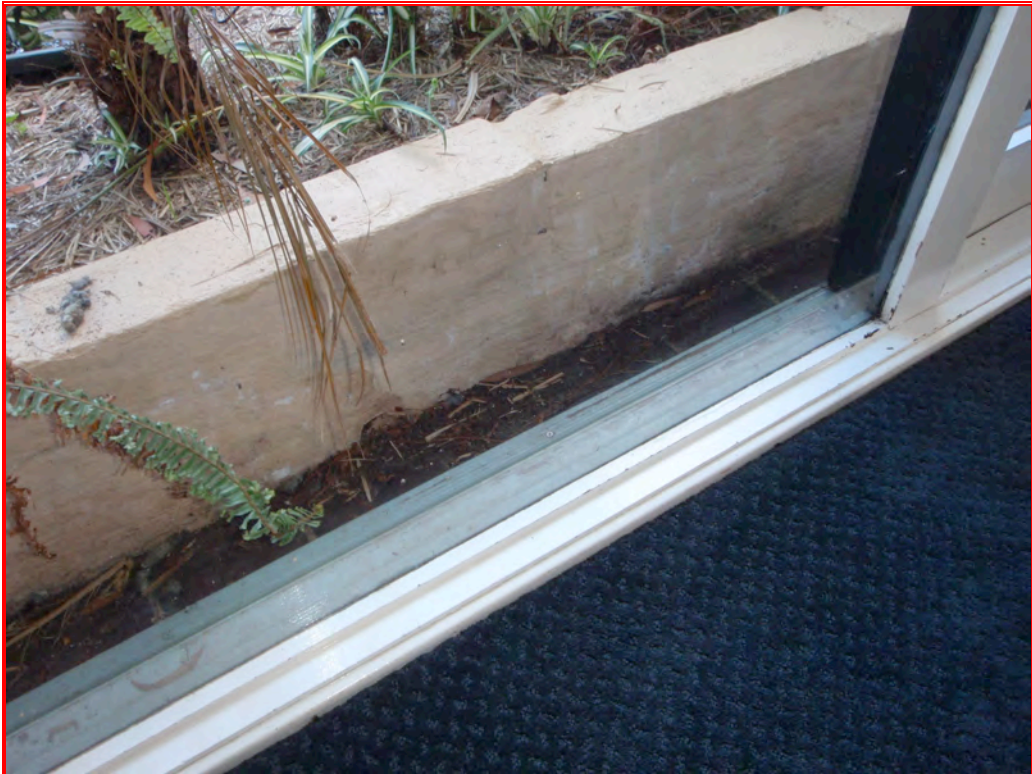
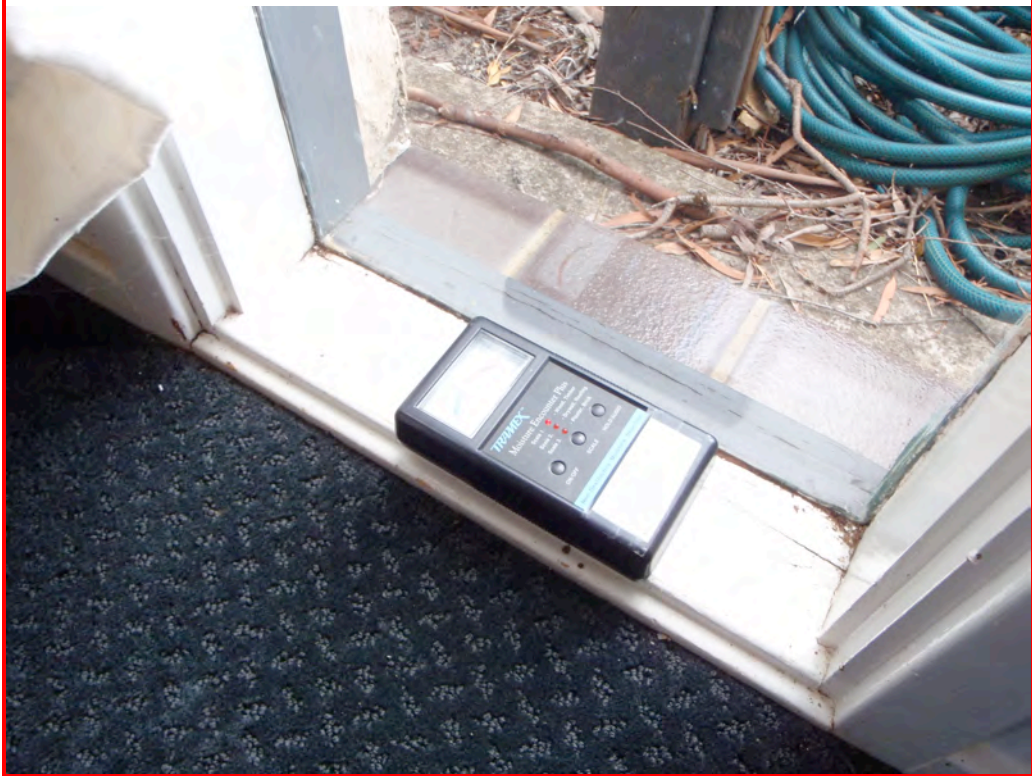
The internal floor level is almost level with the external ground level in areas. Moisture entry has occurred to the front living area in several locations and decay was noted to the window sill internally. The external ground level will need to be lowered and flashings to the window sills may need to be replaced. Further invasive inspections will be required to understand the work required to repair these defects.

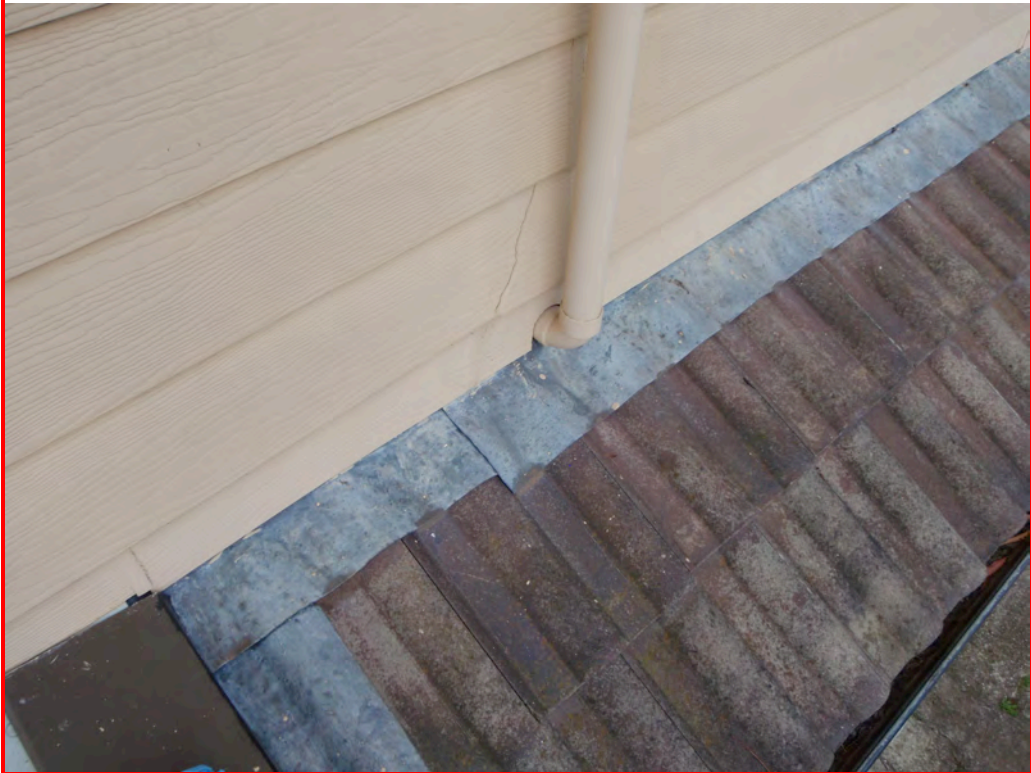
Replace the split fibre weatherboard cladding to the right side.

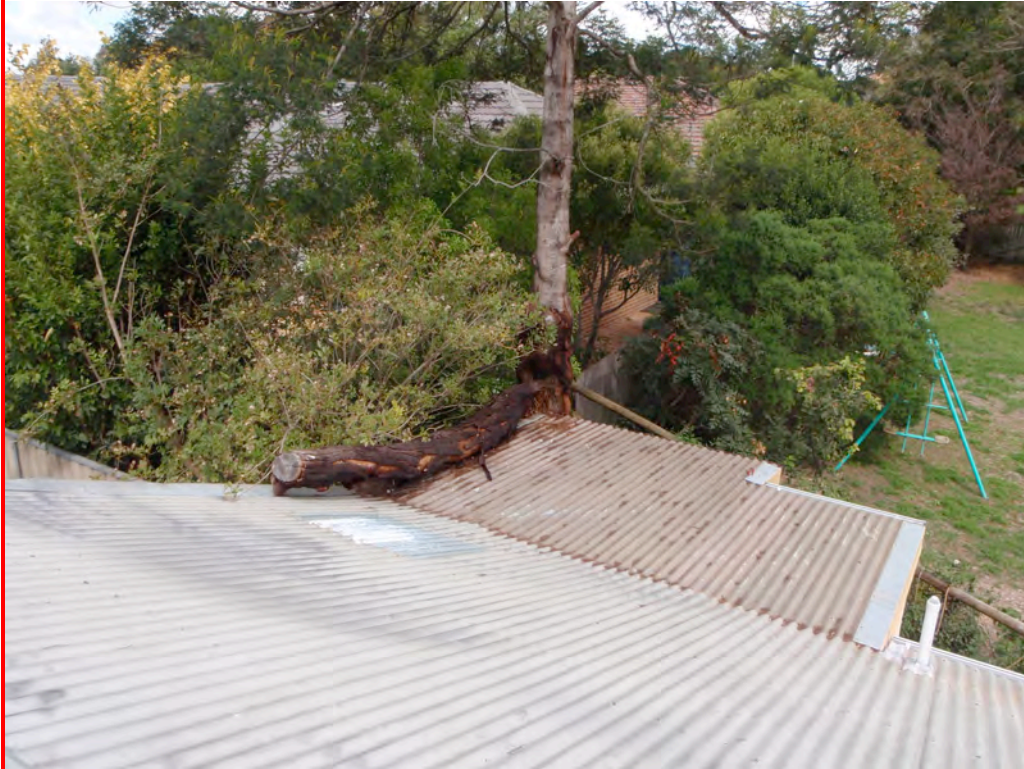
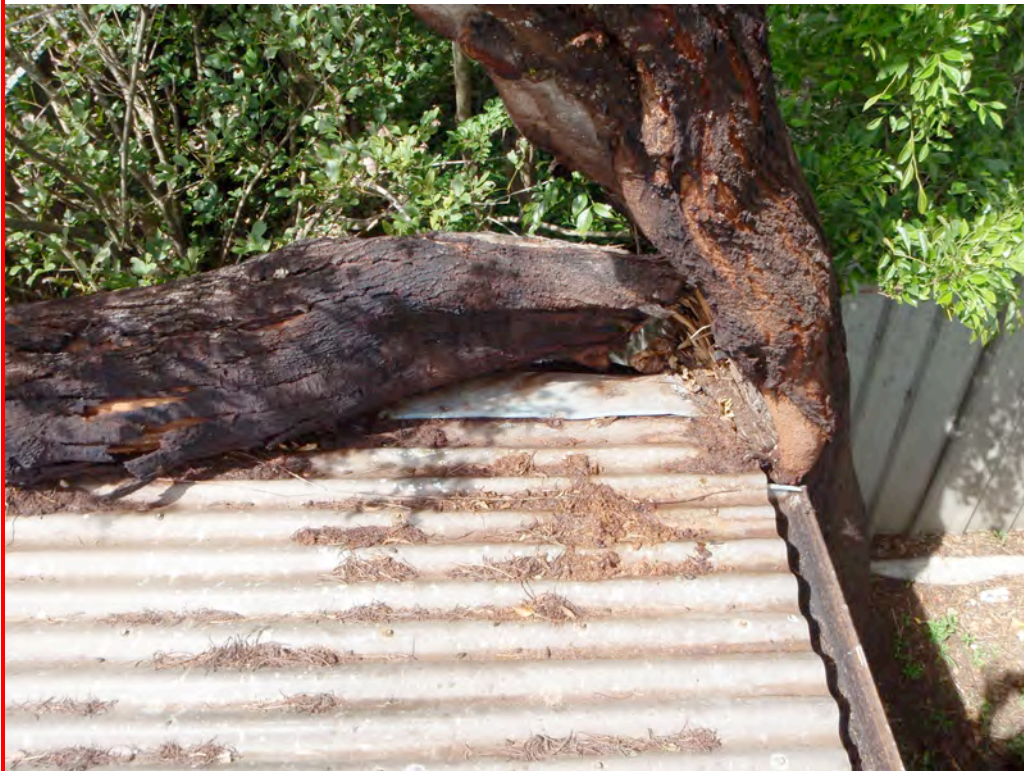
Remove the fallen tree from the garage roof and repair the impact damaged roof sheeting and barge capping. The living part of the tree should also be removed as it is too close to the building and is damaging the structure.

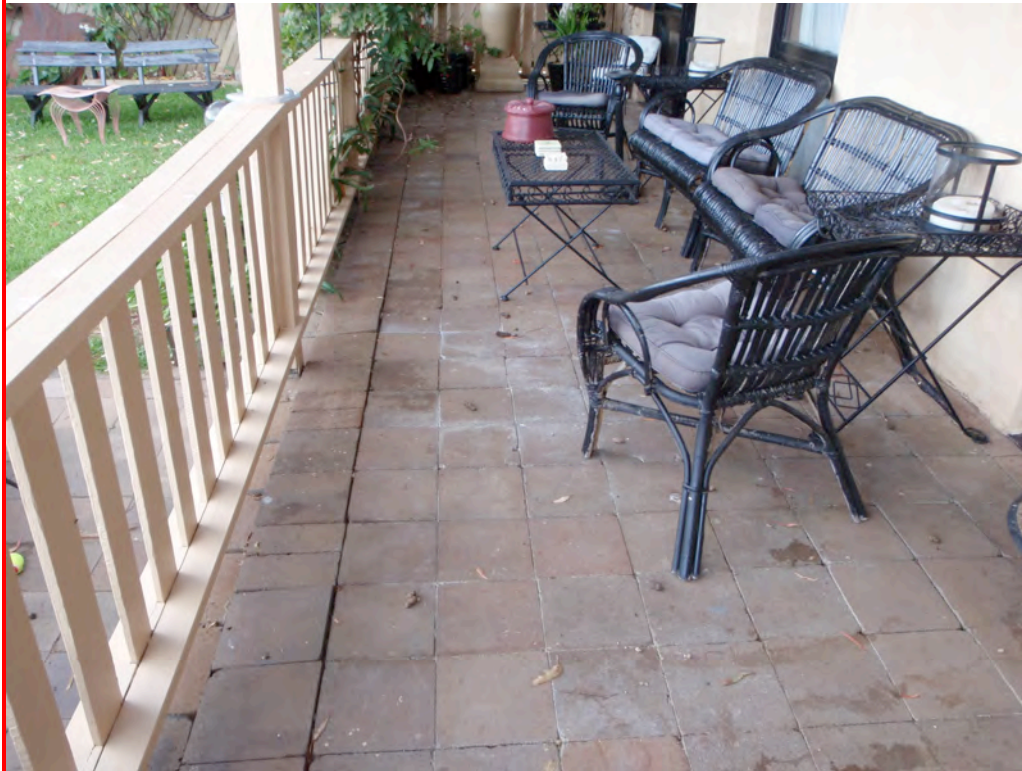
Re-lay the subsided paving to the left side patio area.

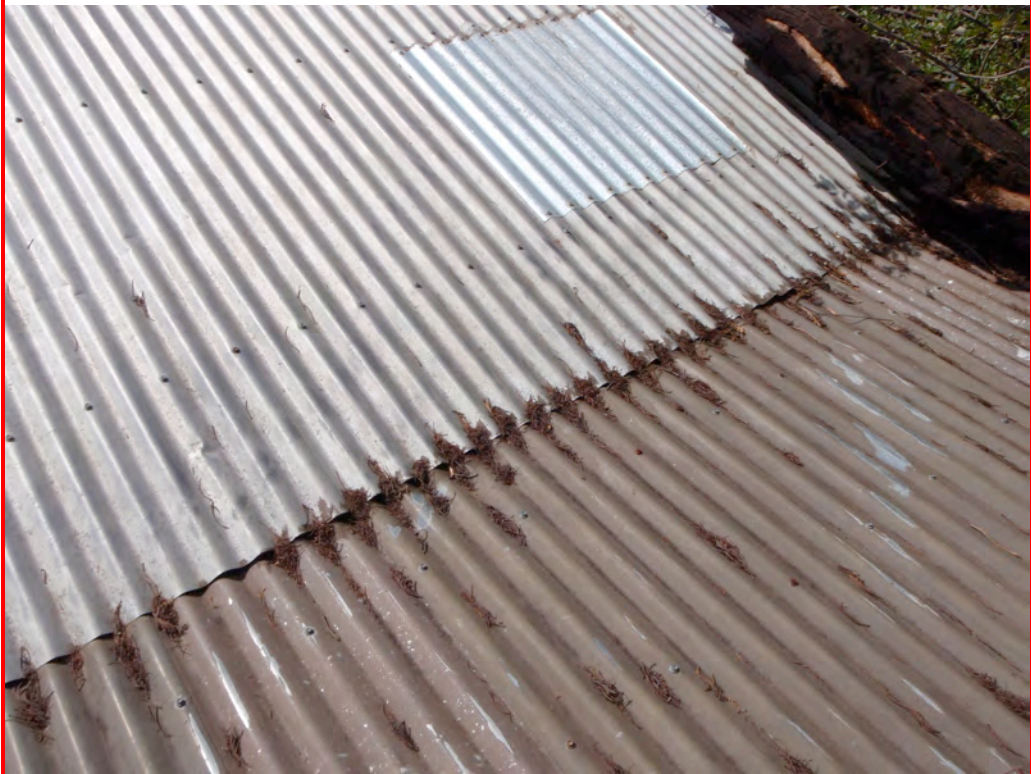
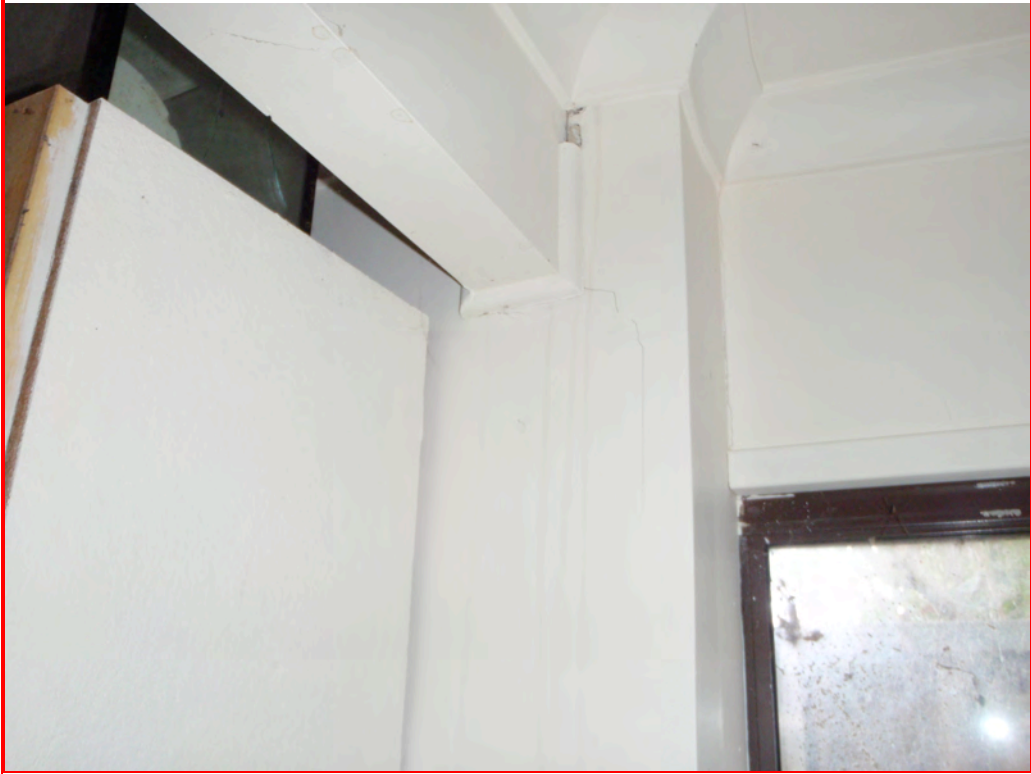
Improve flashing to the garage roof where the levels change.  
Moisture entry has occurred to this area.

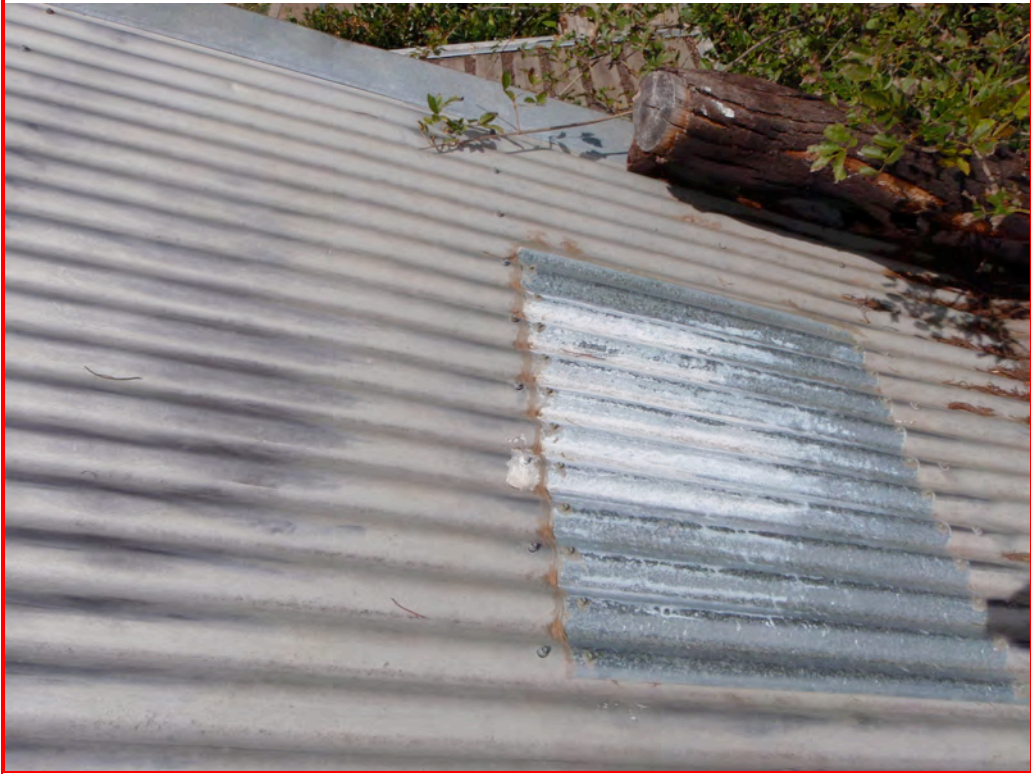
Silicon sealant has been used on the garage roof sheeting. This silicon should be regularly changed to prevent future moisture entry. Ideally the entire length of roofing should be replaced.

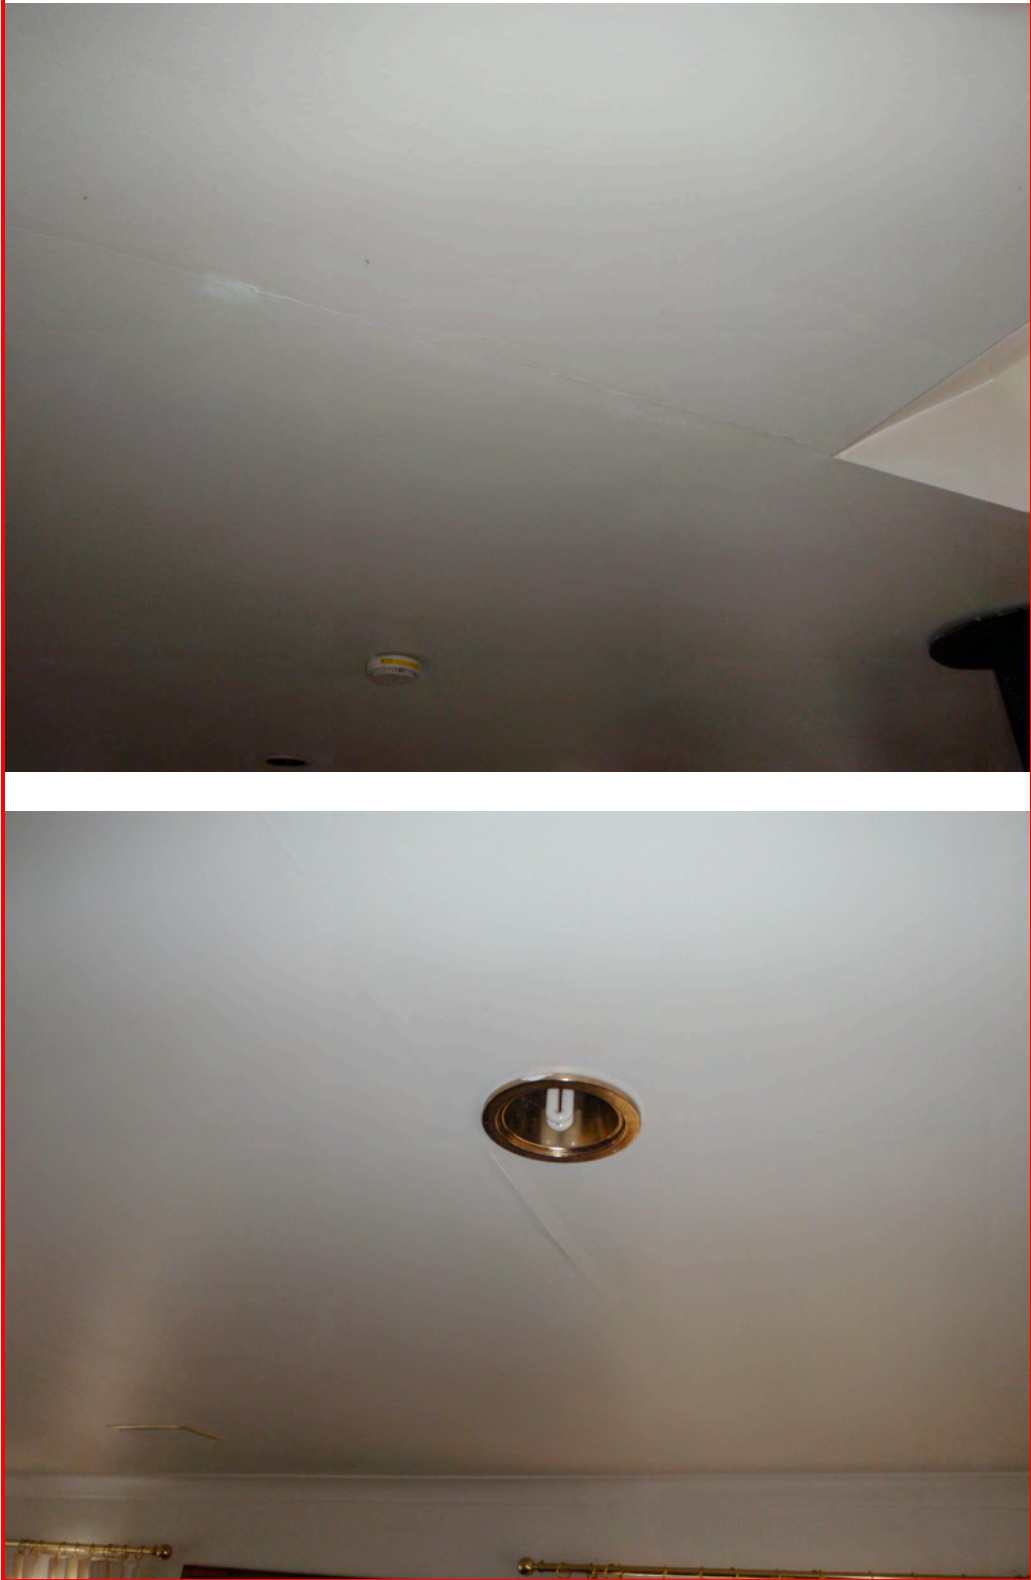
Internal Notable Items:	
<p>Cracks have developed to ceilings to various areas throughout.</p> <p>These cracks have been caused by the differential movement between the roof and ceiling framing, and poor setting of the joints. Patching can be carried out before the next paint.</p>
