Childs Property  
Inspections

# Pre-Purchase Building Report

## BUILDING DESCRIPTION

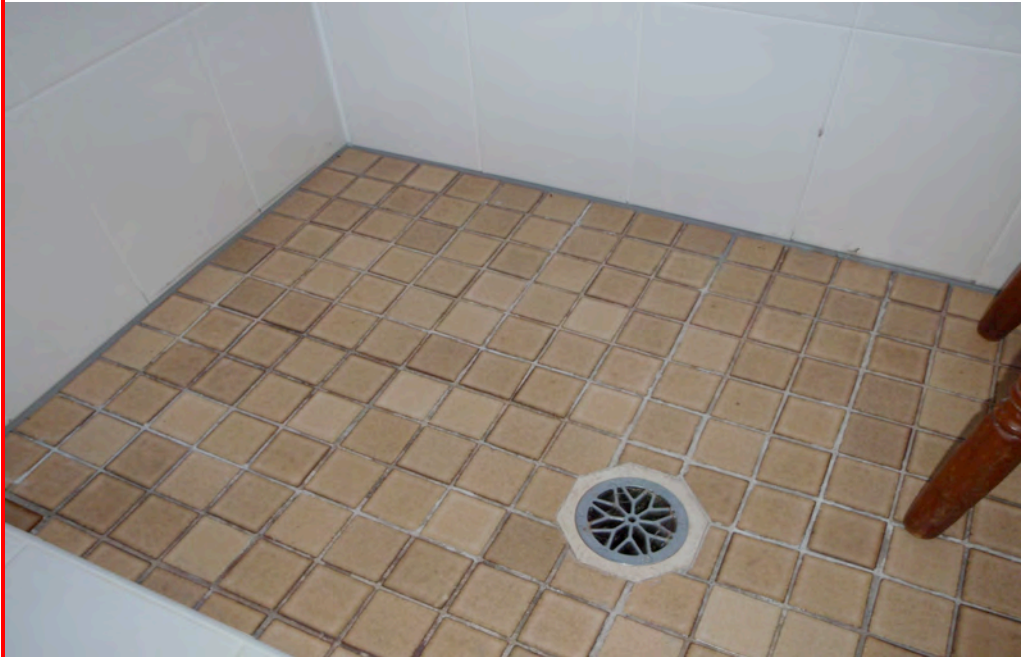
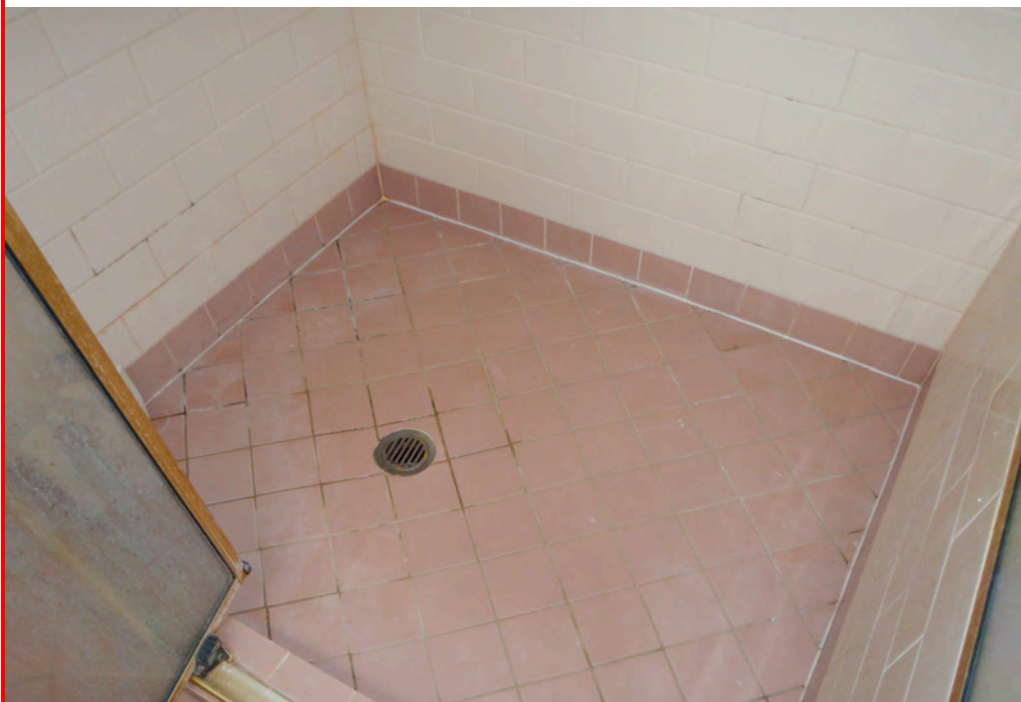
Silicon sealant has been used in the showers to the ground floor bathroom and ensuite.

The use of silicon sealant is a commonly used remedy for leaking showers. This can stop leaks for a short period, however it is only a temporary repair and will fail in time.

The silicon sealant in the shower should be removed and further tests made to check for leaks. If leaks are occurring, immediate repairs will be required.

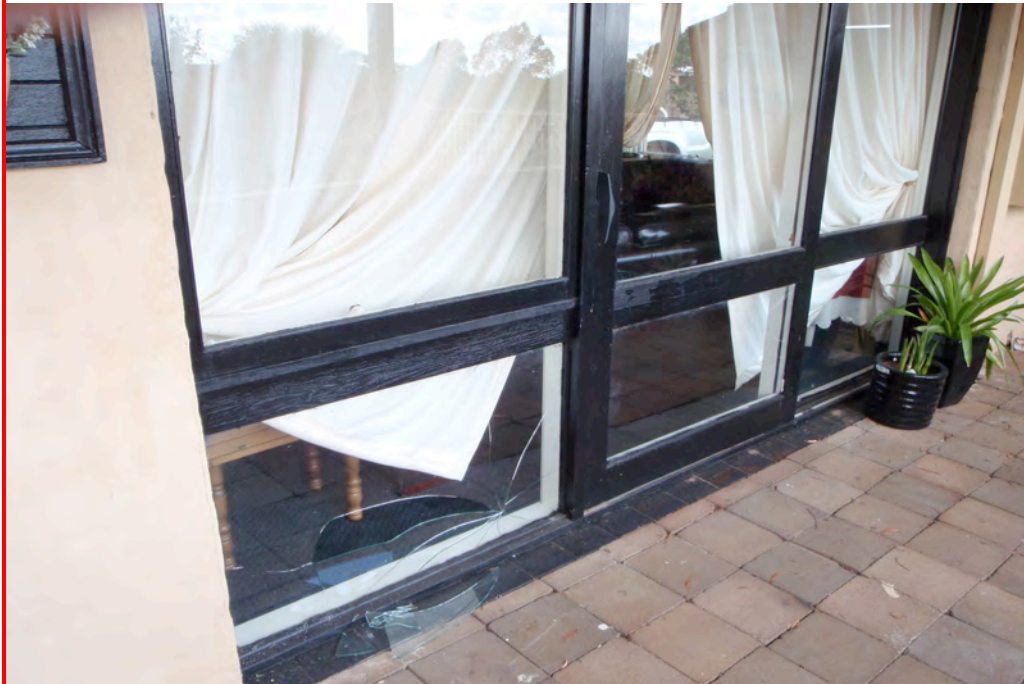
The timber windows in a number of areas require maintenance, including:

Replacement of broken glazing  
Replacement of glazing putty  
Easing and adjustment  
Replacement/maintenance of hardware

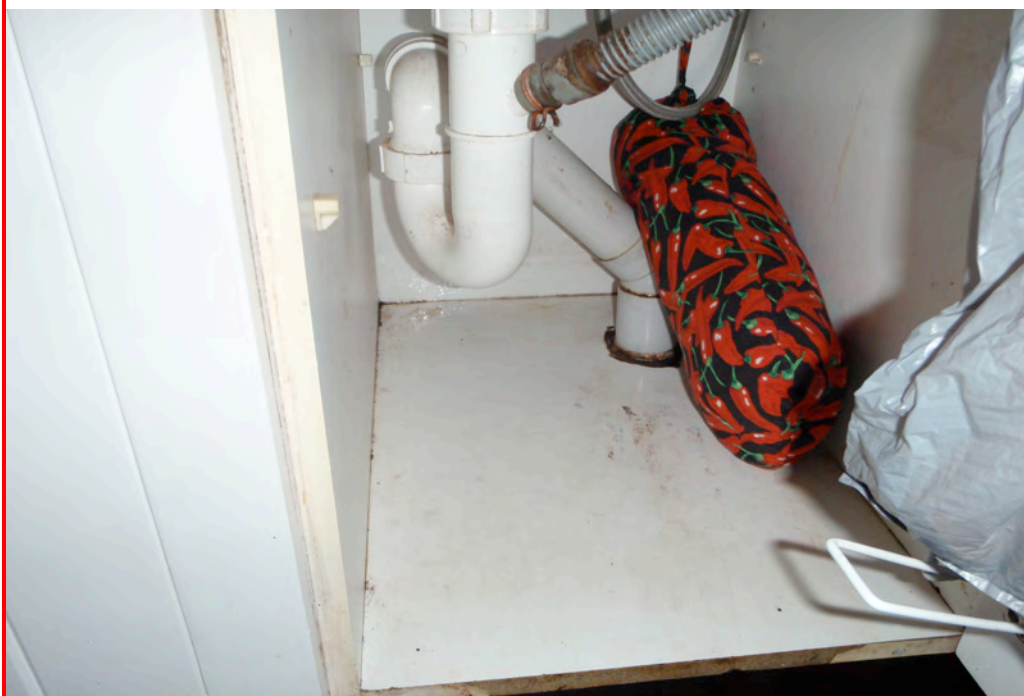
Consult a plumber to check and repair the leak below the kitchen sink. Some moisture damage has occurred to the cupboards.

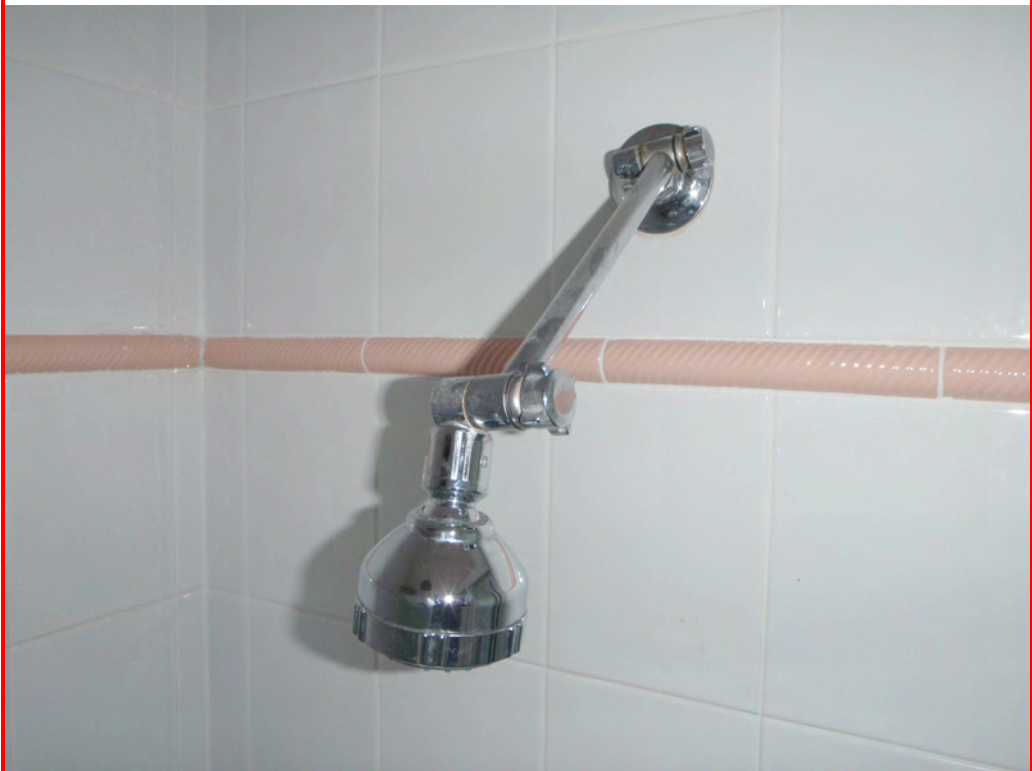
Servicing is required to a number of leaking taps and loose shower rose.

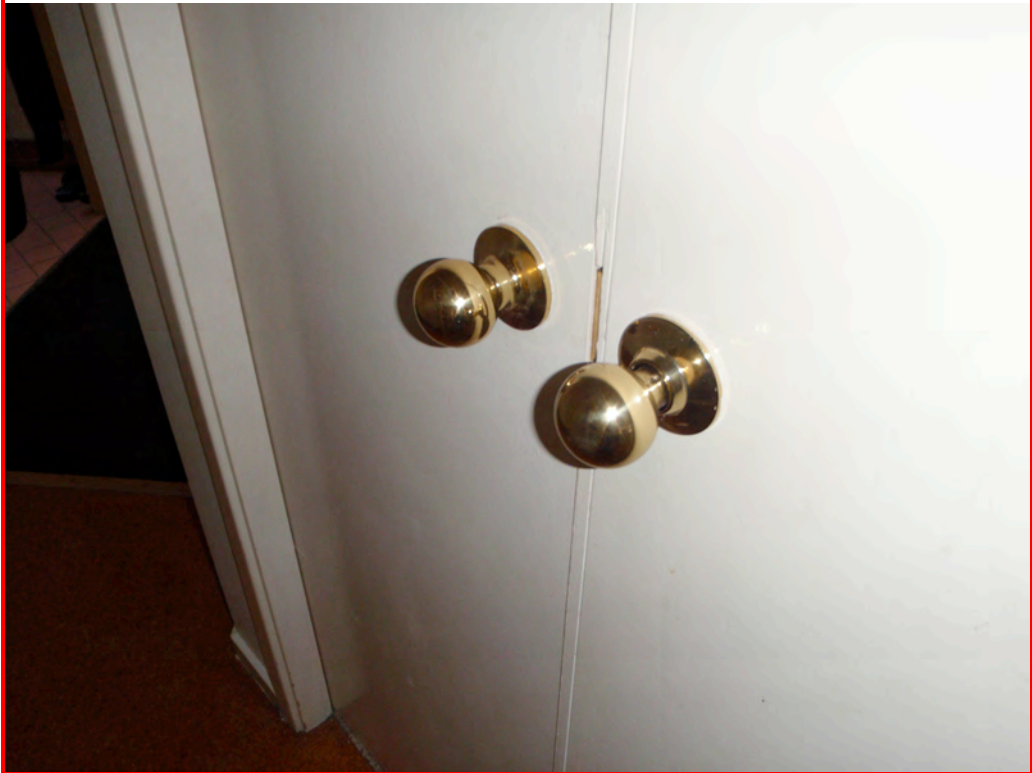
Servicing is required to the loose door handles and hardware.

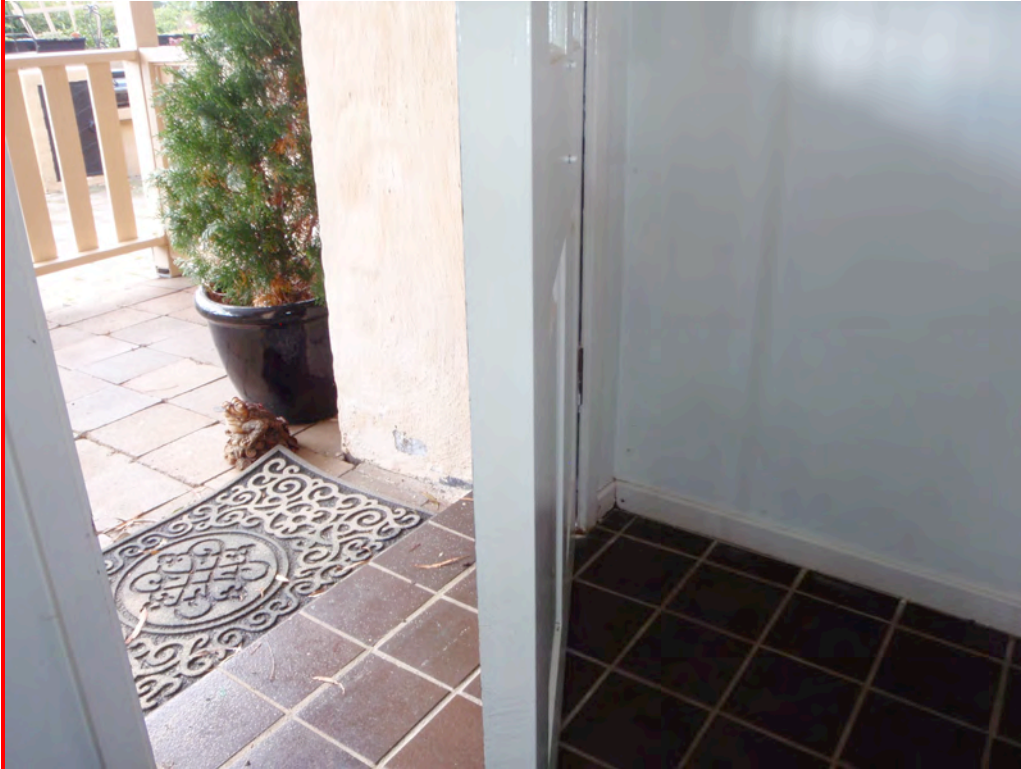
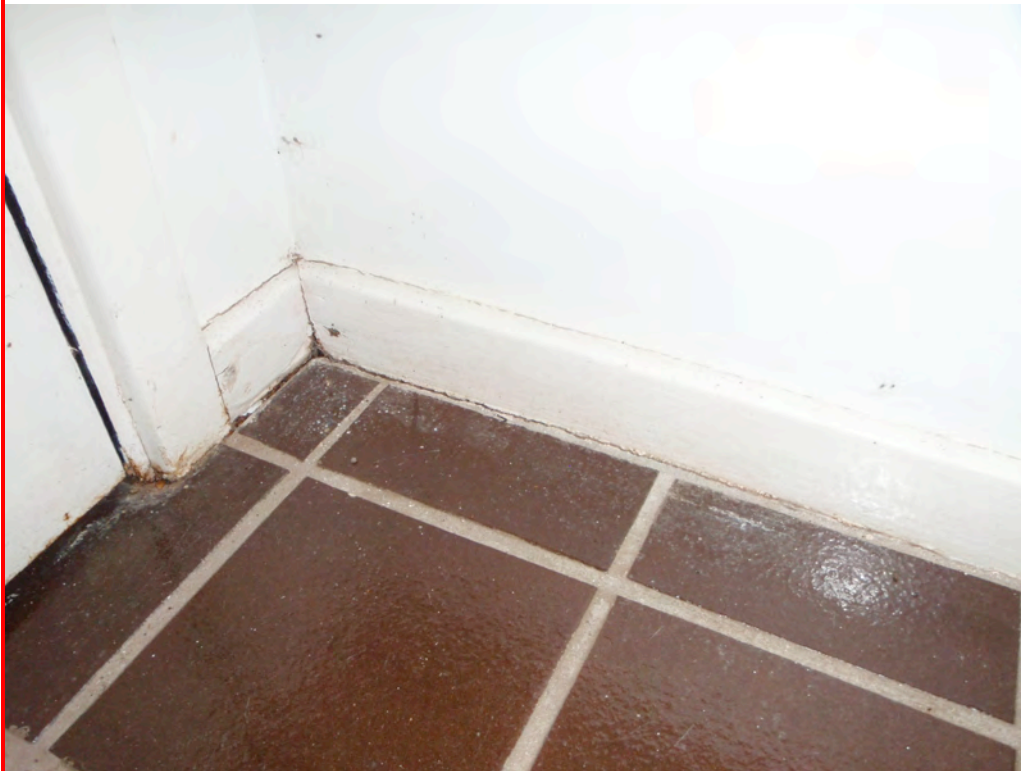
Rising damp to the external wall at the left side of the living room has transferred across the cavity and is damaging the adjacent skirting board. Invasive investigations will be required to determine the repairs required to flashings and damp proof course.

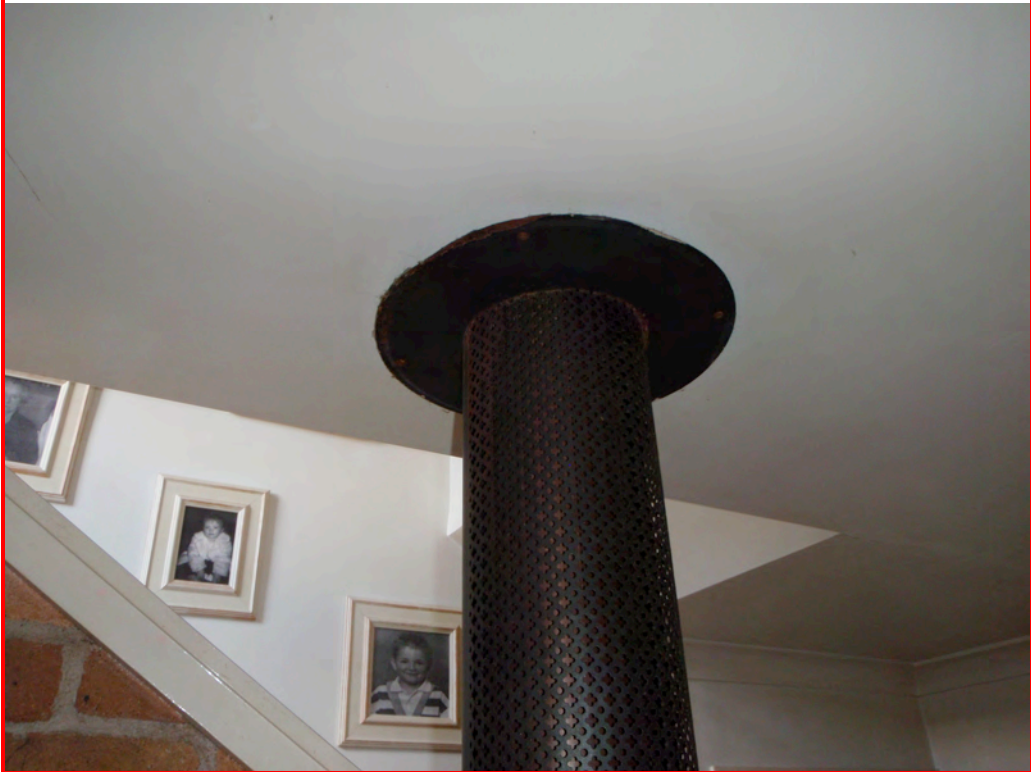
Replace the rusted ceiling cover plate to the fireplace flue in the living room.

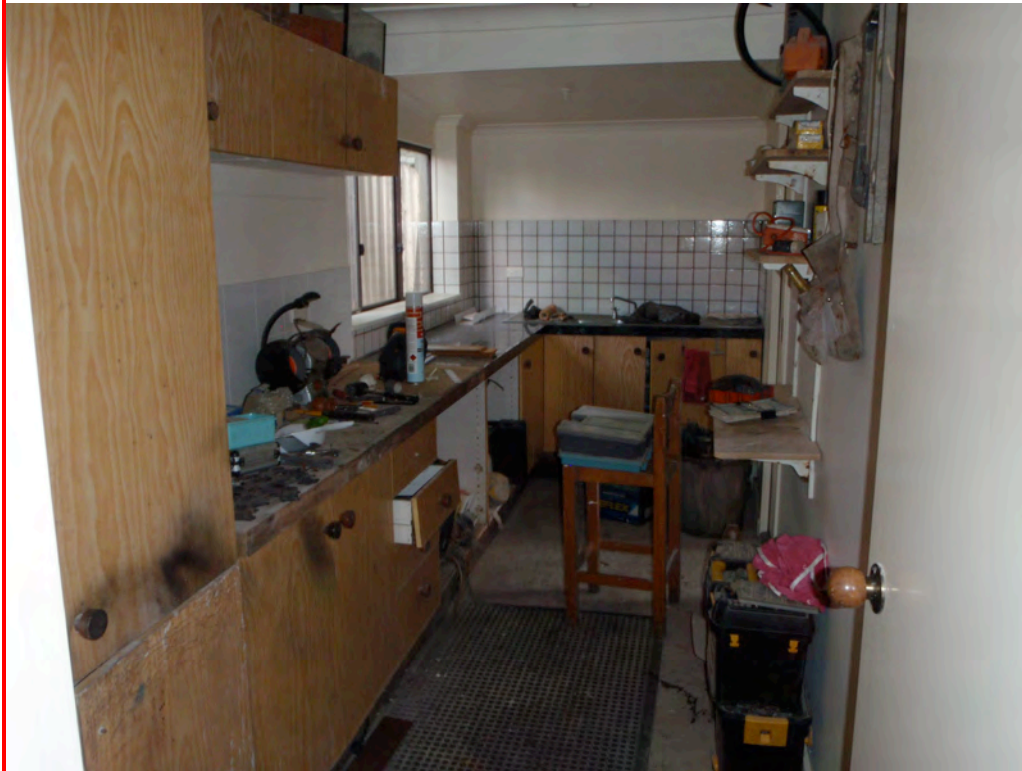
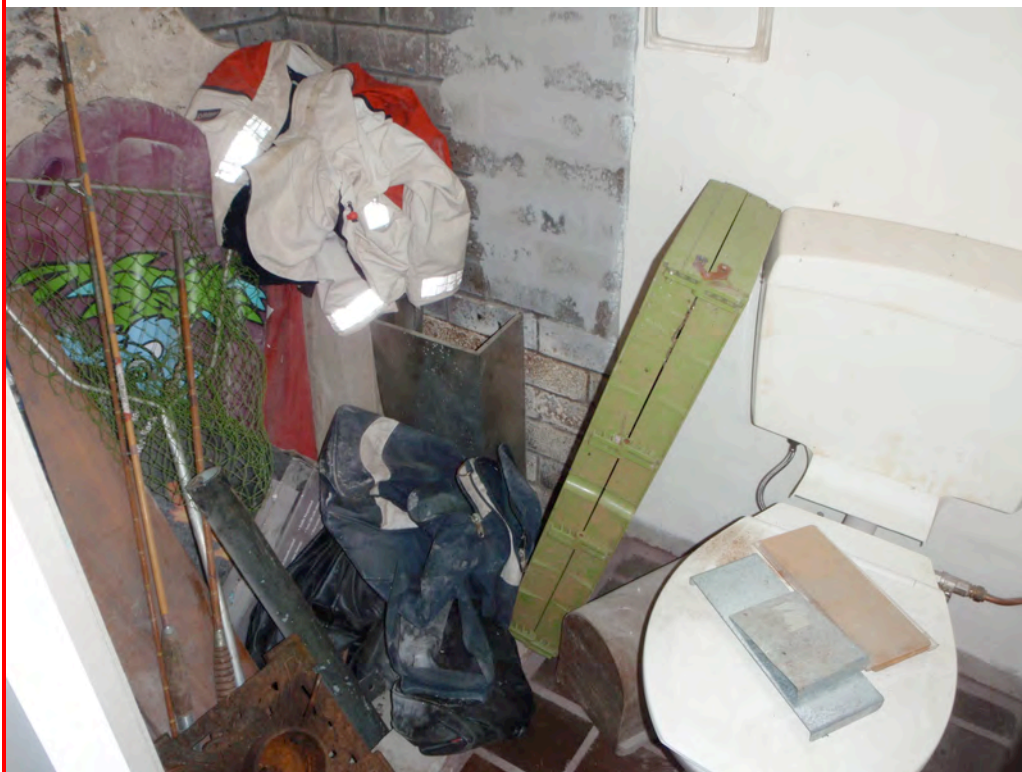
The kitchen and bathroom to the garage area are incomplete.

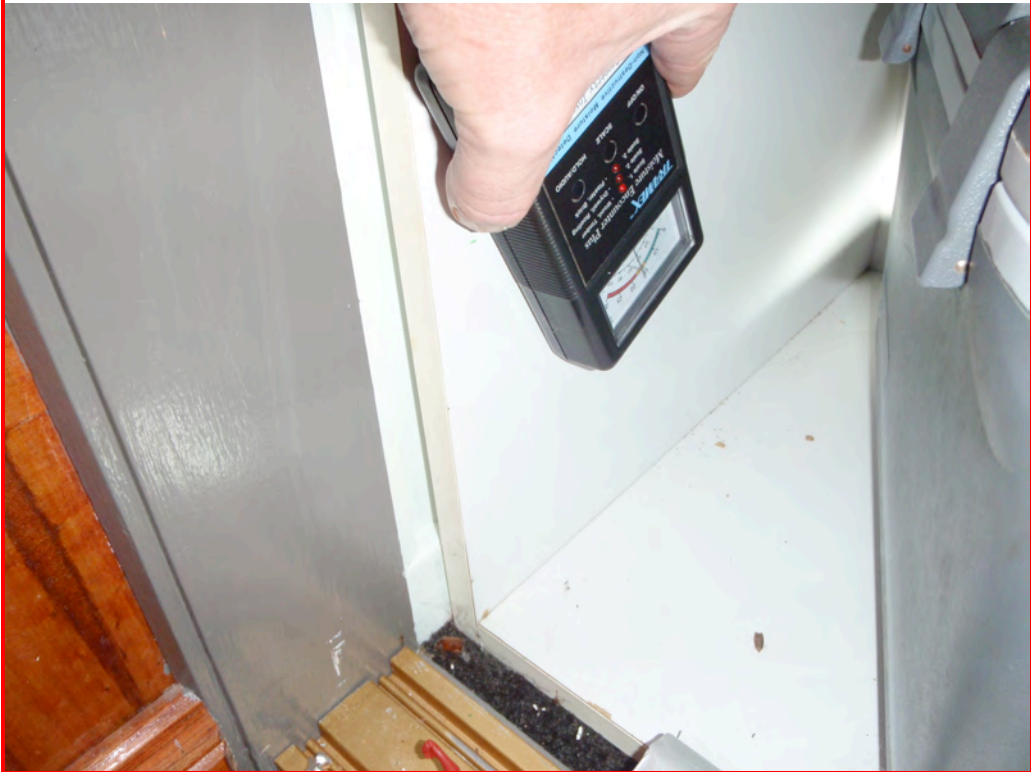
High moisture reading noted to the cupboard backing onto the ground floor bathroom.

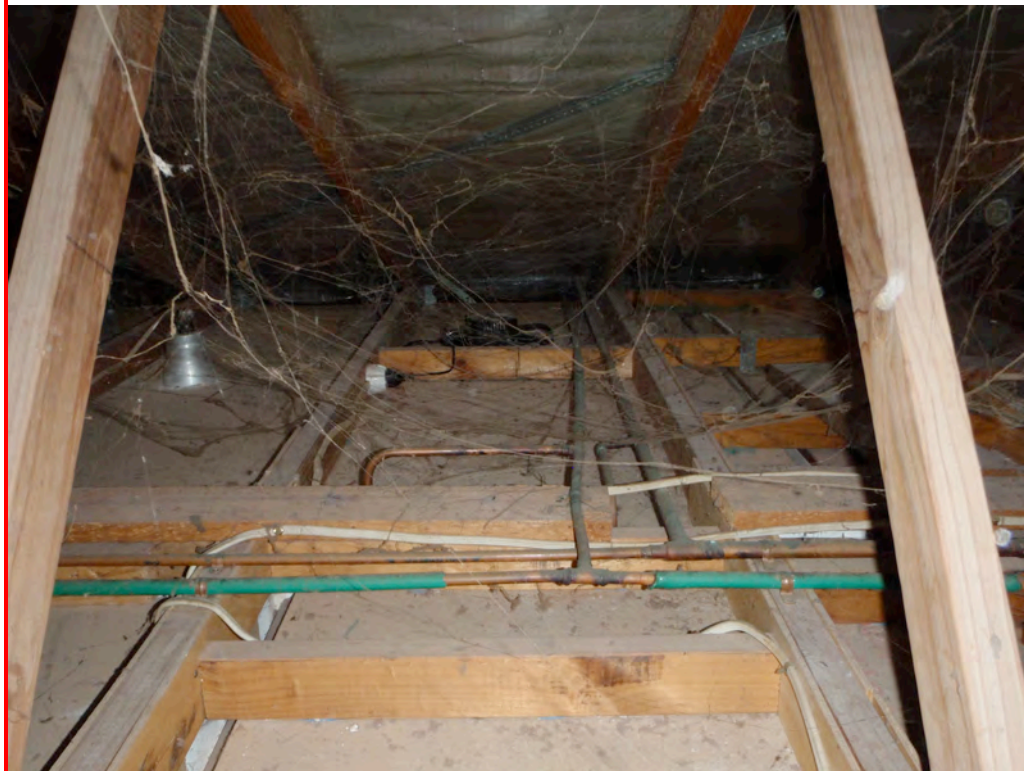
Exhaust fans are ducted into the roof space of this home and little ventilation is provided in this area. Ventilation improvements to the roof space should be made to help prevent high moisture levels in building materials, which can lead to mould and decay.

Fitting of roof ventilators or connecting the exhaust fan to ducting, which is fitted to roof ventilators, is recommended.

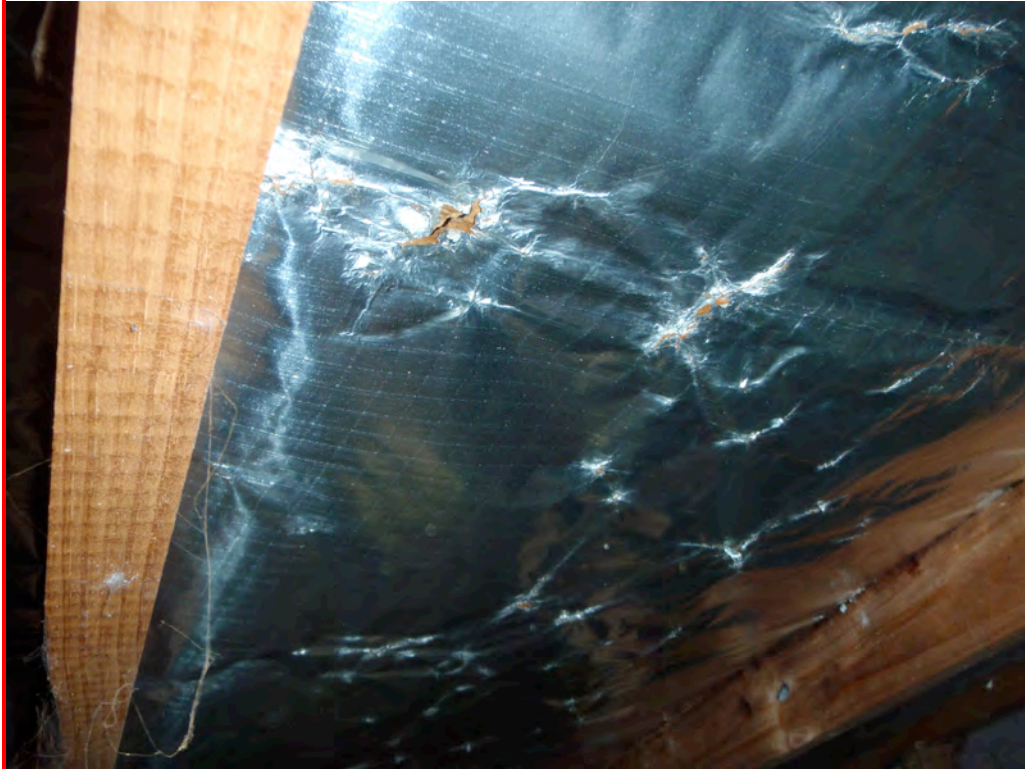
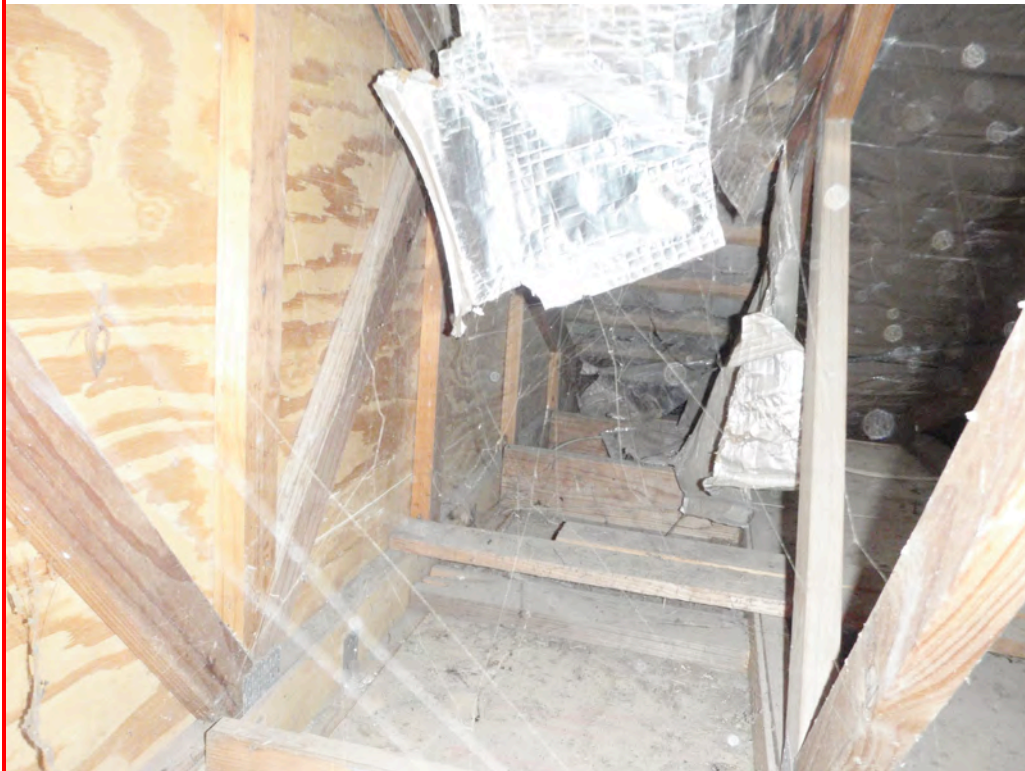
Patch the ripped sarking to the underside of the roofing to allow this material to operate correctly and shed any water entering the roof void to the gutters. Contact a roofing specialist to carry out this repair.

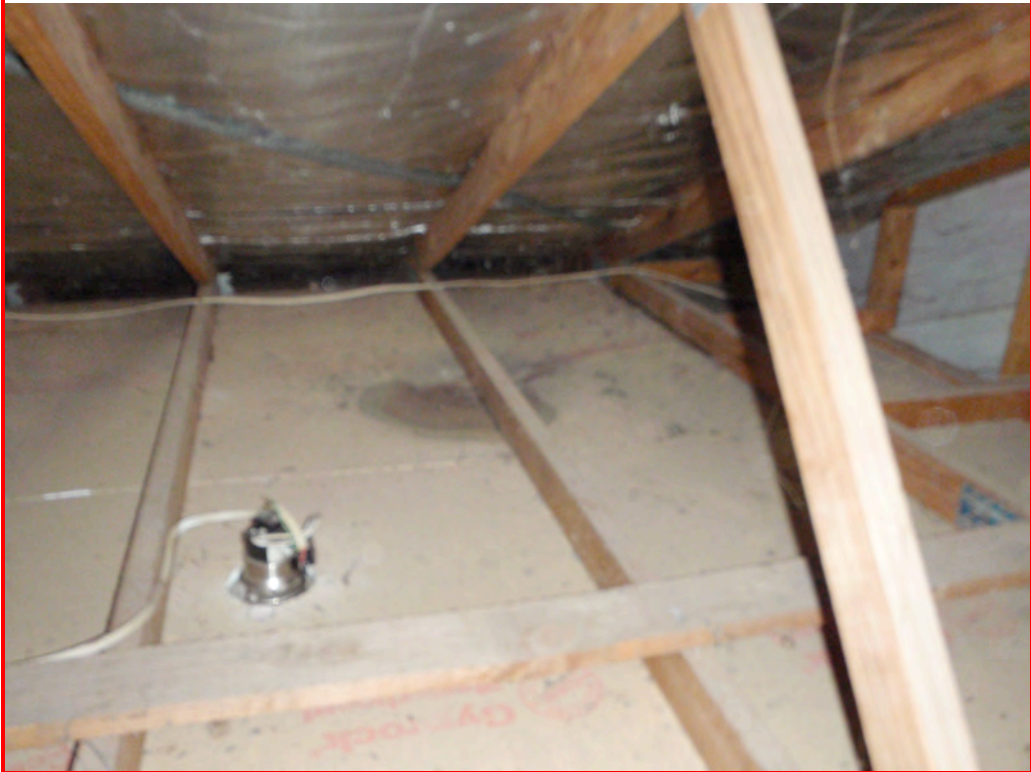
Water staining was noted to the ceiling over the rear left corner bedroom. No moisture readings were noted at the time of the inspection.
