Childs Property
Inspections
Building Completion Report

Childs Property Inspections was commissioned by _____ to carry out a completion report on the above property. The purpose of this report is to provide a list of incomplete or defective works to the builder for rectification prior to occupation.

The property inspected is an apartment of full masonry construction located on the first floor in a five storey complex. This structure is on pier and strip and suspended concrete slab footings, with a re-inforced concrete roof.

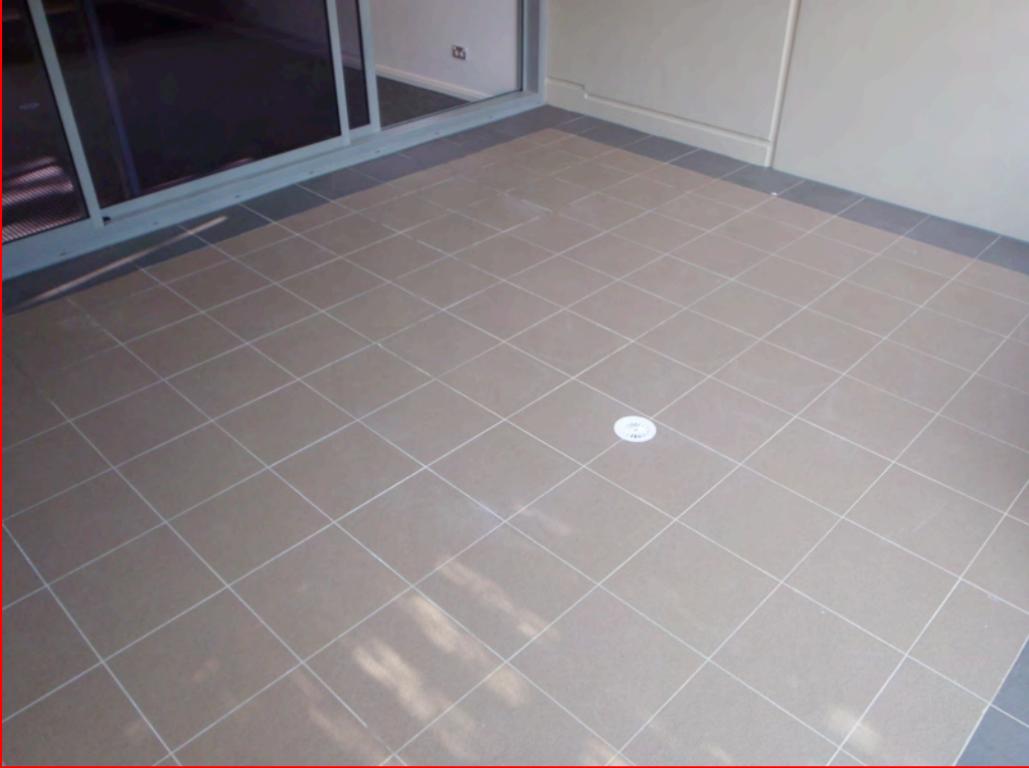
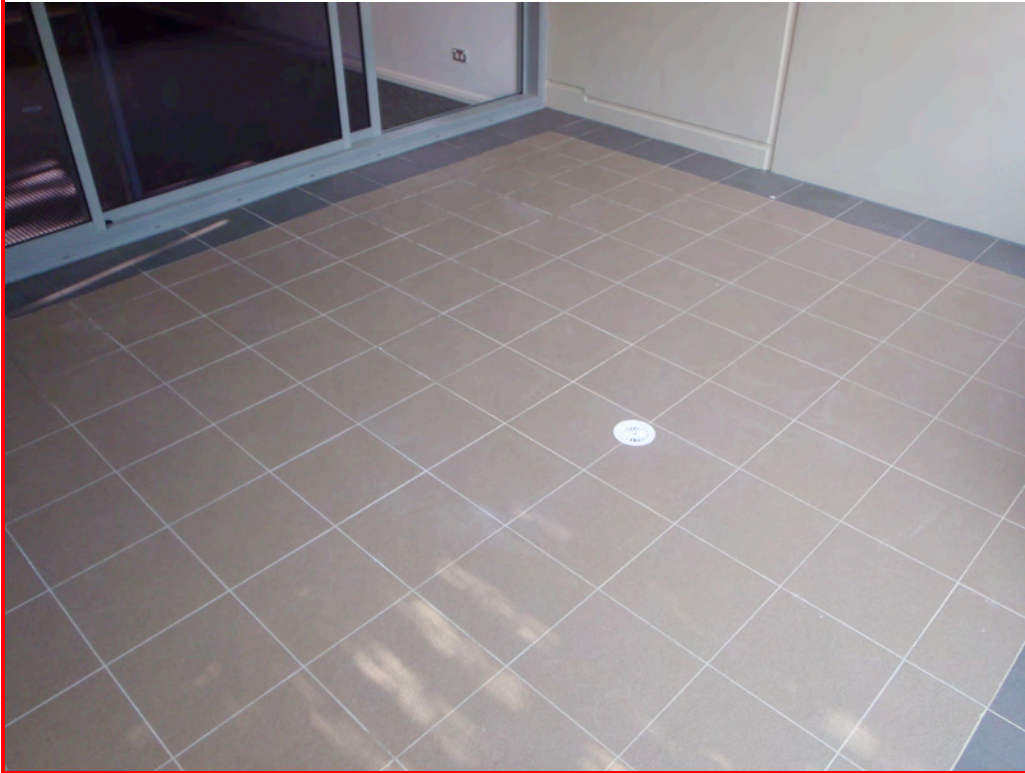
External:	
Approximately 25% of the balcony floor tiling is drummy and requires replacing.

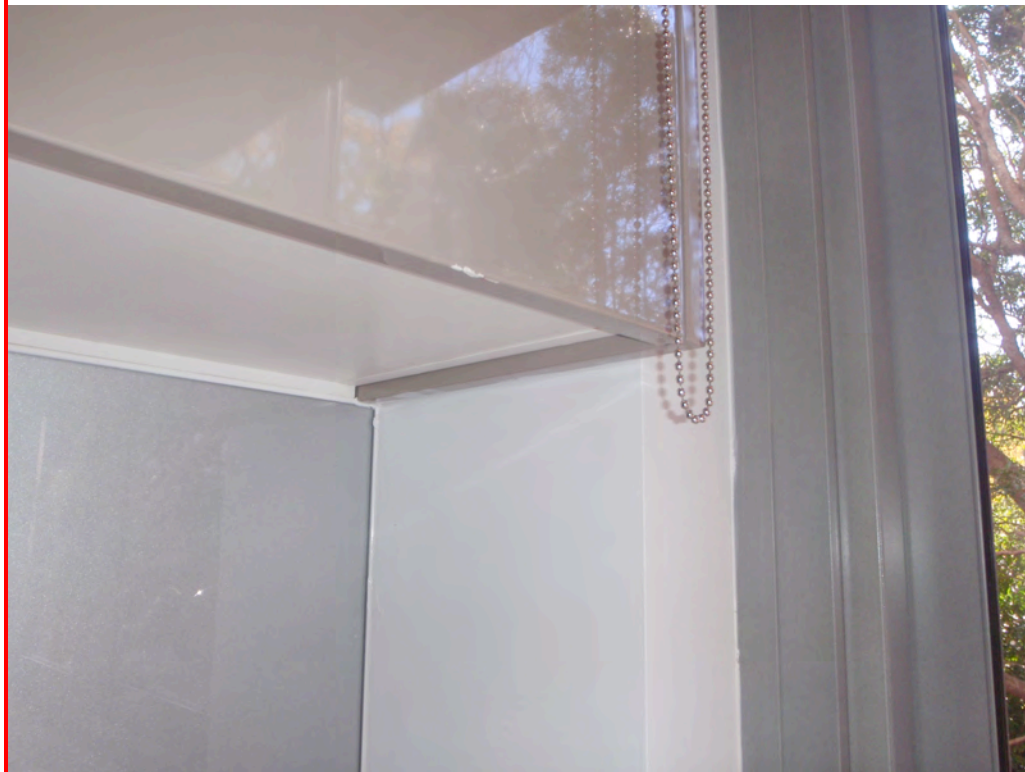
Repair the paint chip to the kitchen cupboard door near the window.

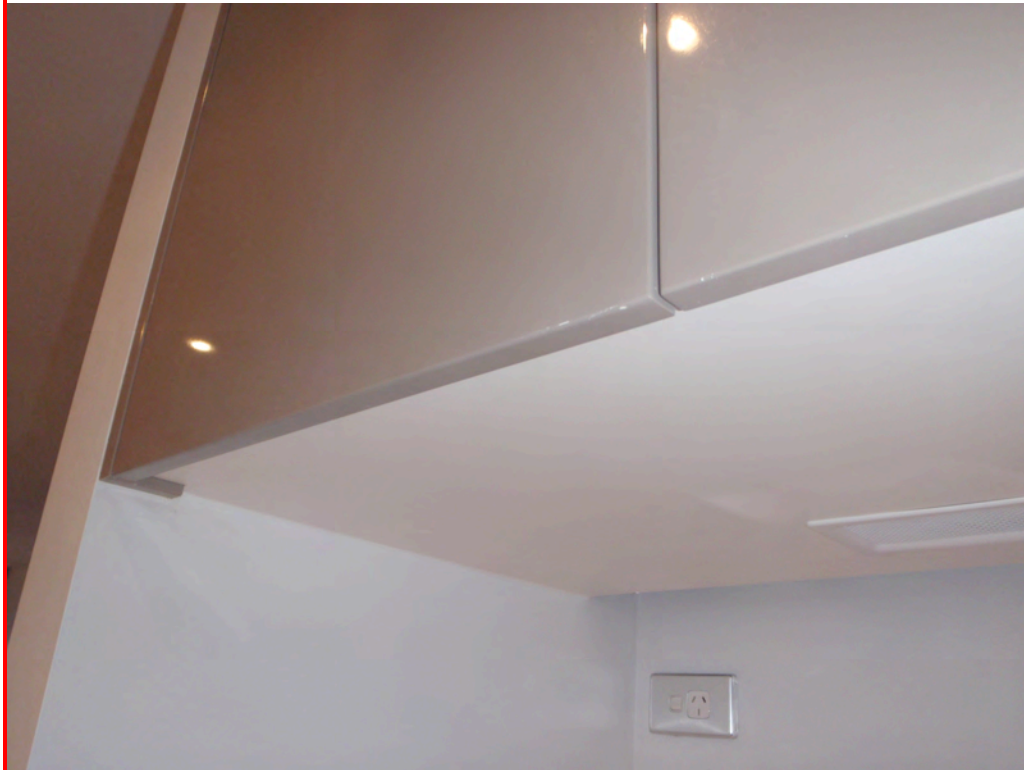
Repair the paint chip to the double doors above the fridge alcove.

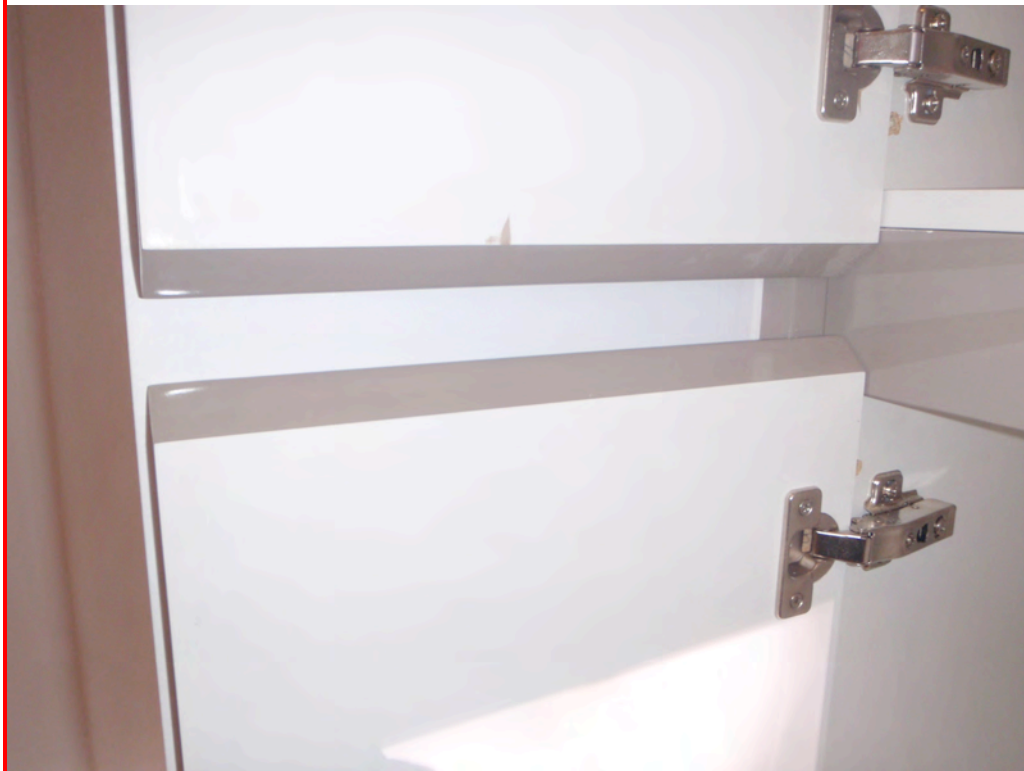
Remove over spray from inside the door beside the kitchen stove.

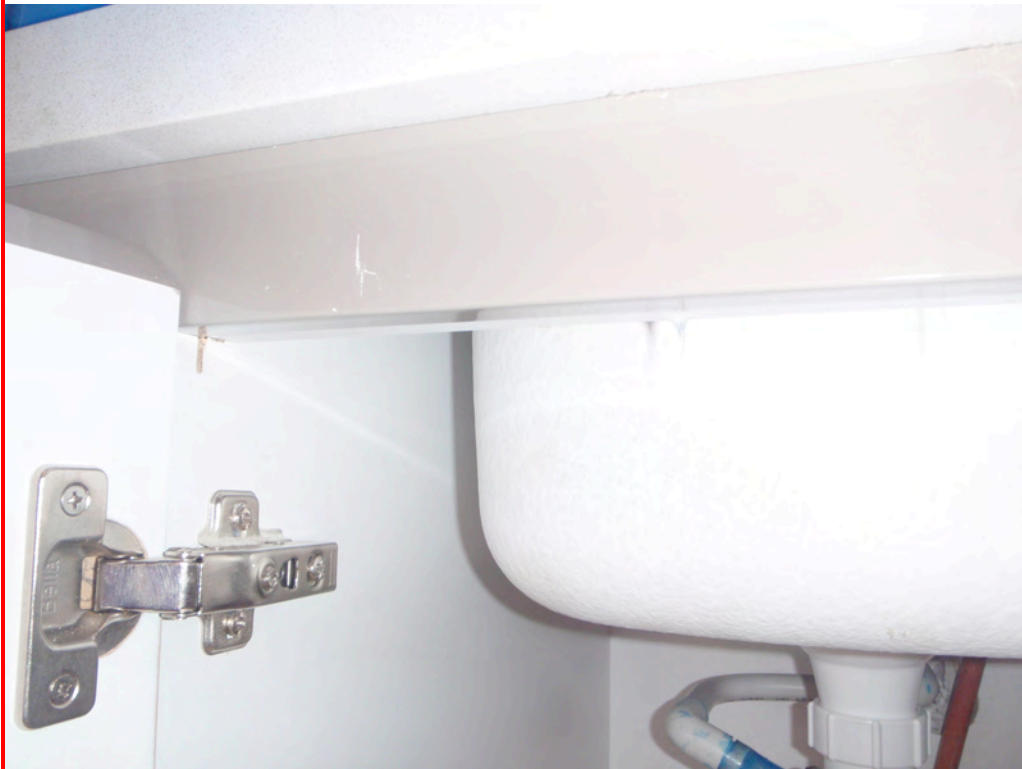
Repair the scratch marks to the panel below the kitchen sink.

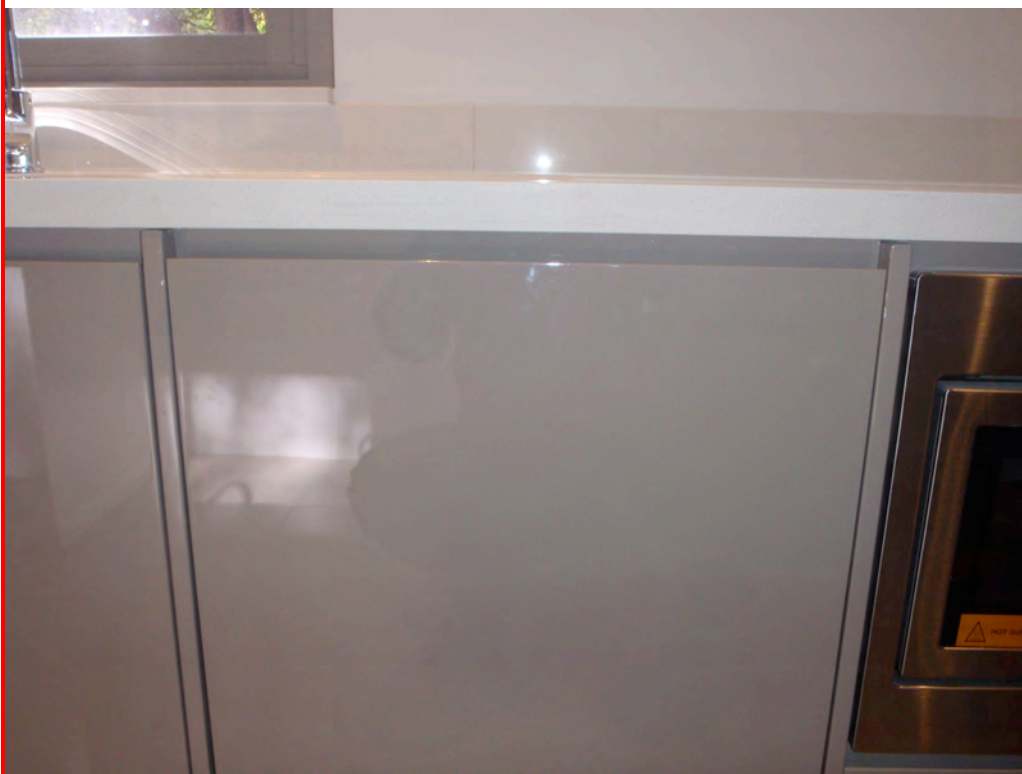
Repair the paint chip to dividing panel on both sides of the dishwasher door.

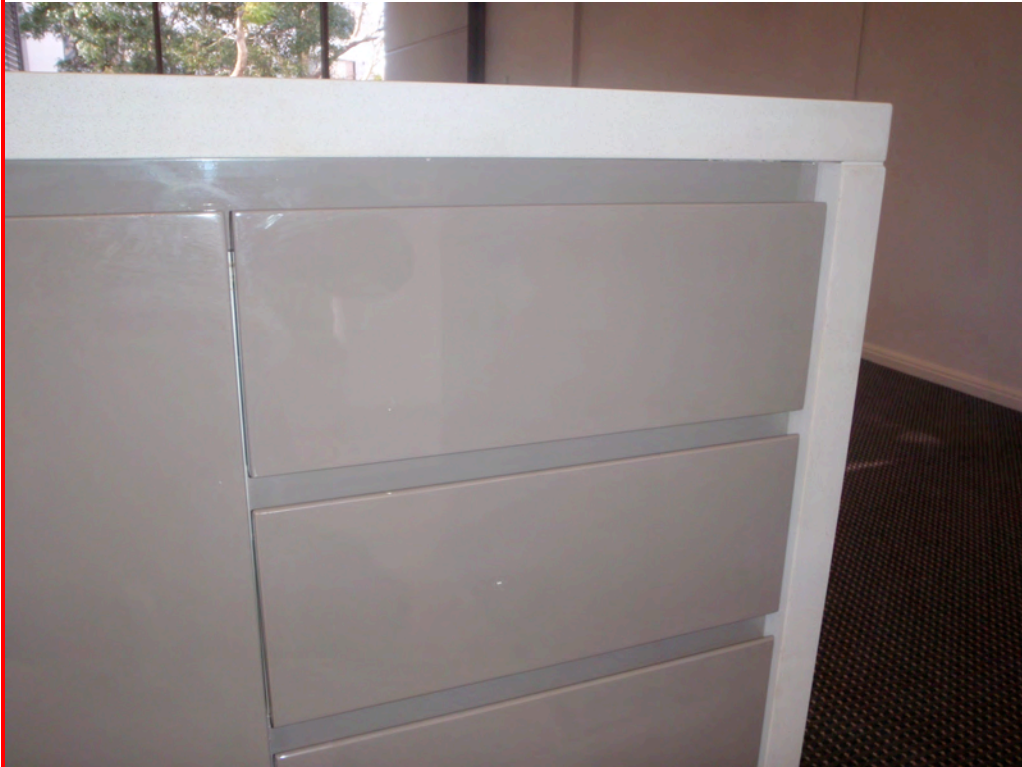
Repair paint chips to the kitchen drawers.

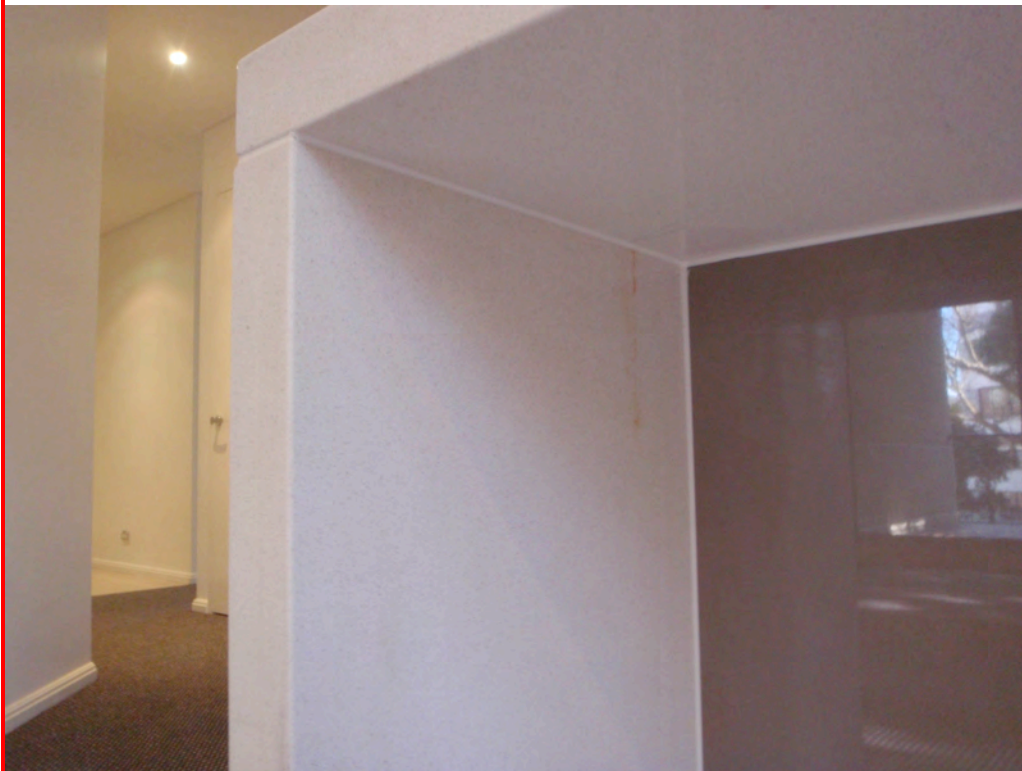
Remove rust coloured stain from the stone side panel below the breakfast bar.

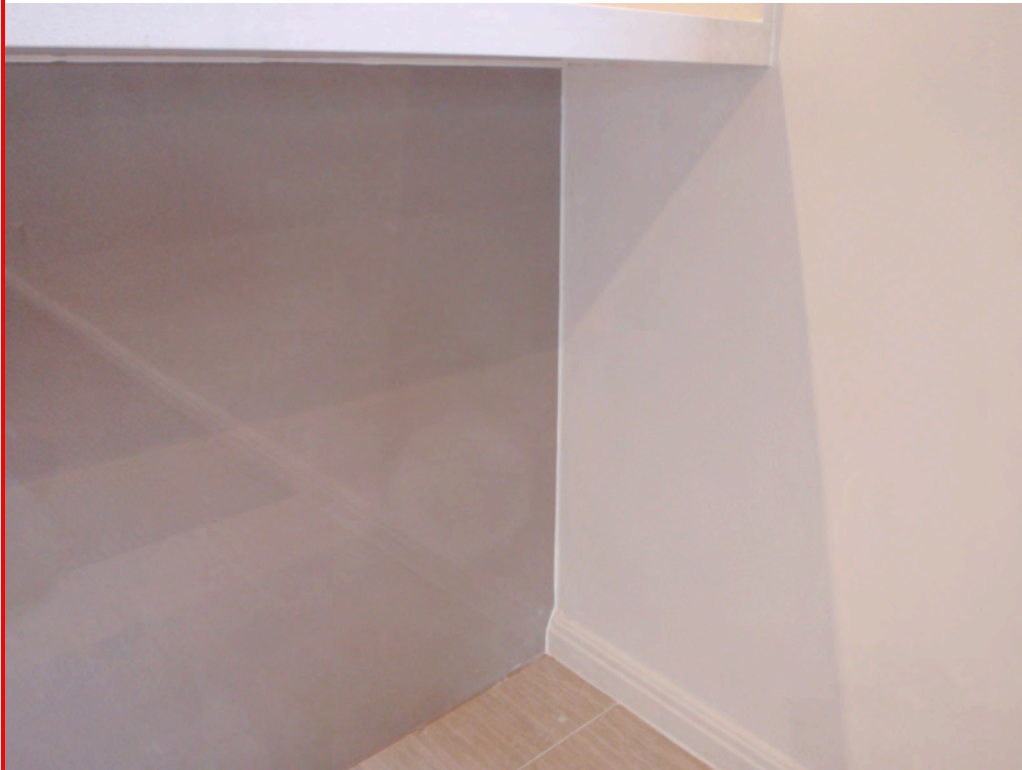
Repair the wall plasterboard finish below the kitchen breakfast bar where it meets the panel.

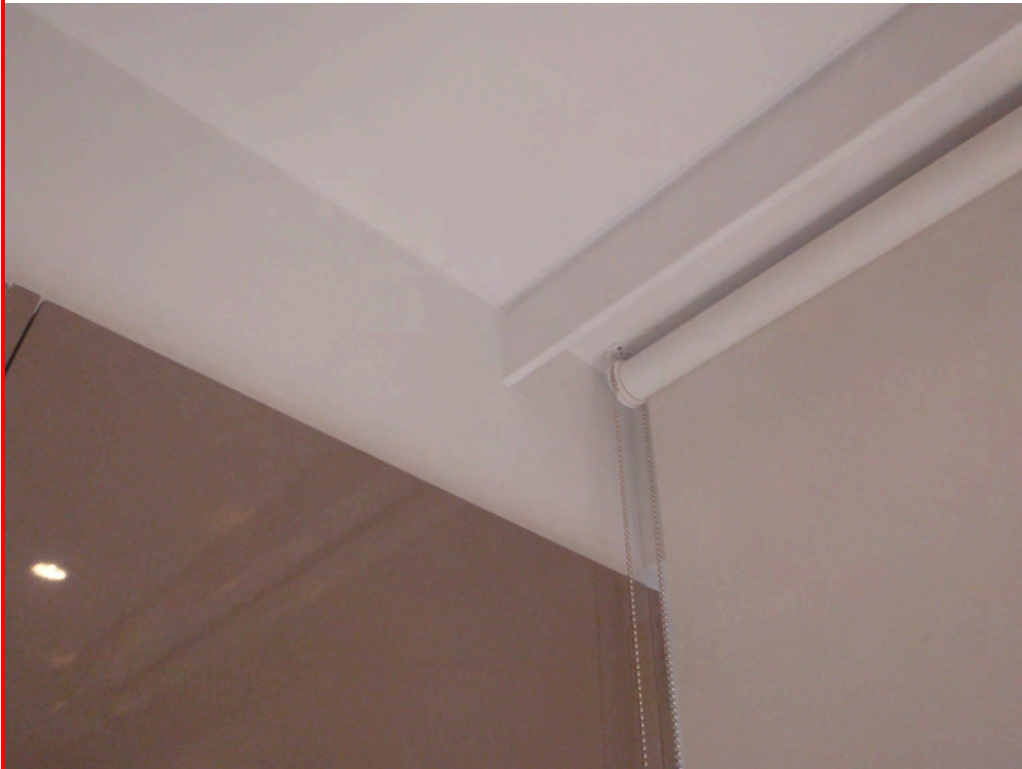
Repair the wall finish to the area surrounding the kitchen window pelmet.

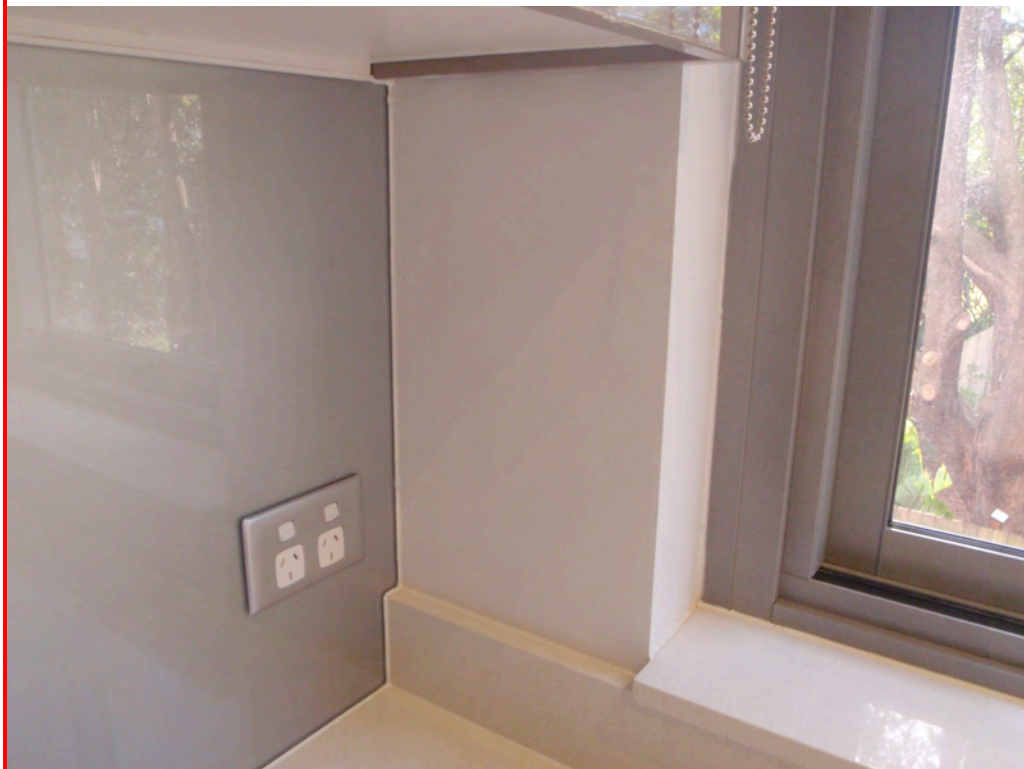
Improve paint finish to the wall beside the kitchen window.

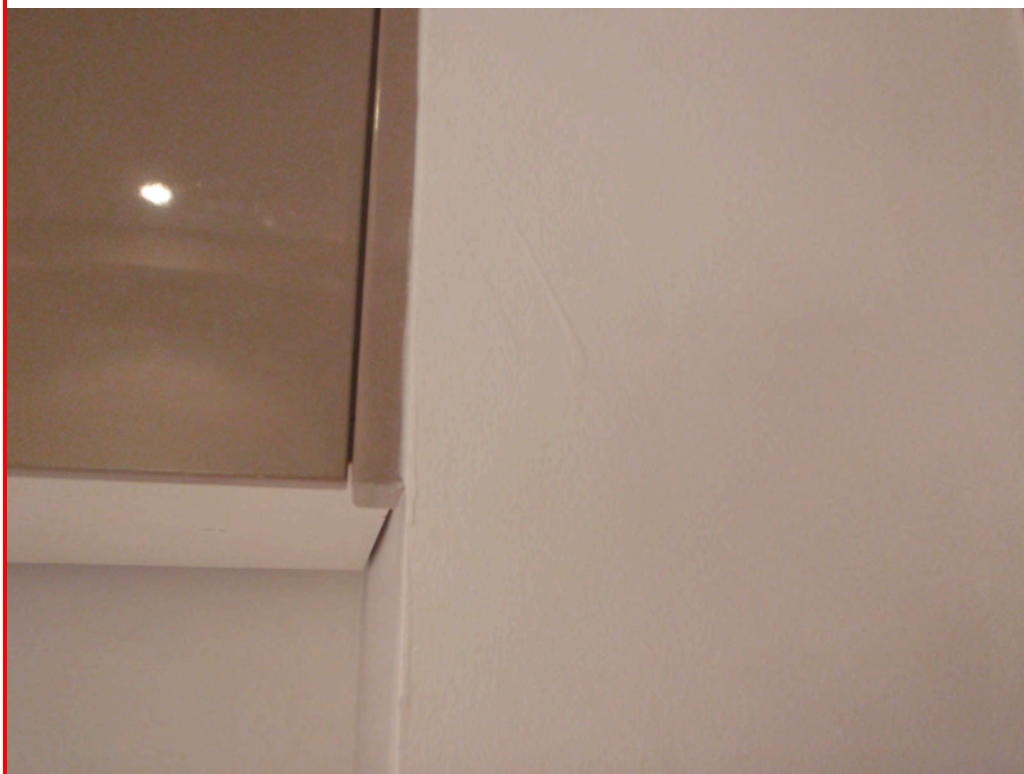
Improve the rough paint finish to the kitchen wall beside the fridge alcove.

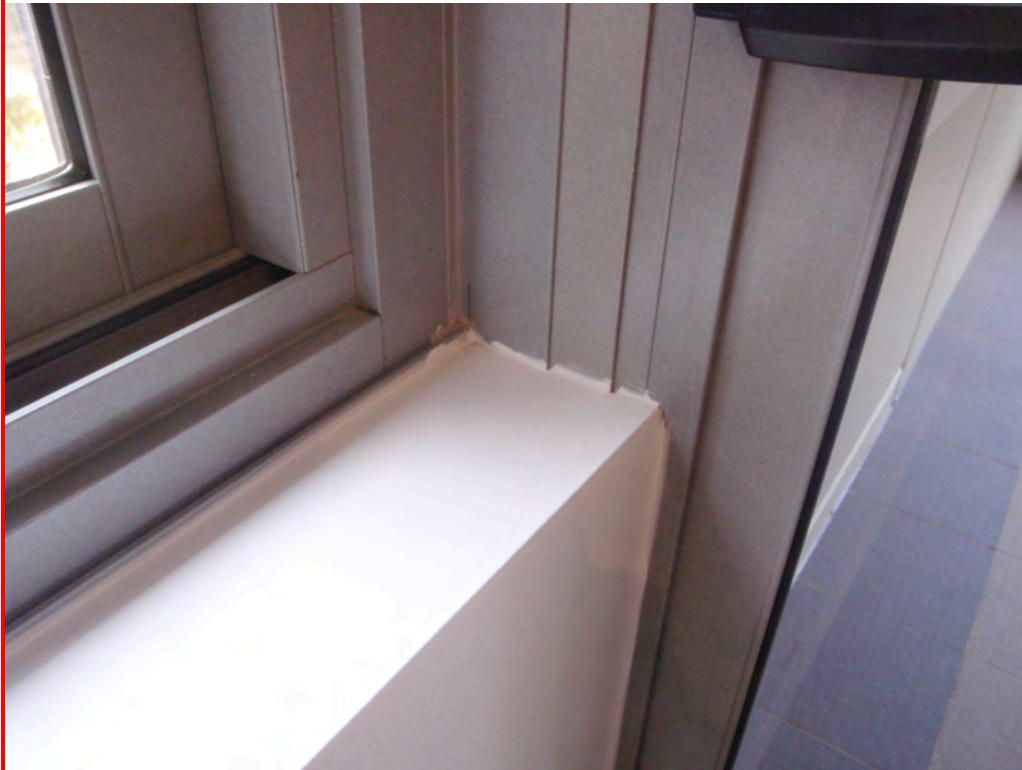
Remove excess paint from the window frame to the balcony door area.

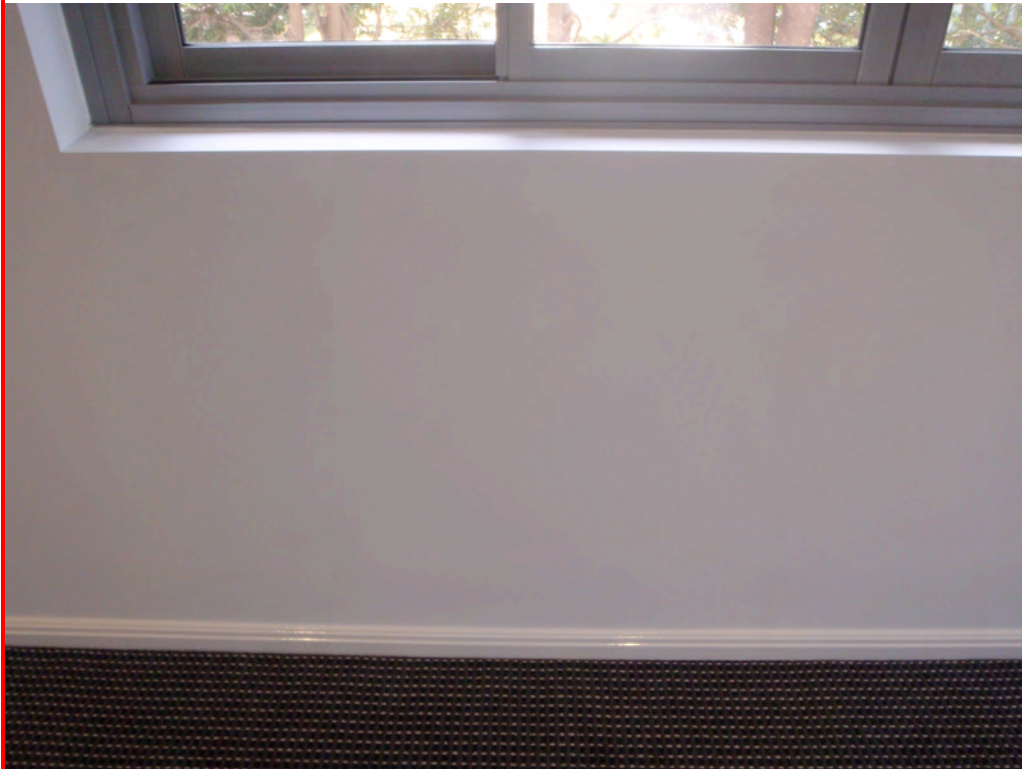
Patch and paint small indentation to the wall below the window near the balcony door.

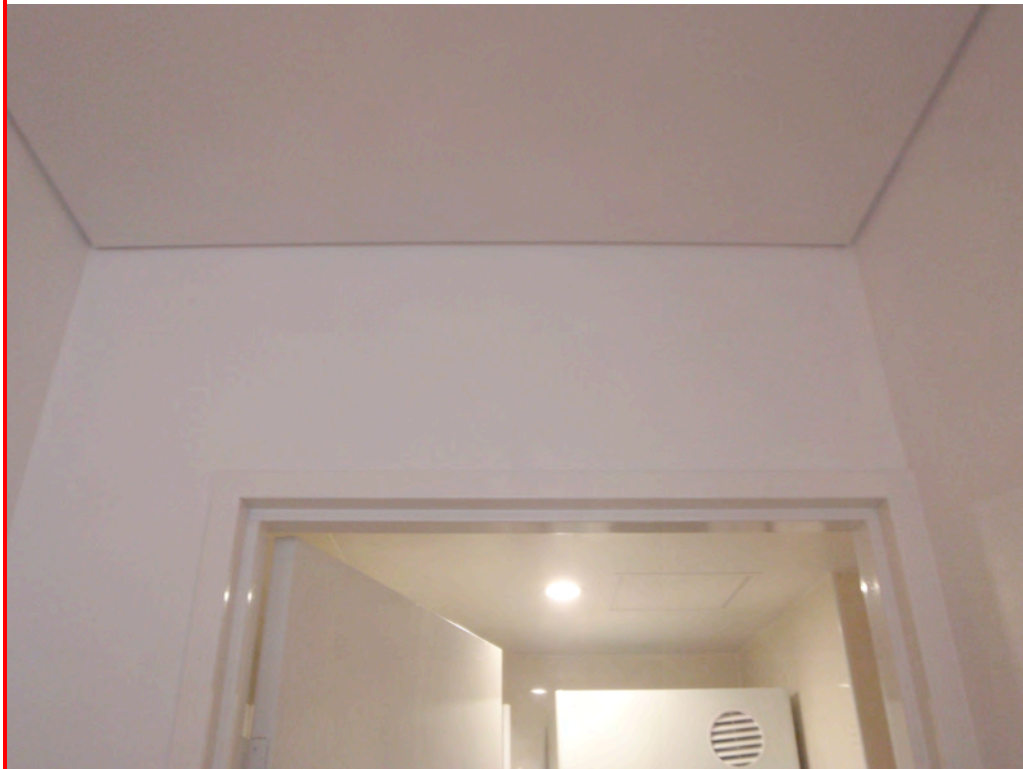
Remove excess paint drips from the wall above laundry door.

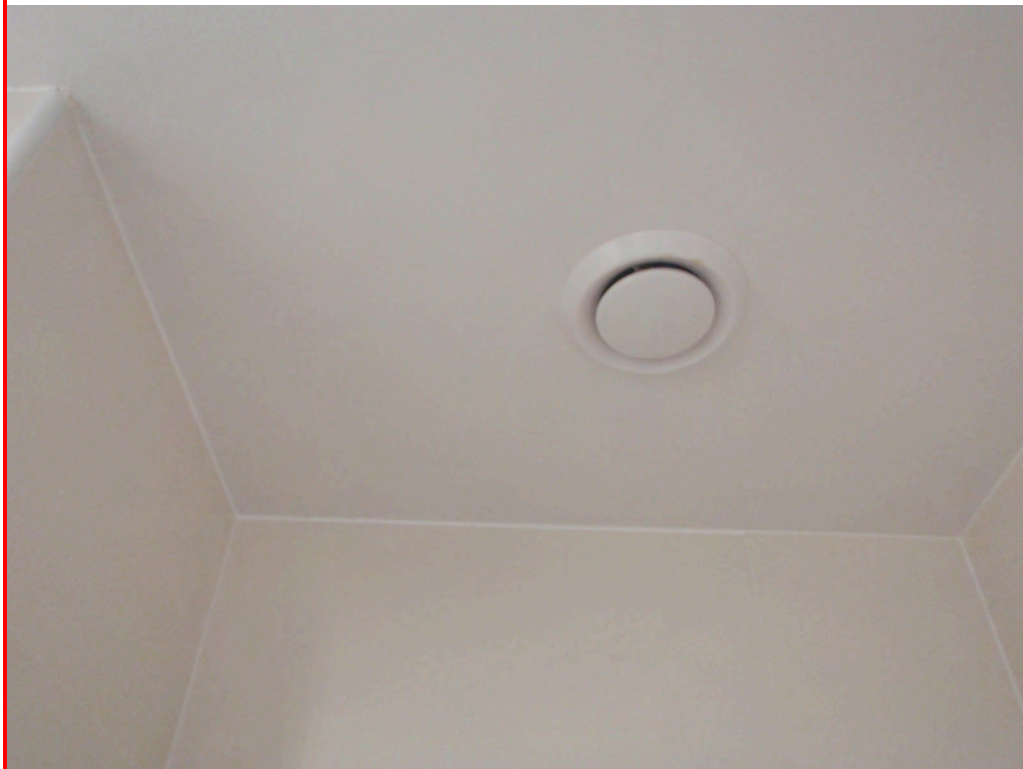
Repair movement in the exhaust fan cover to the laundry.
Exhaust fans to the laundry, bathroom and ensuite appear insufficient.

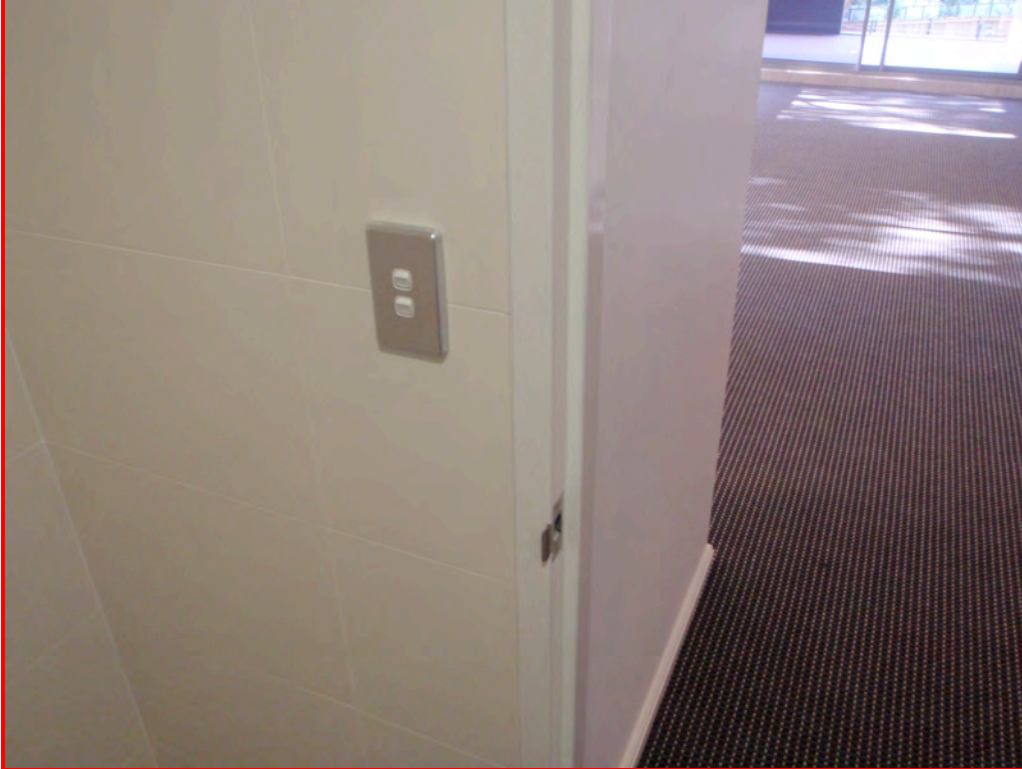
Complete painting to the door frame of the laundry, including behind the door and remove excess paint from tiles behind the door.

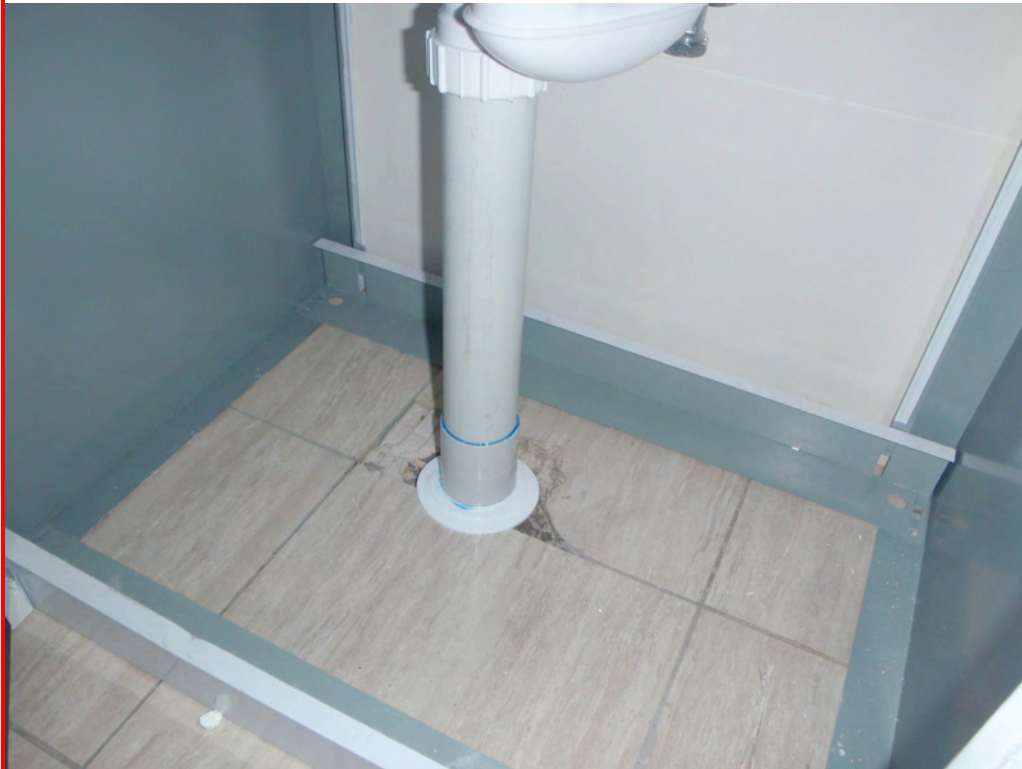
Complete the tiling below the laundry tub.

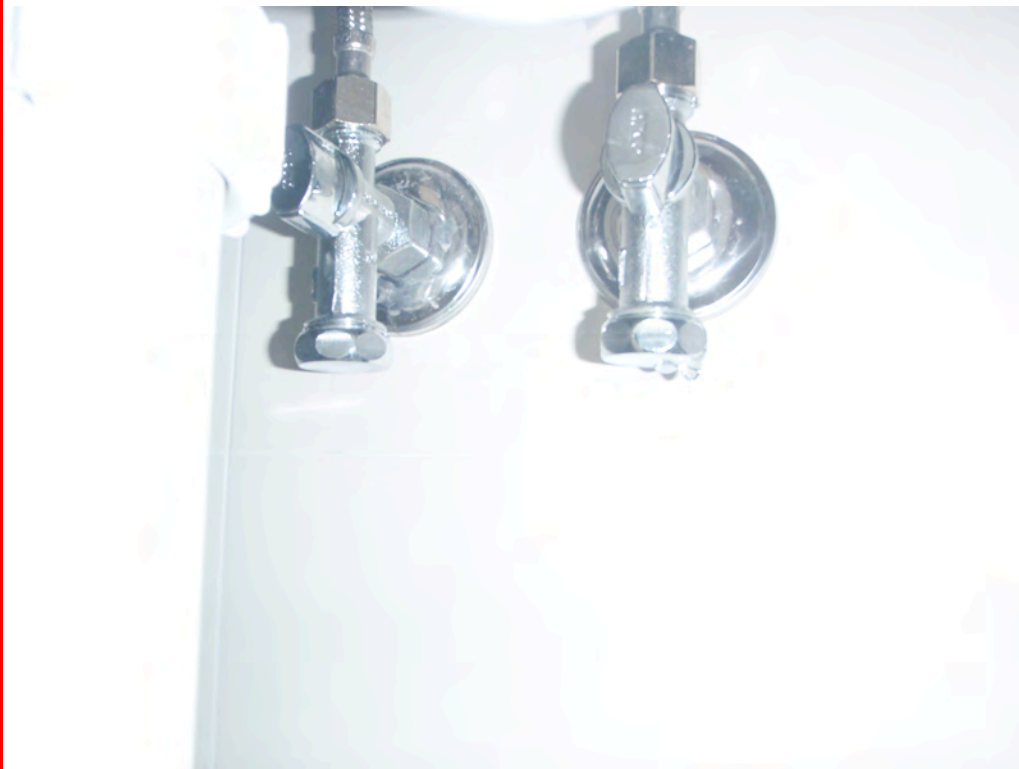
Repair leak in plumbing below the laundry tub.

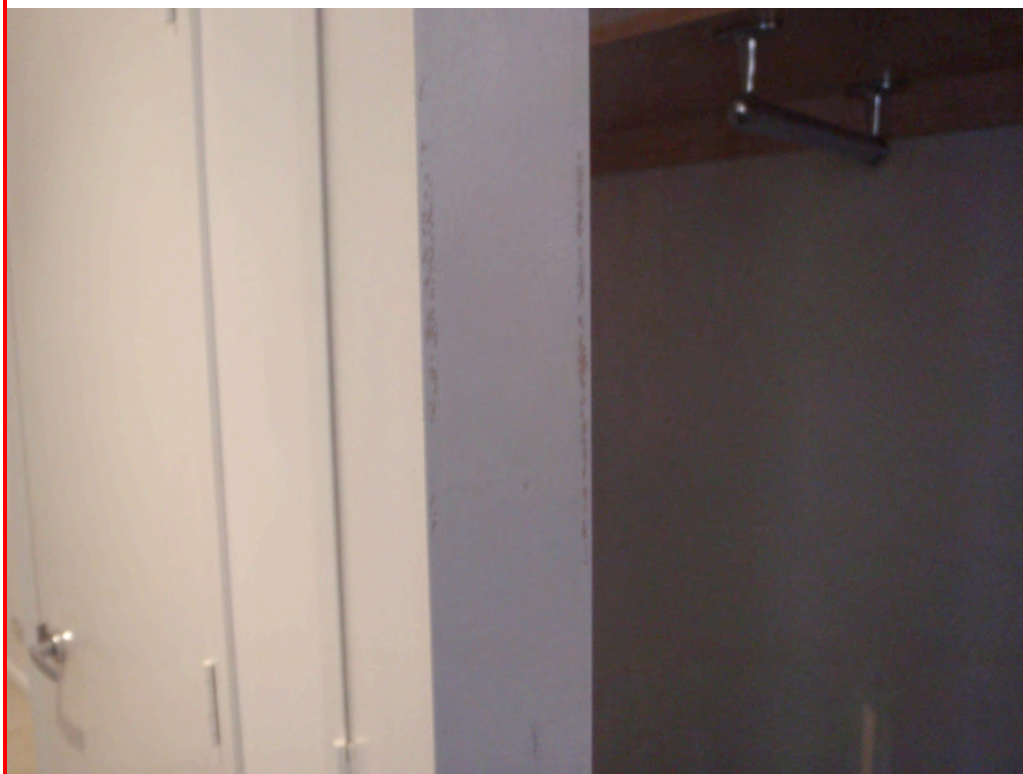
Improve painting to the hallway cupboard door edge on the right.

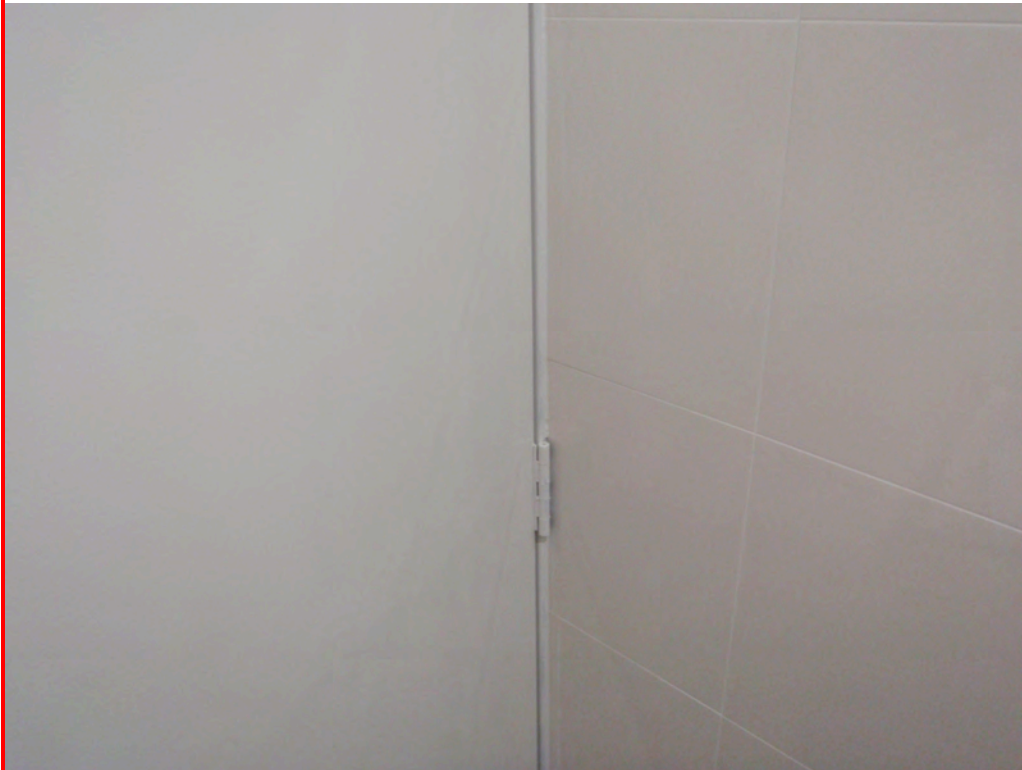
Chip to the edge of the left side hallway door has been patched. This should be re-checked when paint dries.

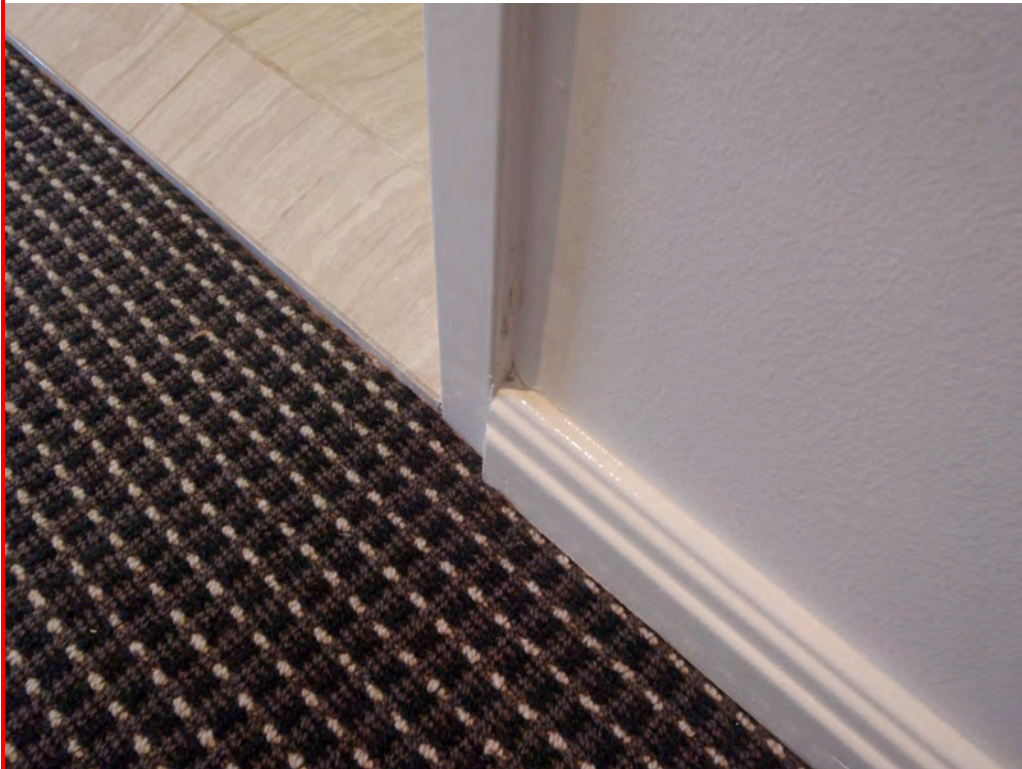
Repair the paint finish to the bathroom door frame at the right side.

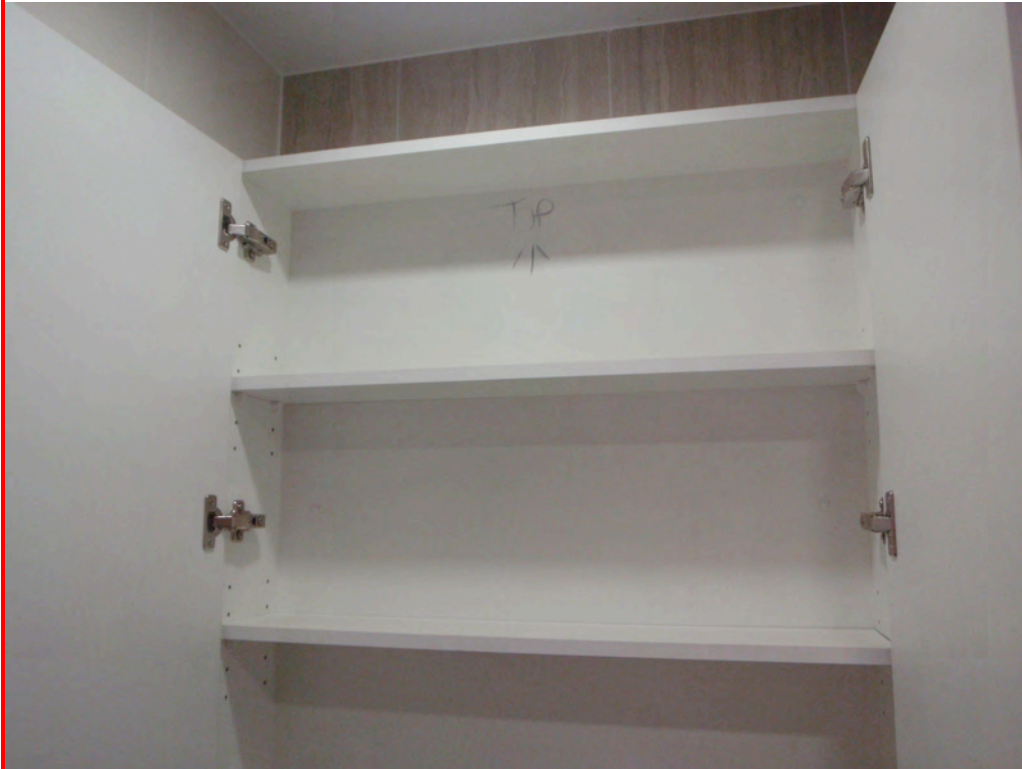
Remove writing from inside the bathroom vanity unit.

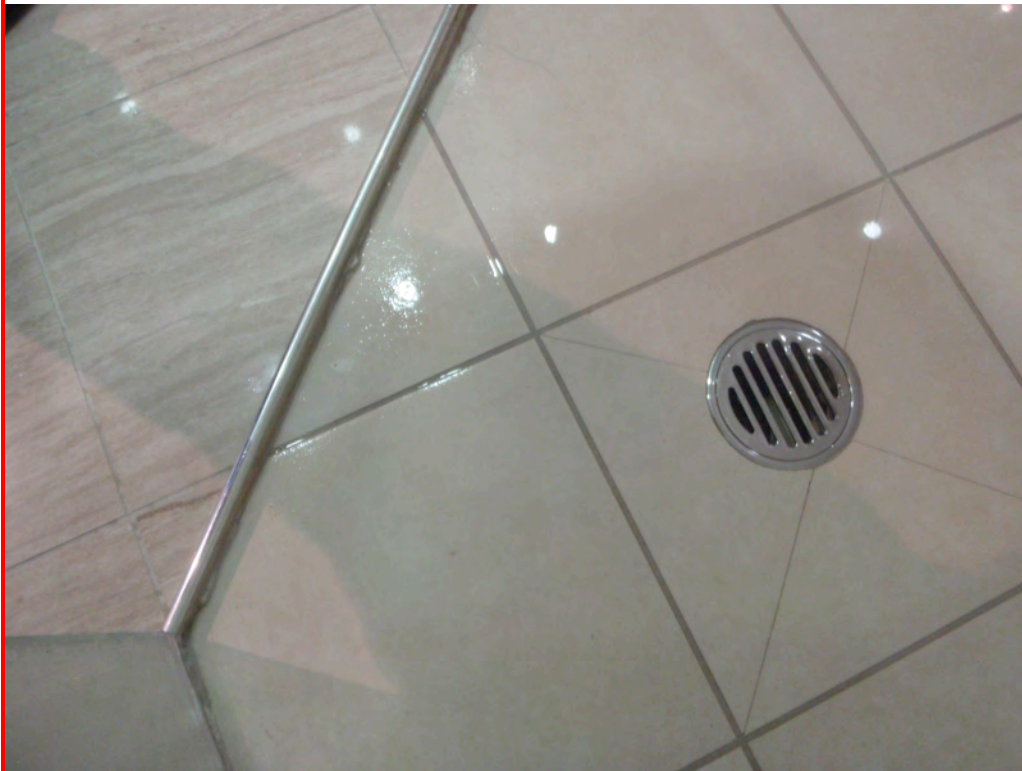
Repair the edge finish below the bathroom shower door.

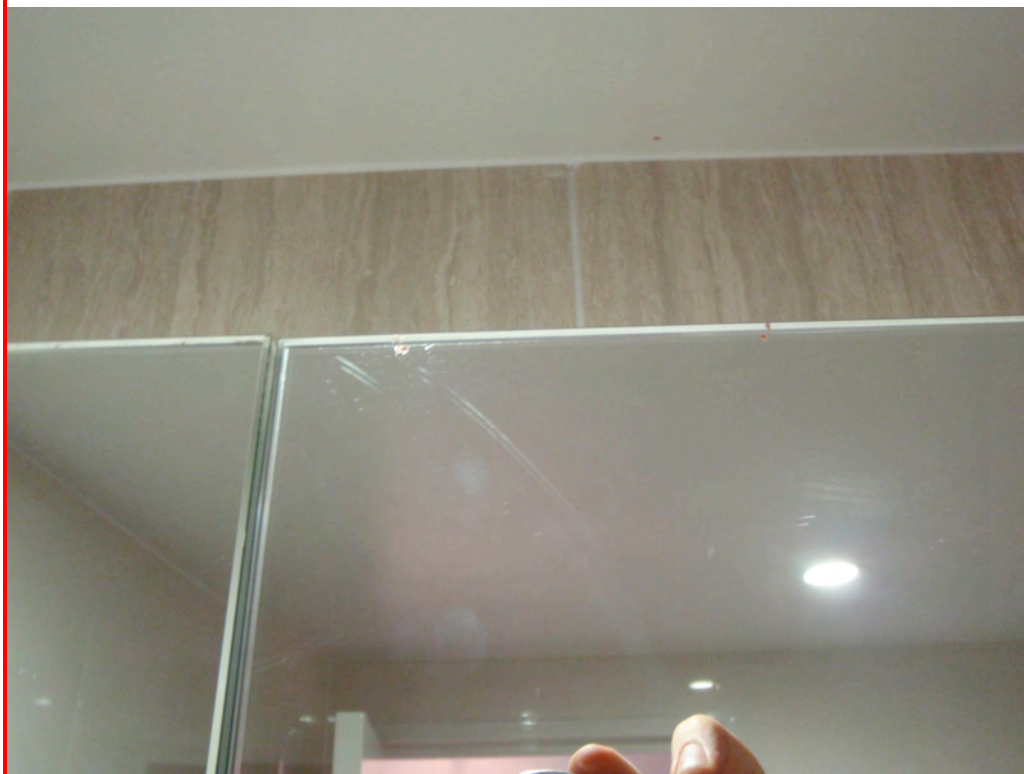
Remove the scratch and brown marks from the vanity mirror in the bathroom.

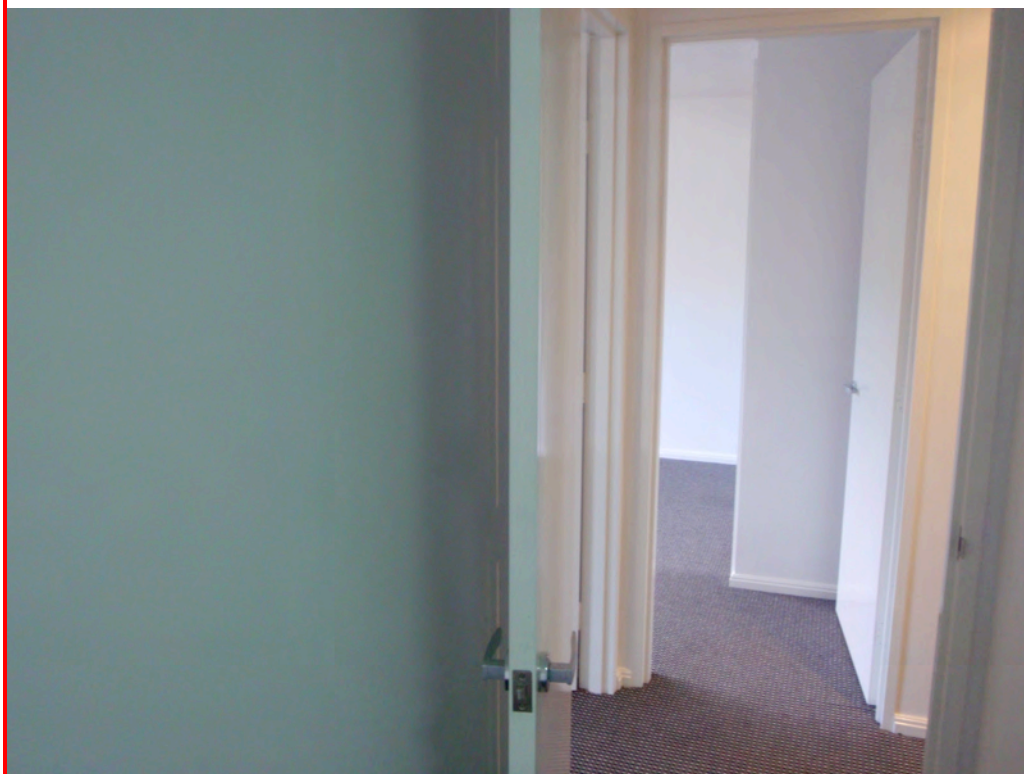
Improve the paint finish to bedroom 3 door edge.

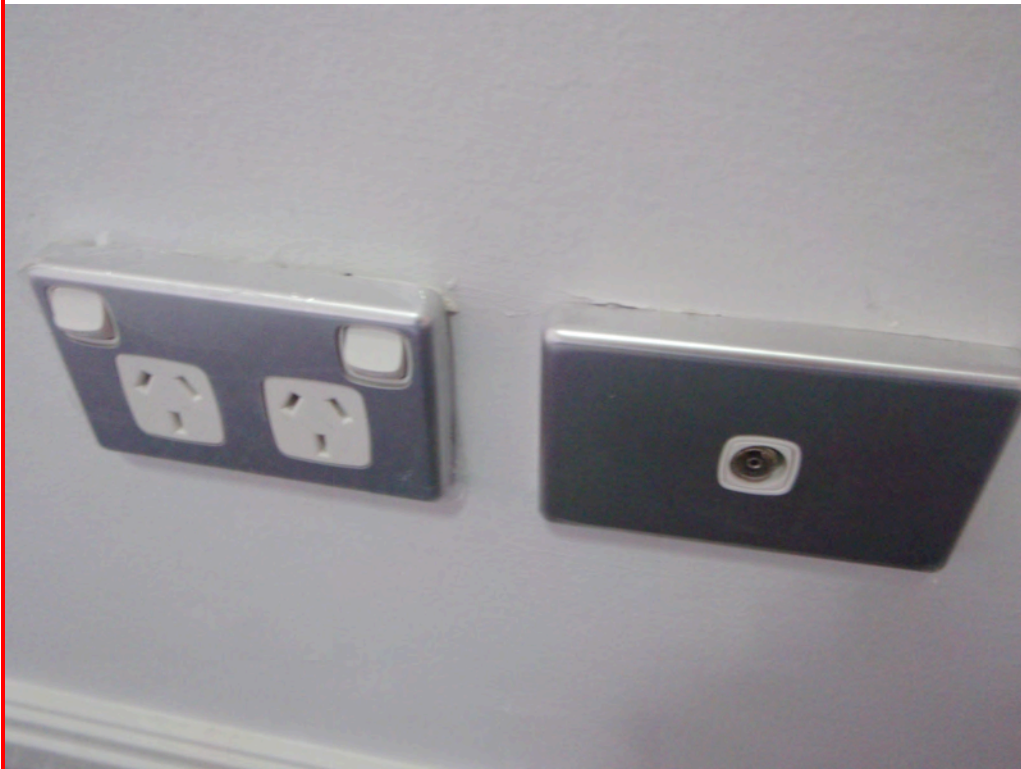
Improve paint finish to wall around bedroom 3 powerpoints.
