Childs Property
Inspections
Building Completion Report

Childs Property Inspections was commissioned by _____ to carry out a completion report on the above property. The purpose of this report is to provide a list of incomplete or defective works to the builder for rectification prior to occupation.

The property inspected is an apartment of full masonry construction located on the first floor in a five storey complex. This structure is on pier and strip and suspended concrete slab footings, with a re-inforced concrete roof.

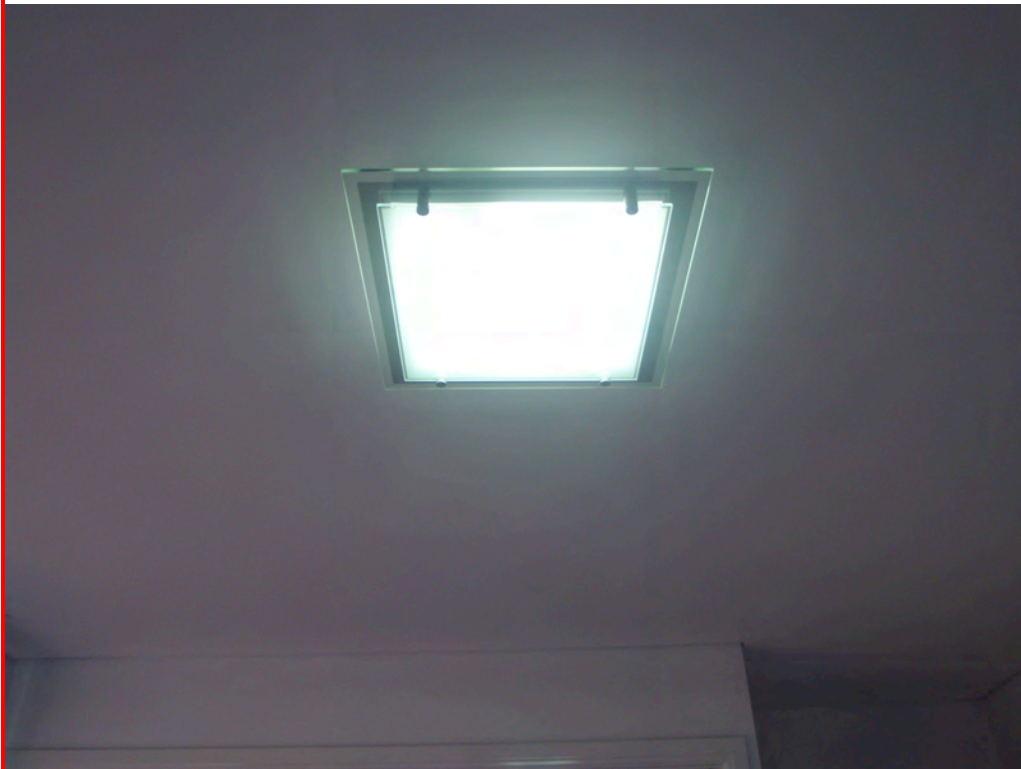
Re-align the out of square light fitting to bedroom 2 ceiling.

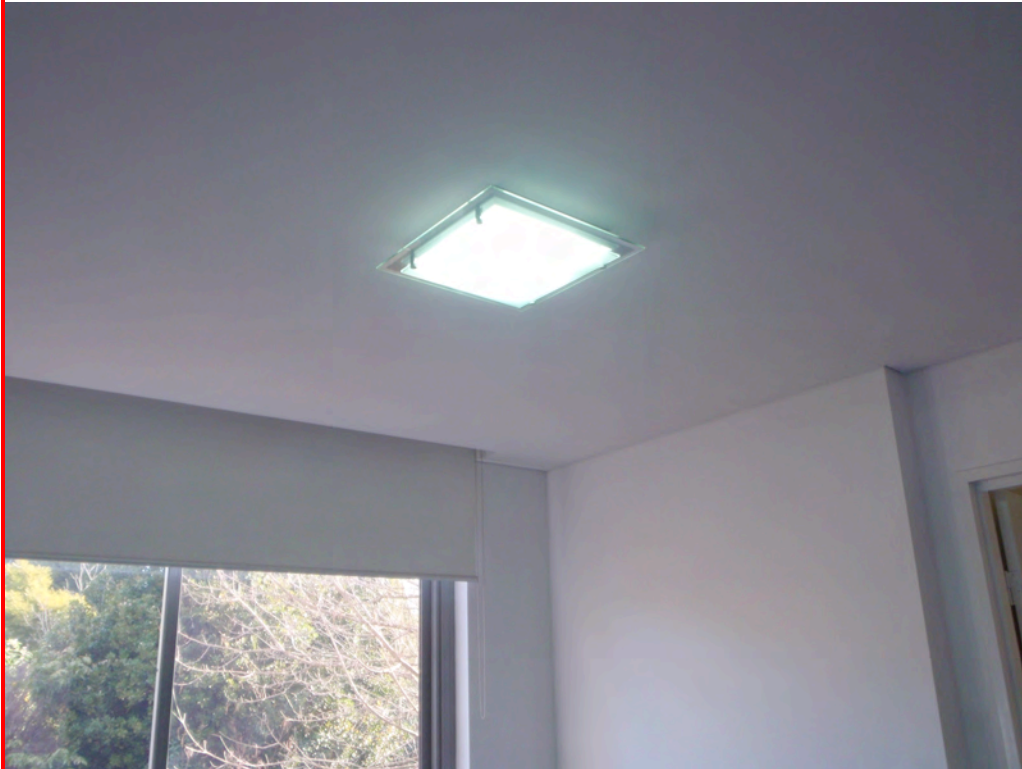
Re-align the out of square light fitting to bedroom 1 ceiling.

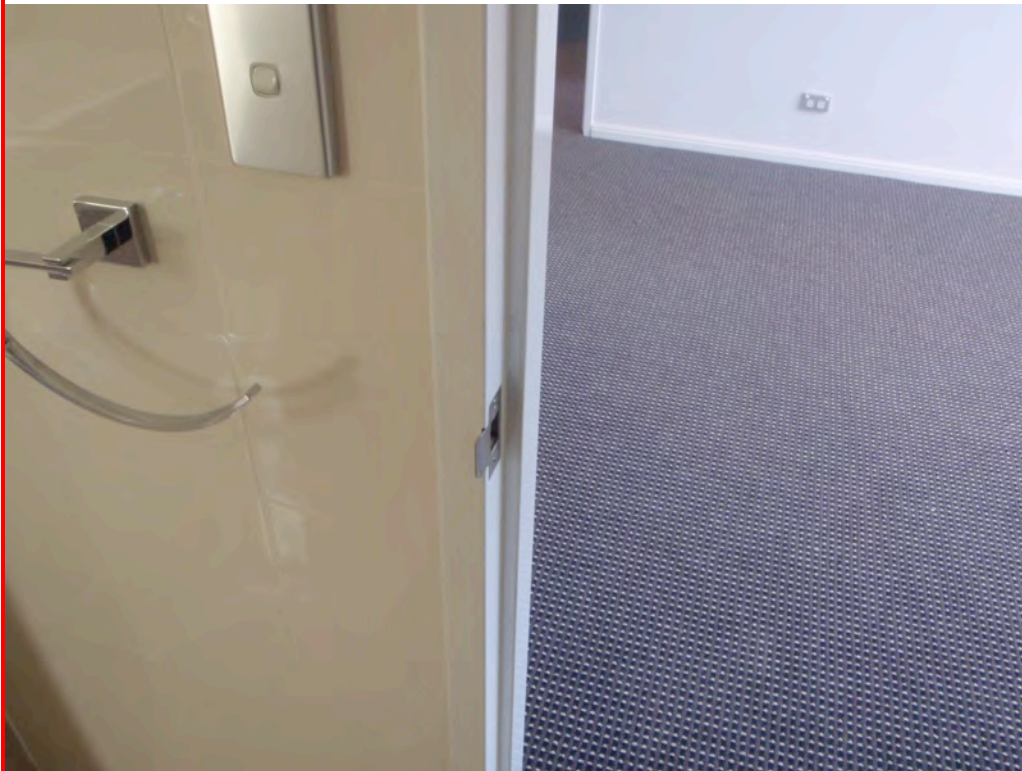
Complete the inadequate paint cover to the ensuite door frame.

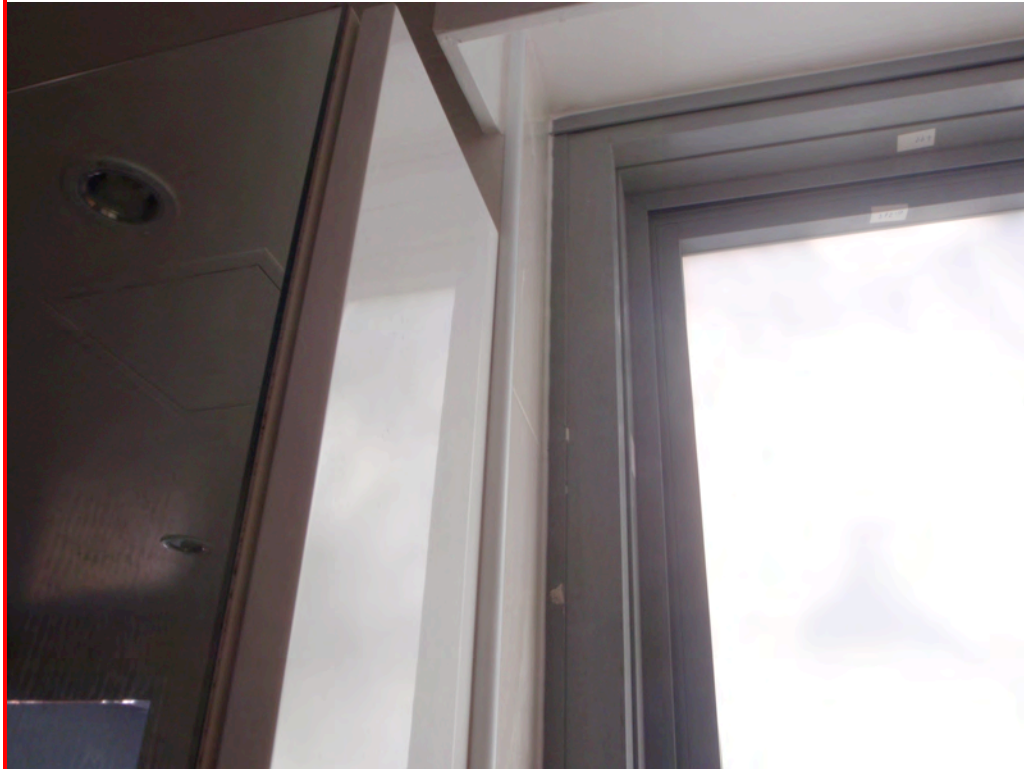
Remove grout from the ensuite window frame.
