Childs Property
Inspections

Dilapidation Building Report

(PRE CONSTRUCTION)

The property inspected is a single storey, semi detached dwelling of full masonry construction. This structure is on pier and strip footings, with a pitched roof covered in terracotta tiles.

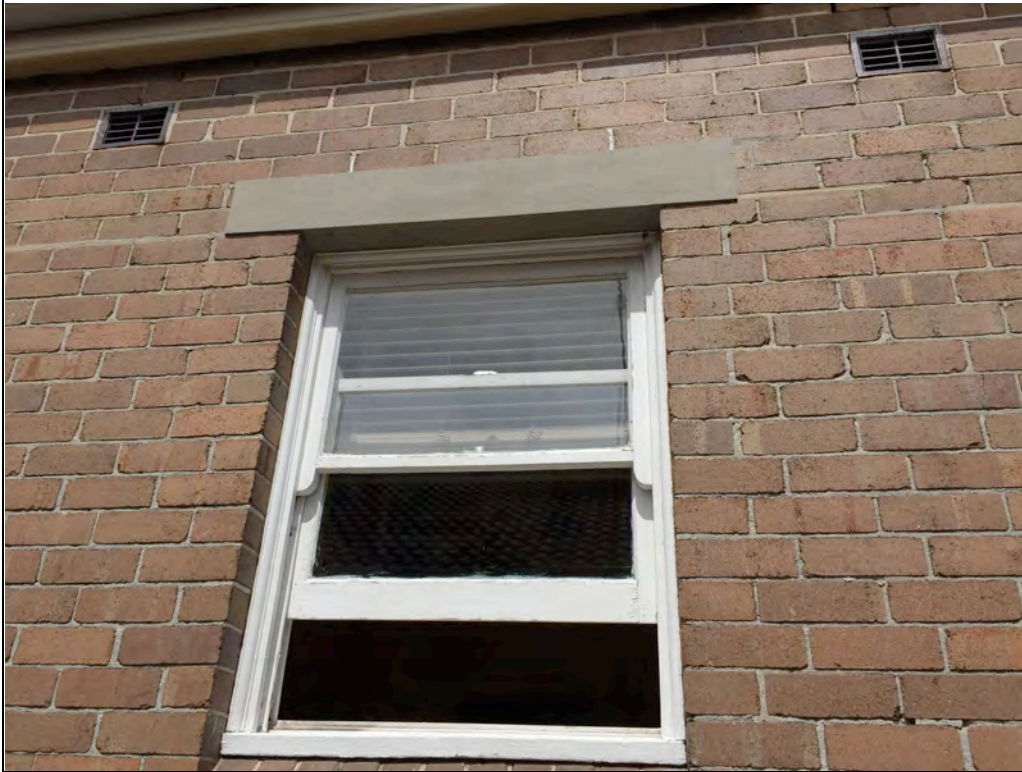
Hairline crack to concrete lintel above the third window left of the front entrance door.

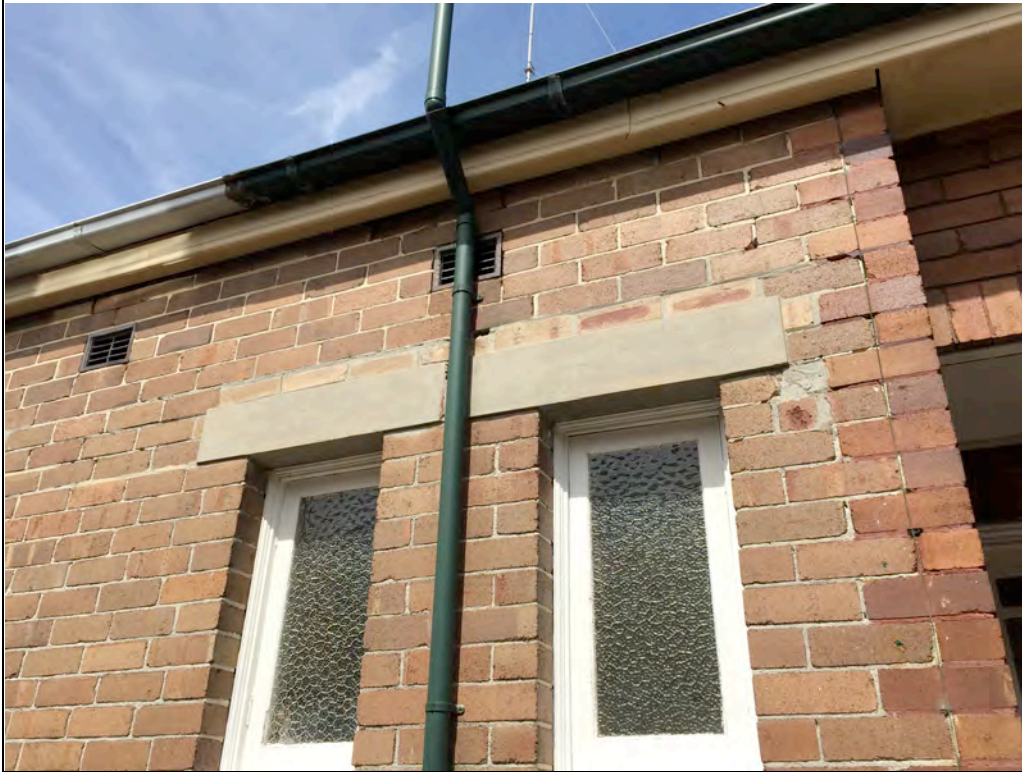
Evidence of repairs to cracks to the brickwork above and adjacent to all concrete lintels at the left side of the building.

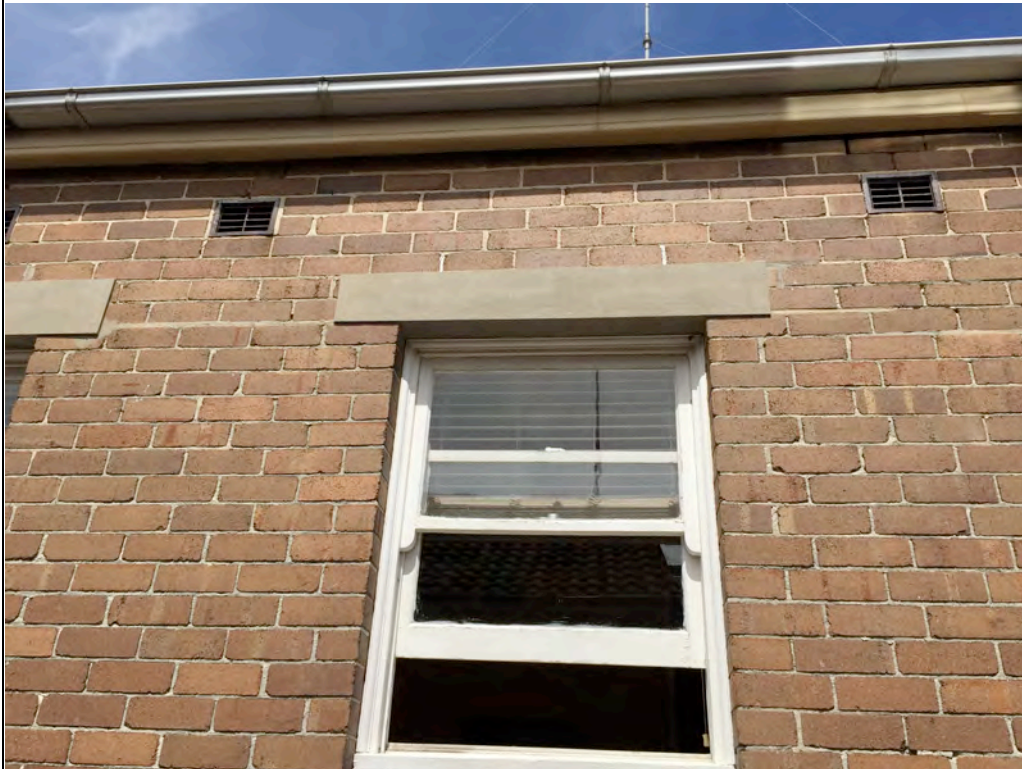
Evidence of repairs to cracks to the brickwork above and adjacent to all concrete lintels at the left side of the building.

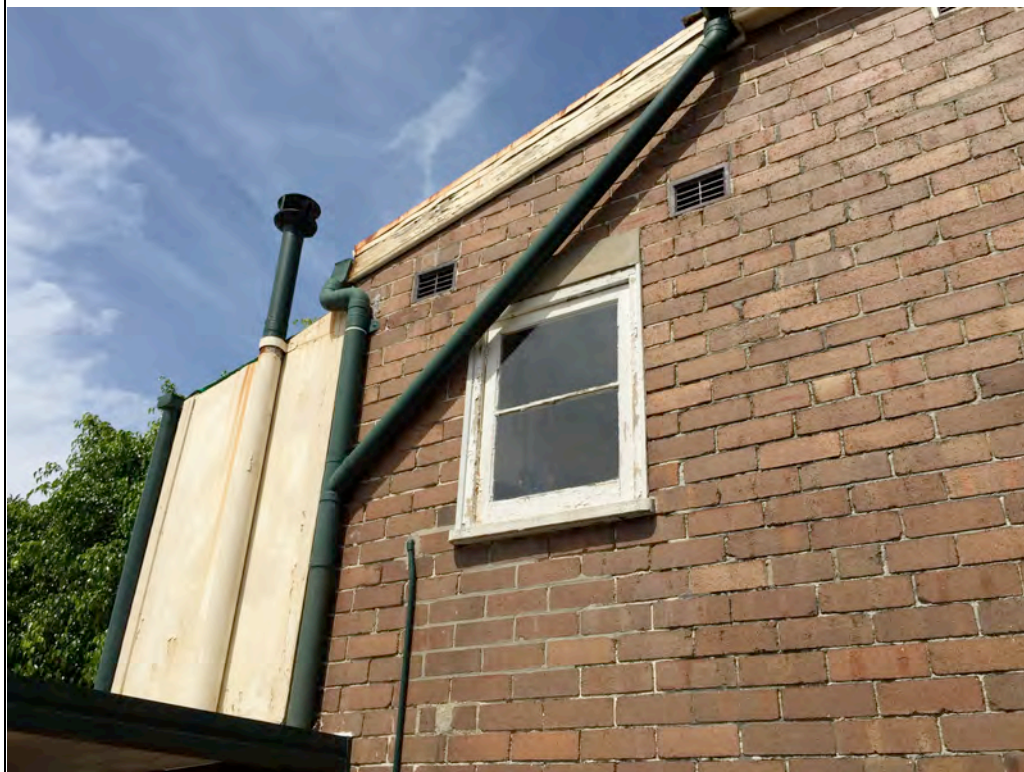
Cracks to brickwork and slab edge at the rear left corner.

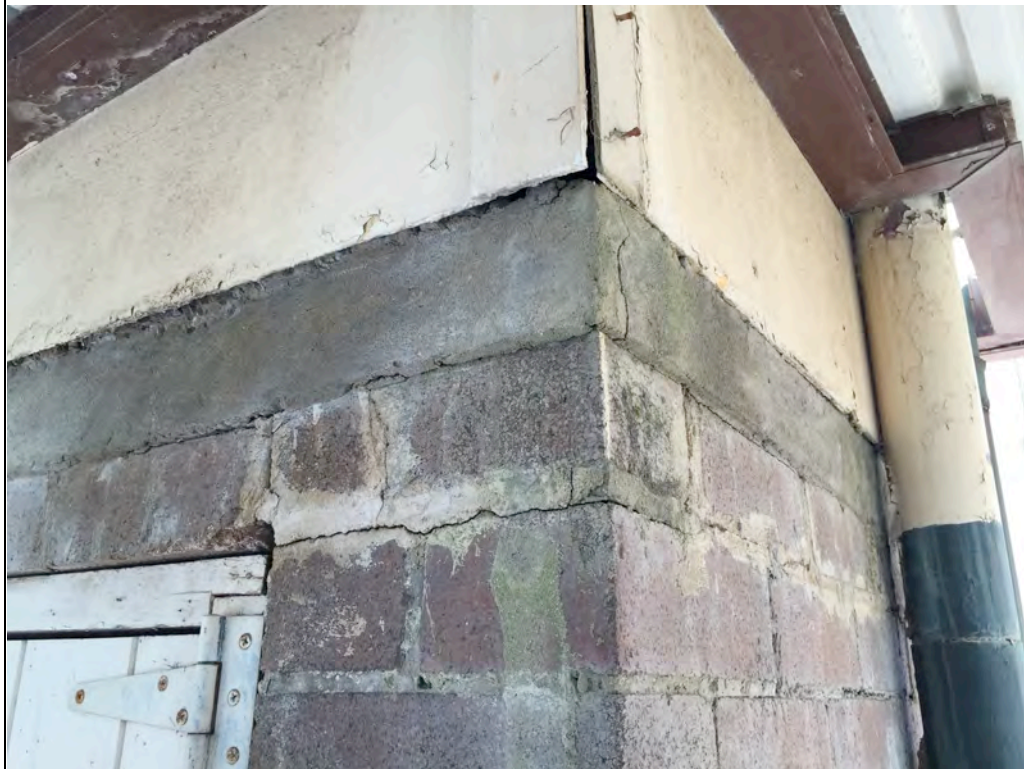
Cracks to the stair landing slab edge at the rear.

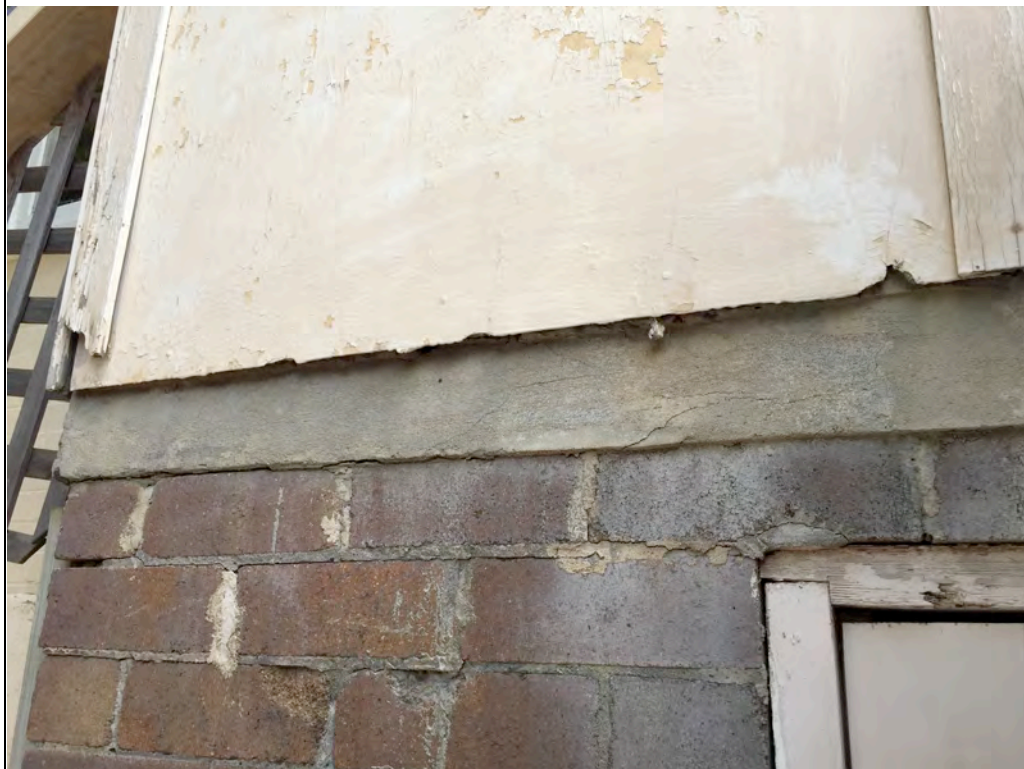
Cracks to the brickwork below the stair landing at the rear.

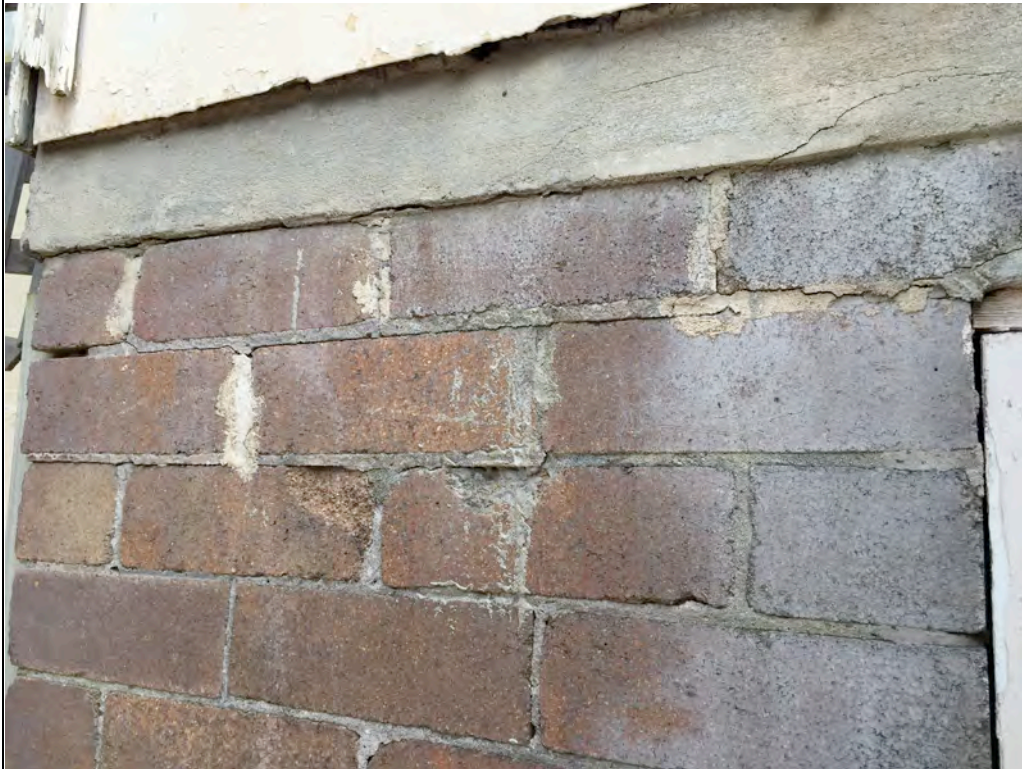
Cracks to brickwork at the rear at the base of the stairs.

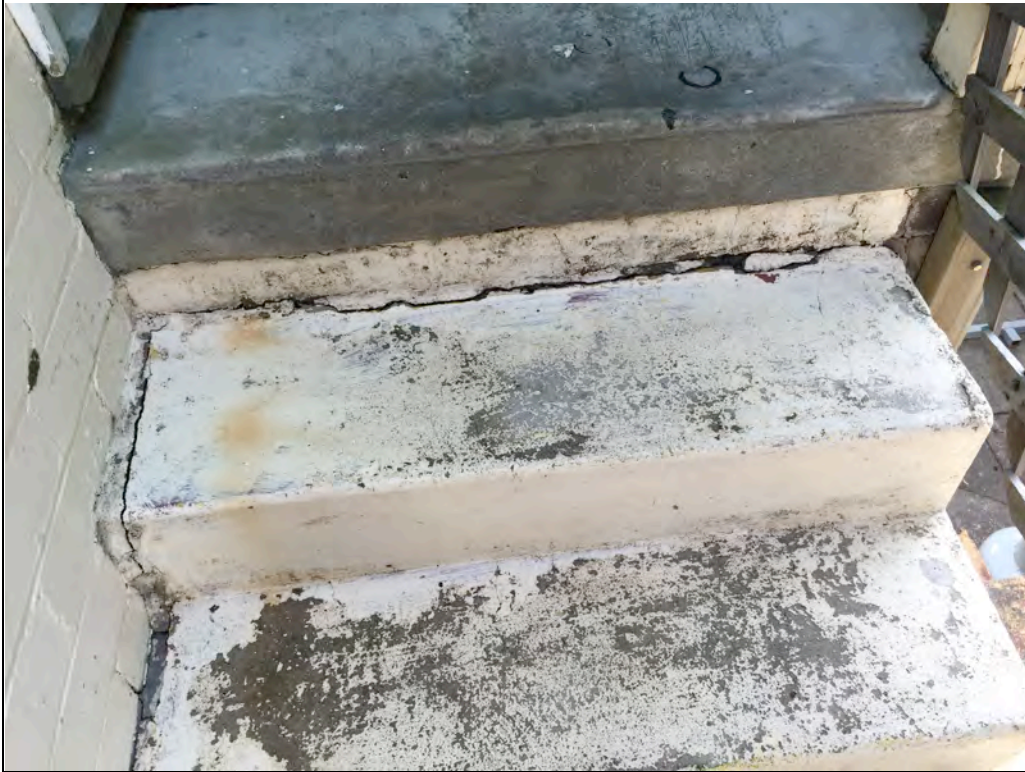
Multiple cracks to concrete pathway at the base of the stairs.

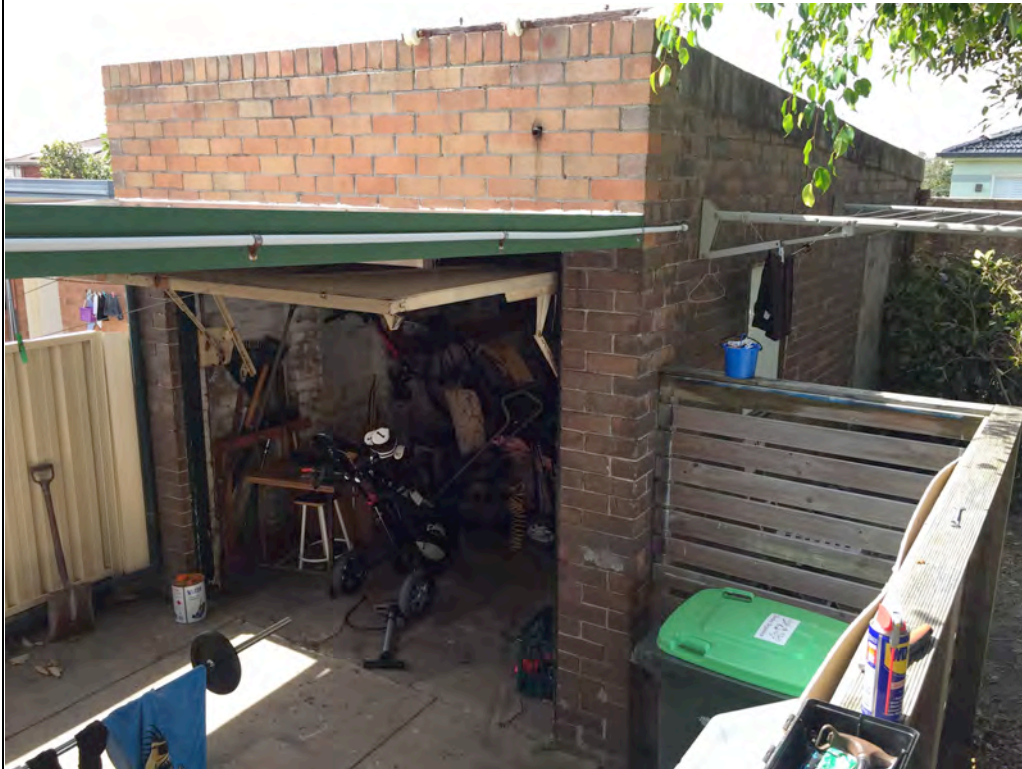
Large cracks above the window to the right side of the detached garage extending into the roof slab.

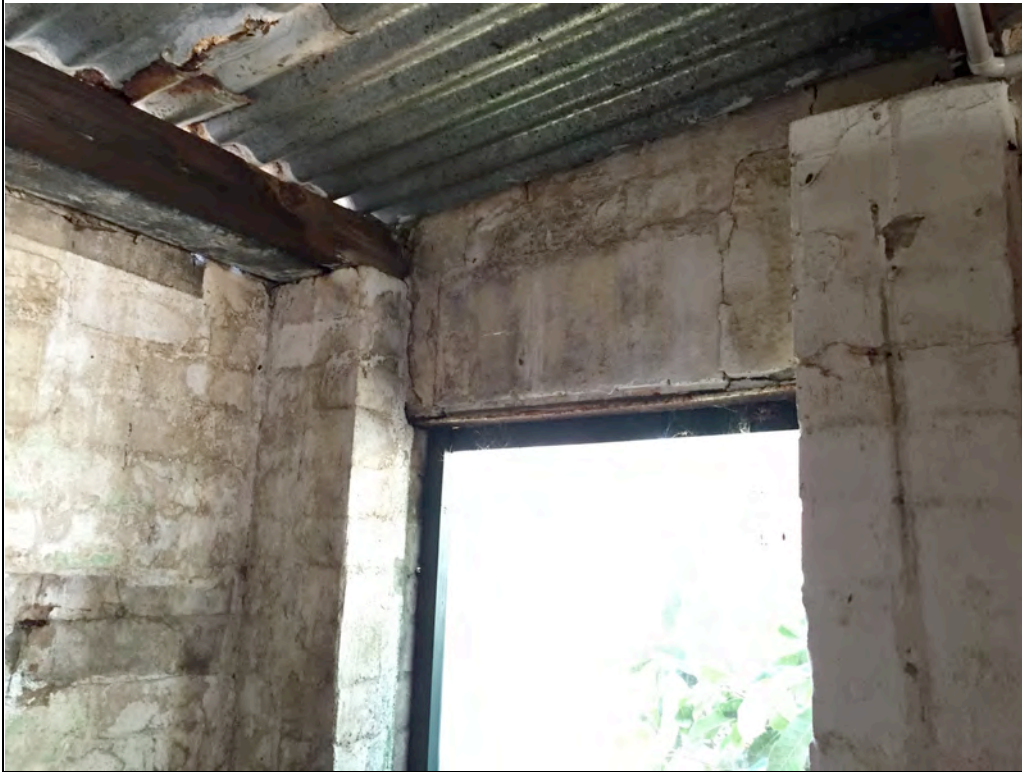
Extensive cracking to the brickwork to the garage as viewed from internally at the rear.

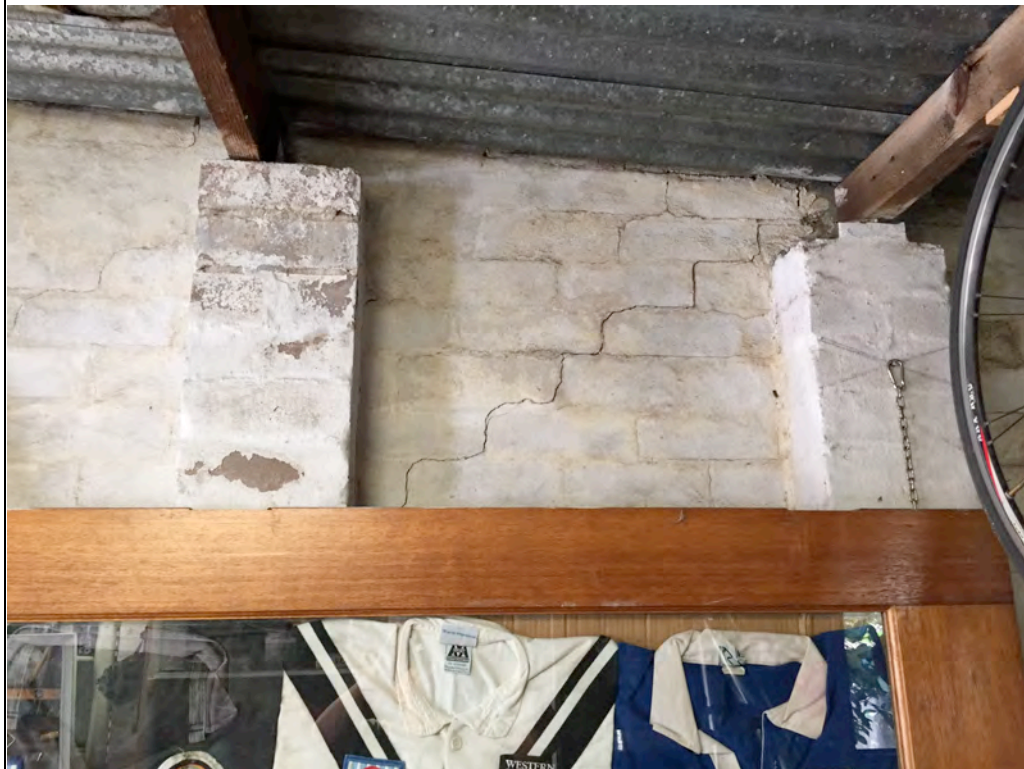
Extensive cracking to the left side of garage.

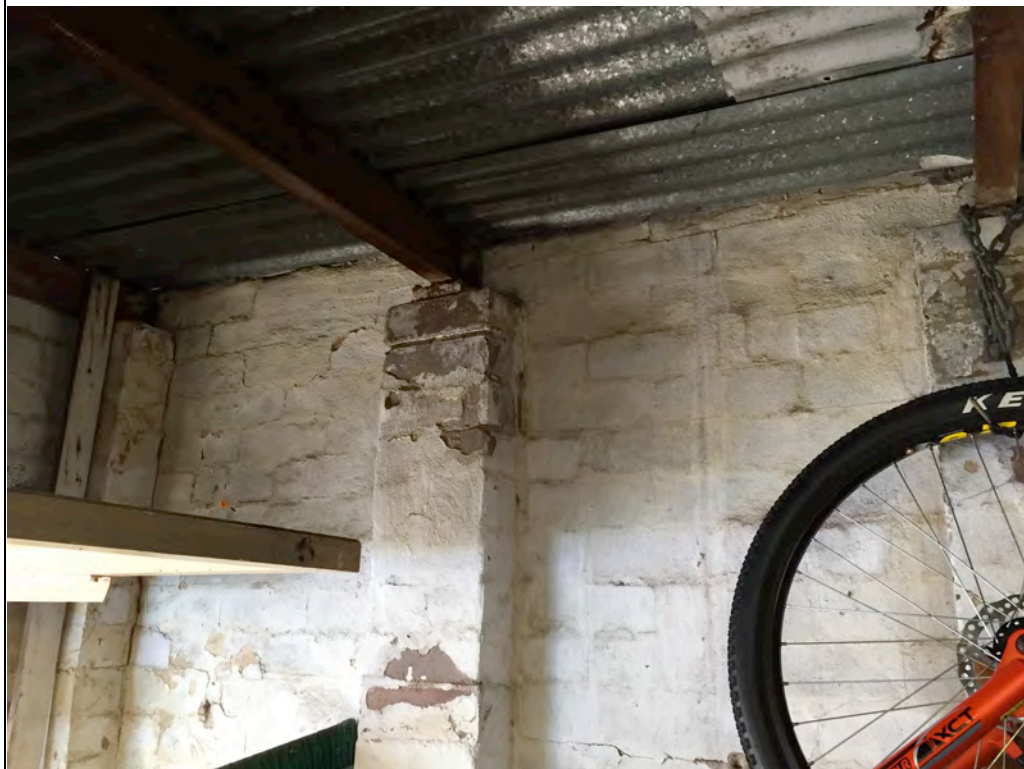
Extensive cracking to the right side of the garage.

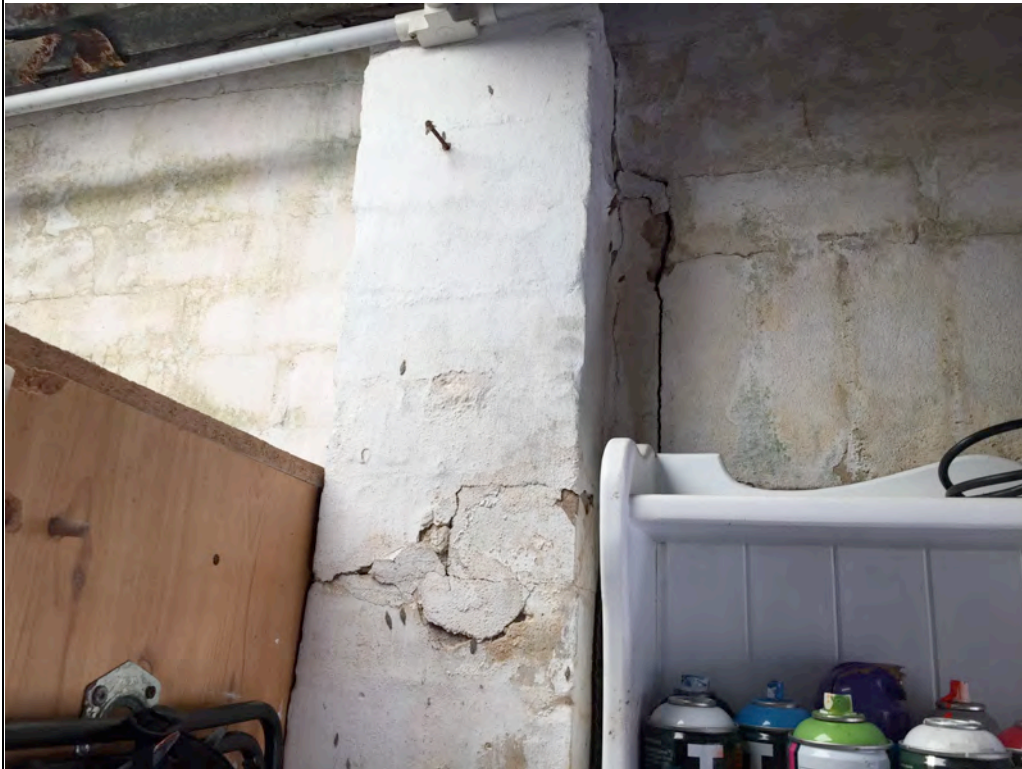
Extensive cracking to the right side of the garage.

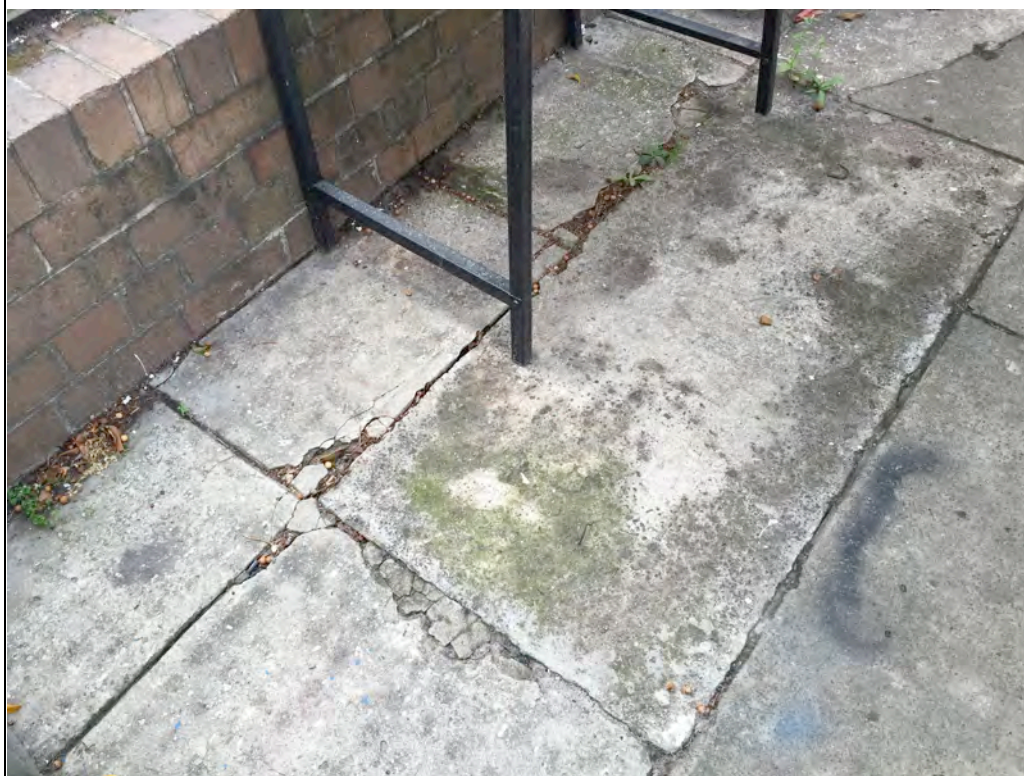
Cracks to concrete at the base of the lower level steps.

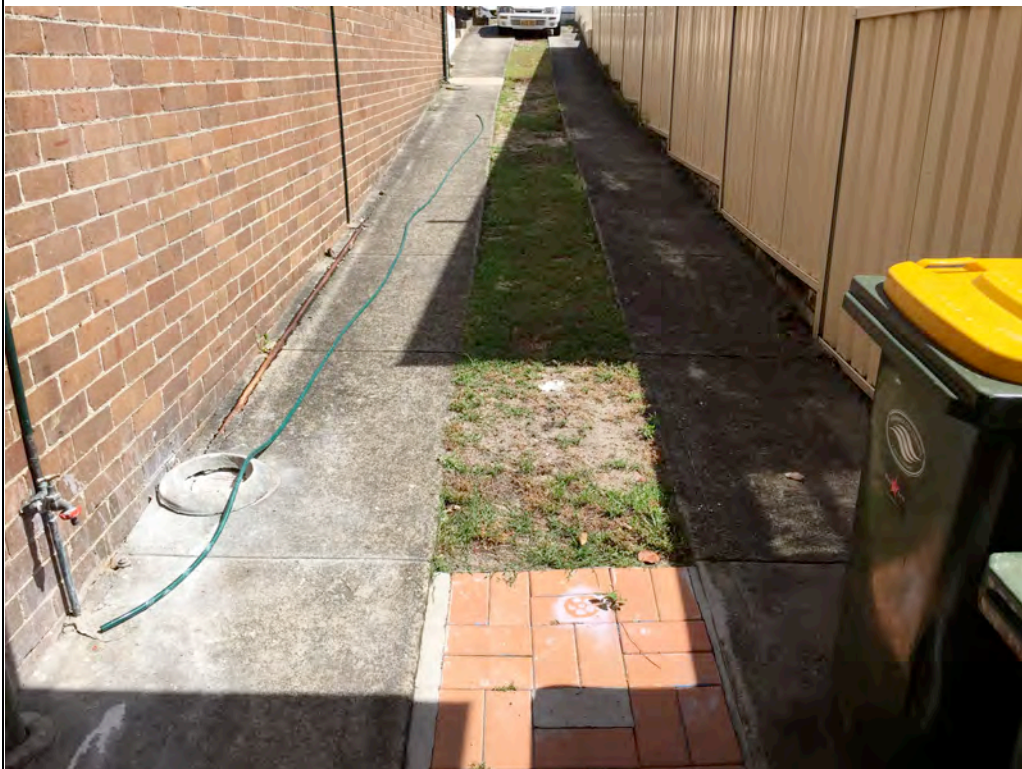
Cracked concrete surrounding the copper water pipe at the rear right corner.

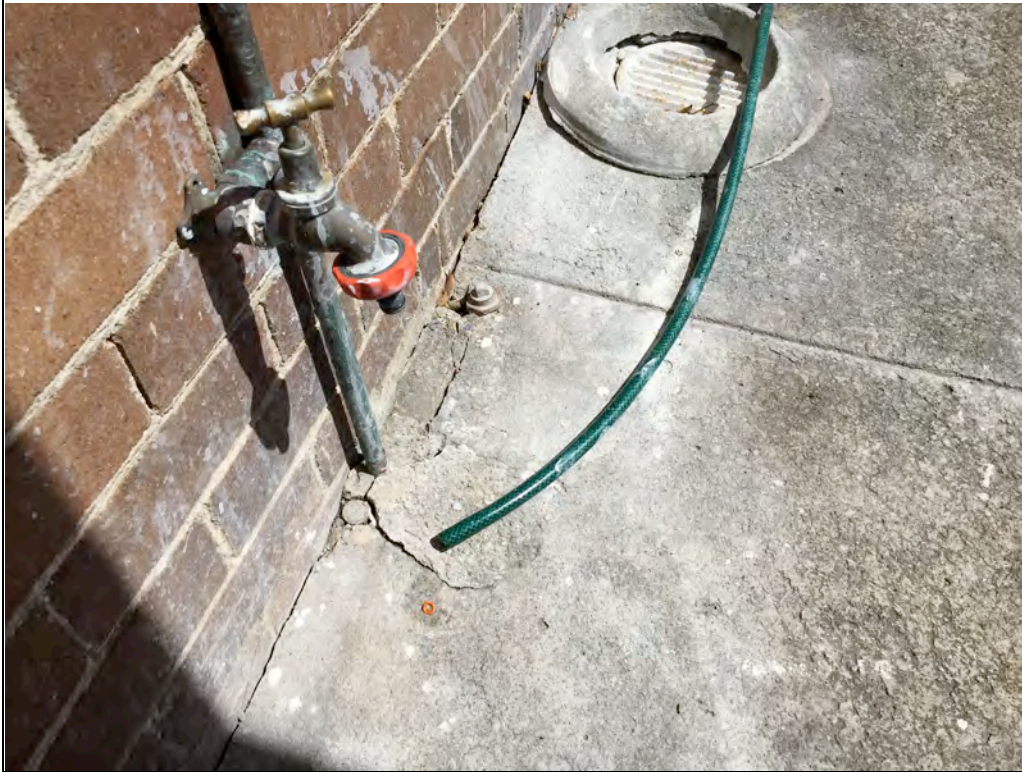
Cracked concrete driveway adjacent to the external wall of the home. Cracks have developed above the water pipe embedded in the concrete.

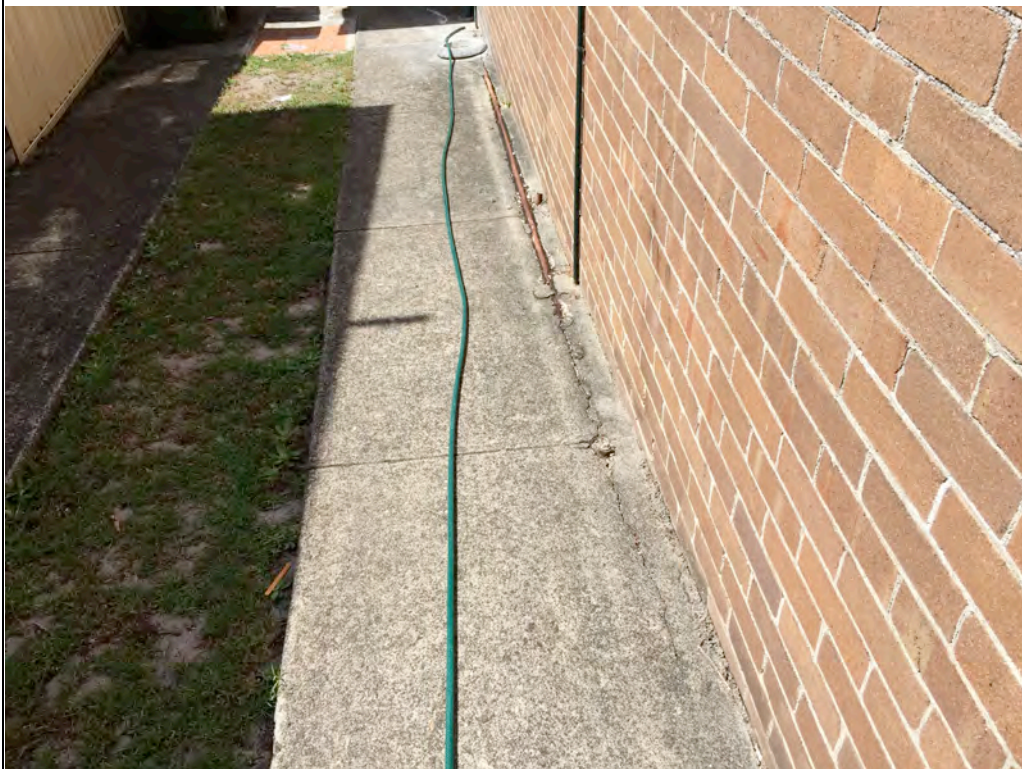
Cracked concrete driveway adjacent to the external wall of the home. Cracks have developed above the water pipe embedded in the concrete.

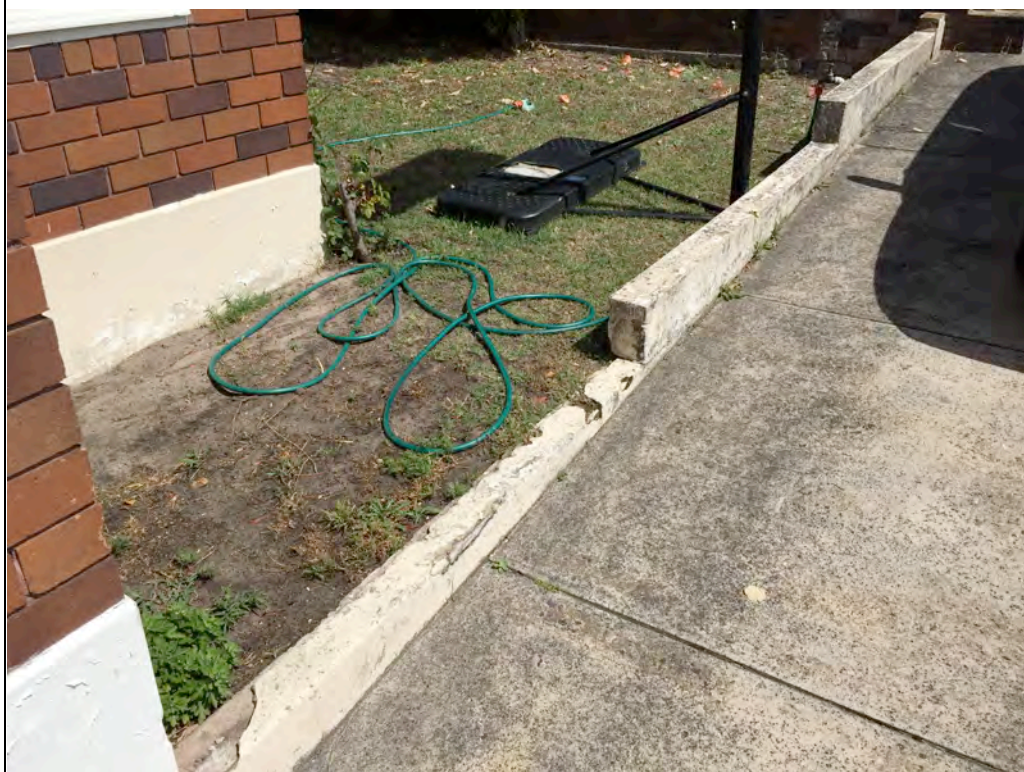
Damaged small brick lawn retaining wall at the right side of the driveway.

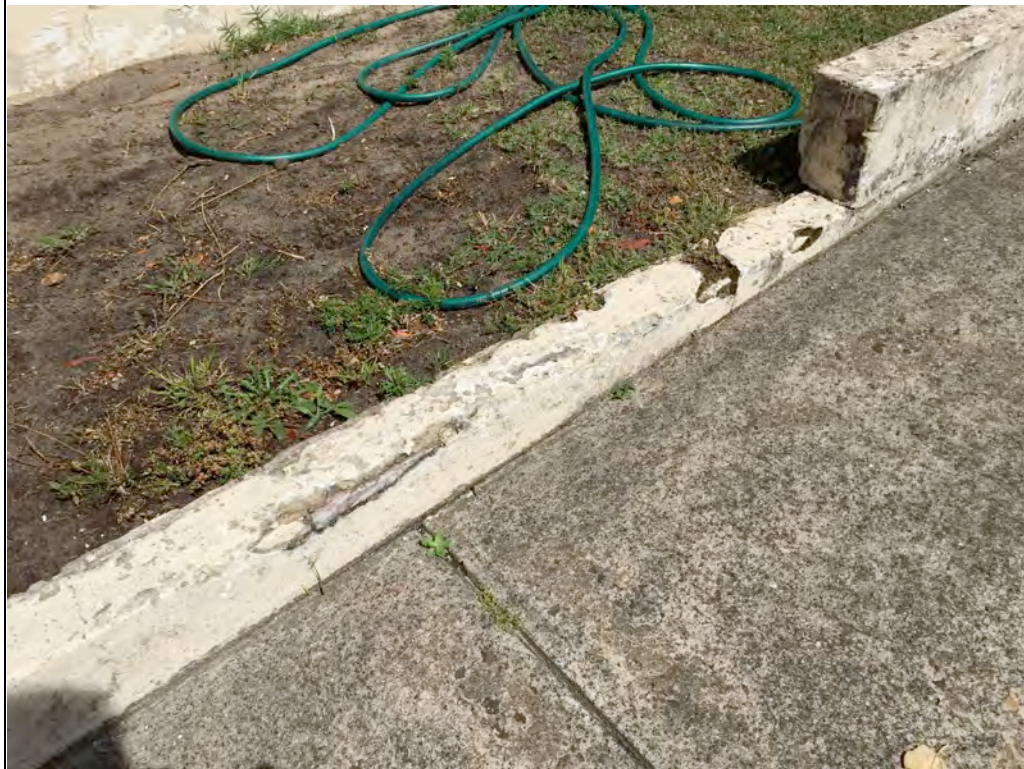
Damaged small brick lawn retaining wall at the right side of the driveway.

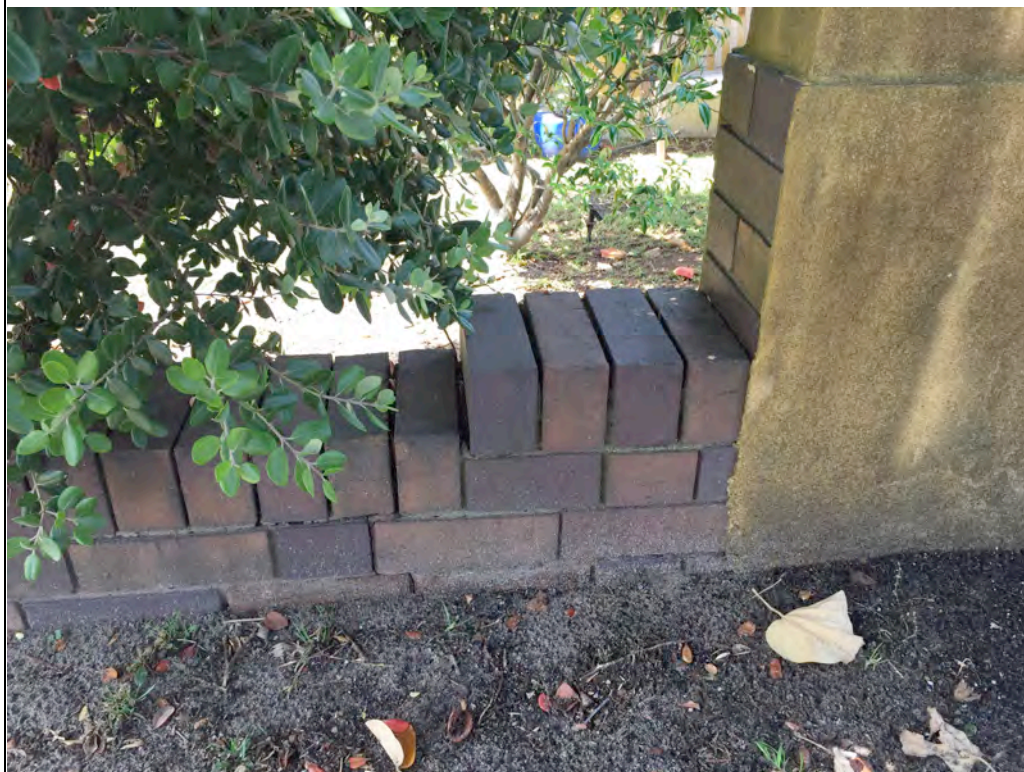
Cracked brickwork and deteriorated mortar joints in the brickwork to the front boundary fence.

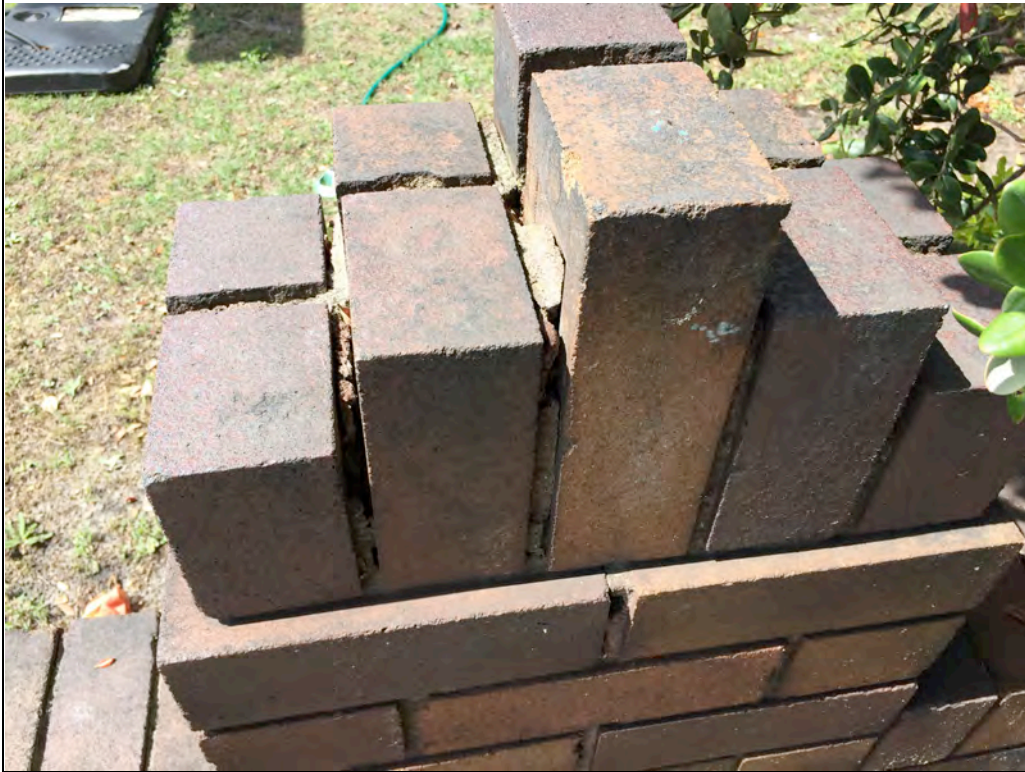
Cracked brickwork and deteriorated mortar joints in the brickwork to the front boundary fence.

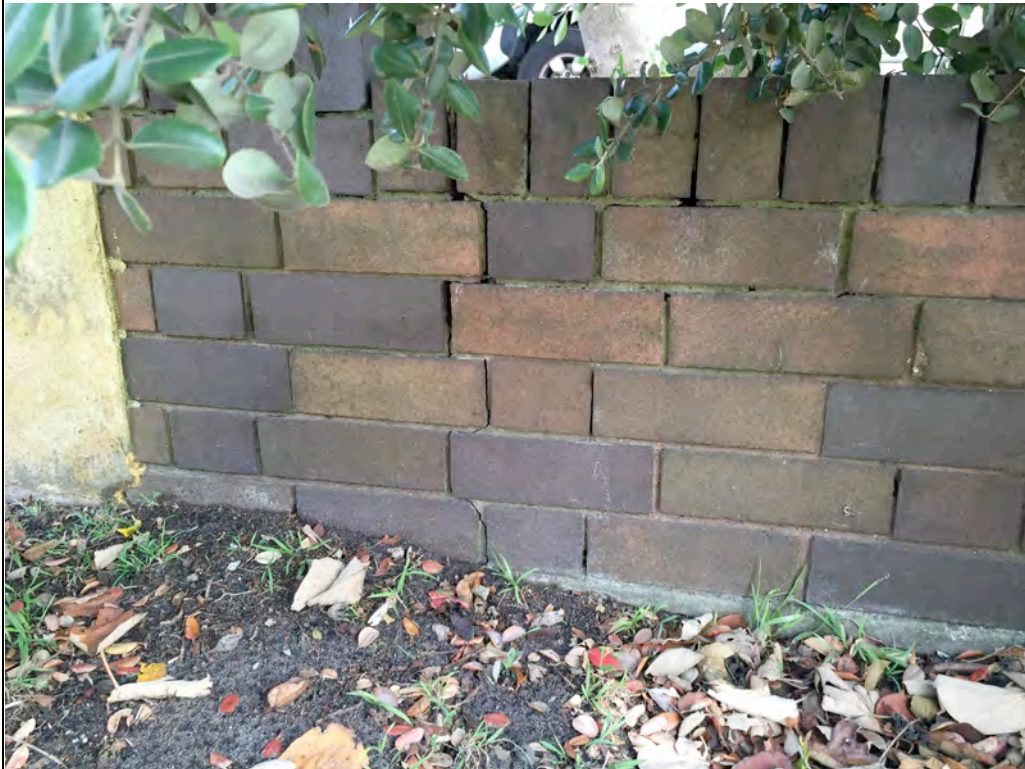
Cracked brick retaining wall at the front right corner of the garage.

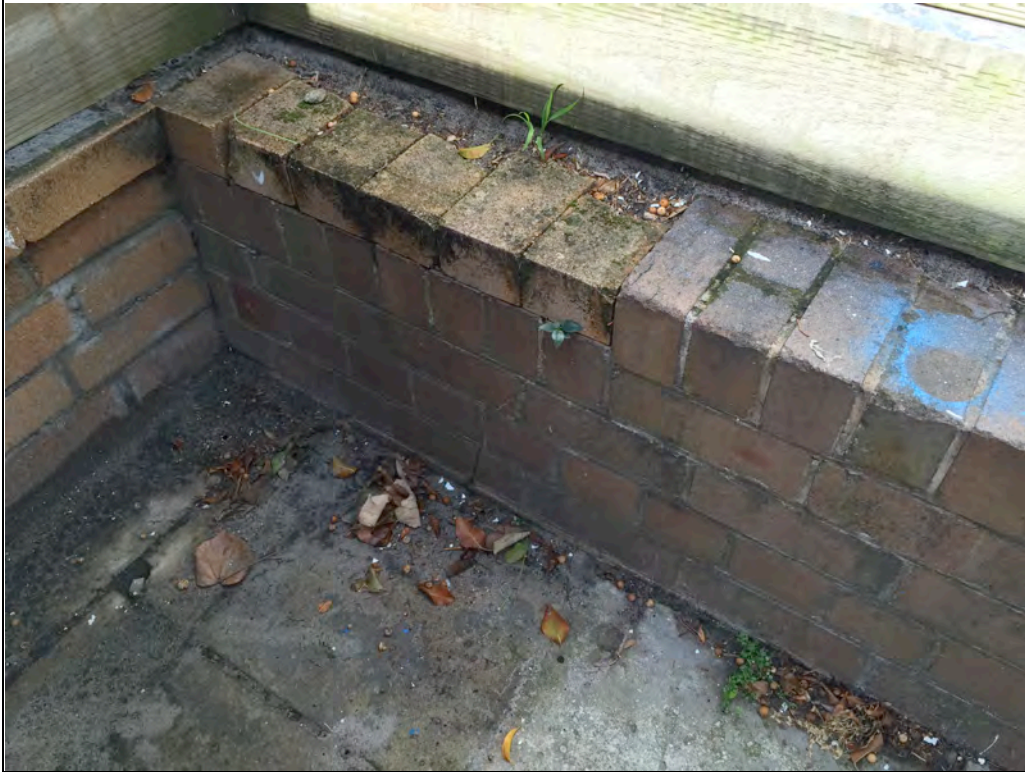
Cracked brick retaining wall at the front right corner of the garage.

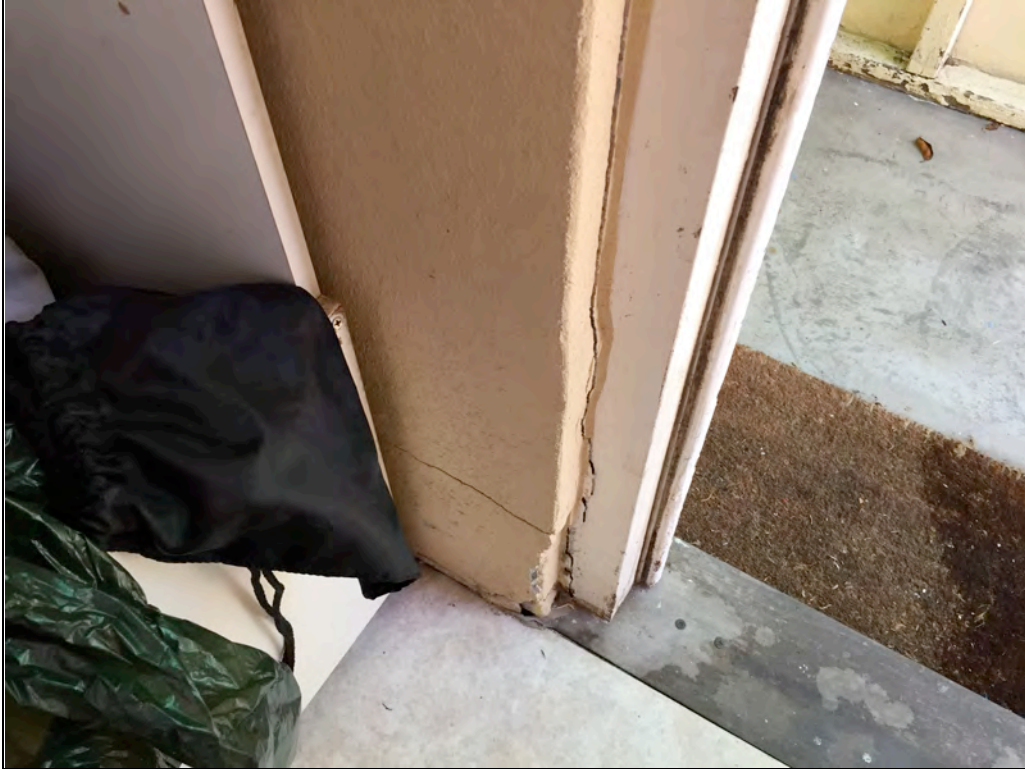
Damaged render below the laundry window.

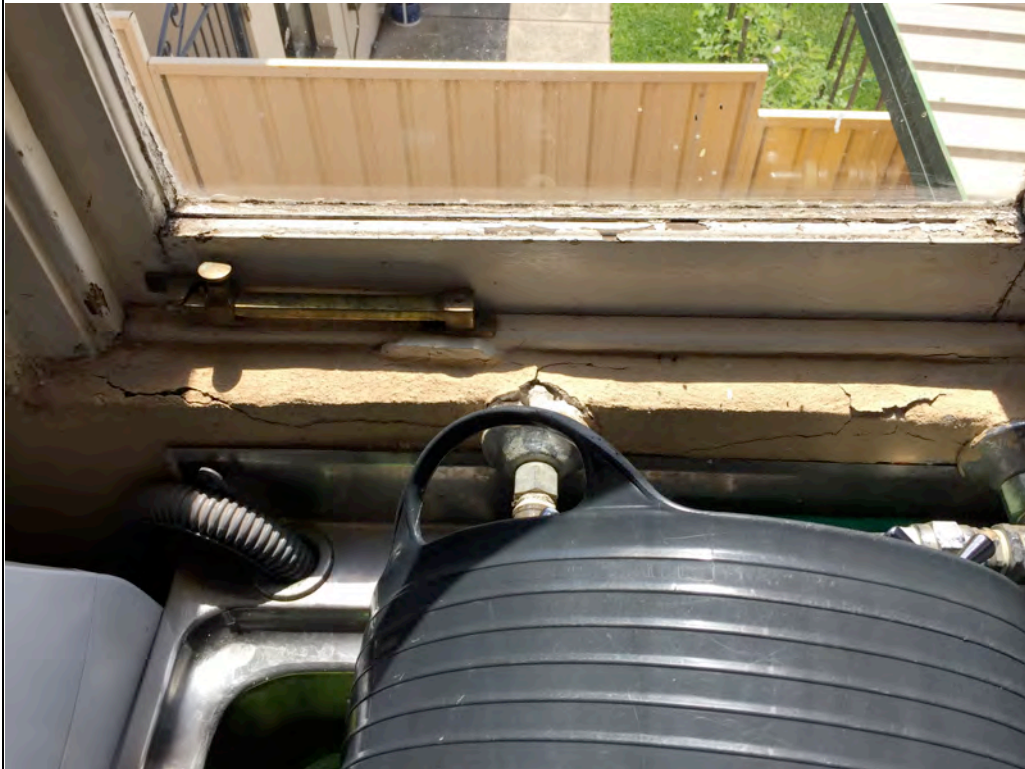
Hairline cracks and drummy plaster render to the kitchen walls in various locations.

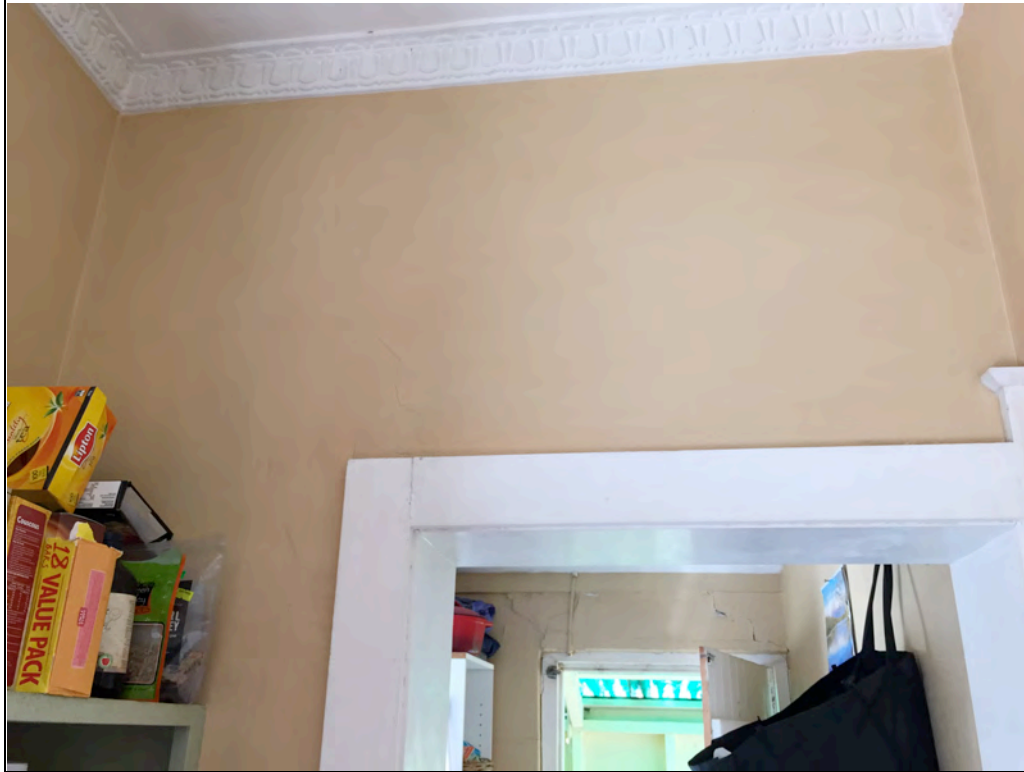
Hairline cracks and drummy plaster render to the kitchen walls in various locations.

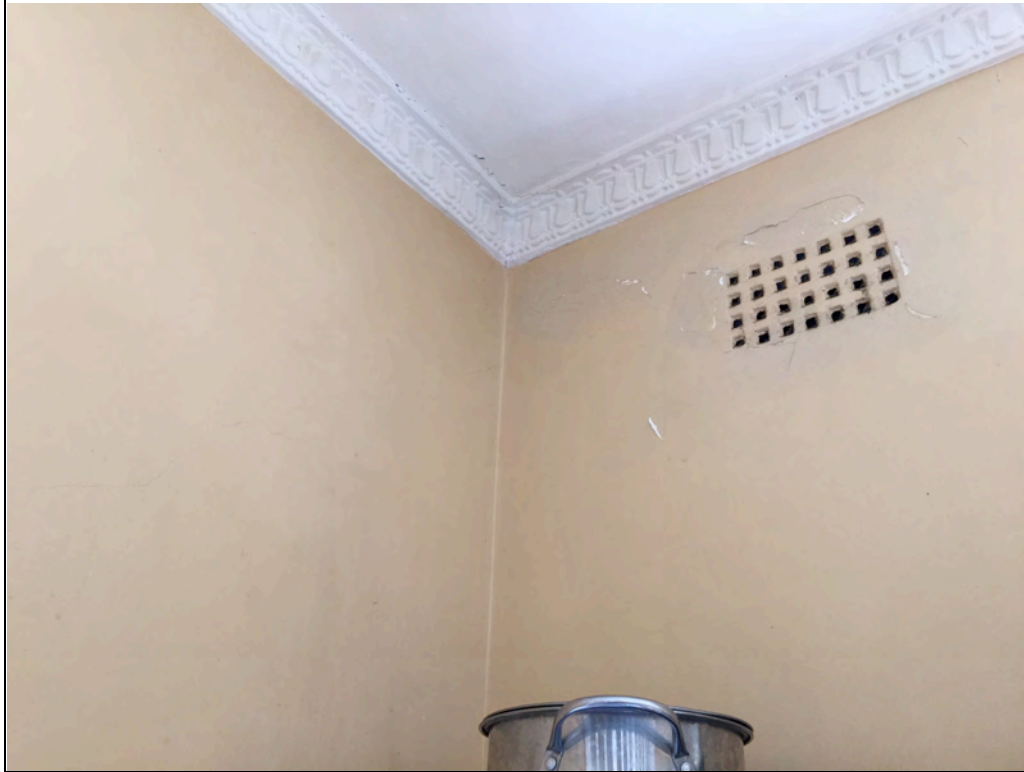
Multiple hairline cracks to kitchen ceiling.

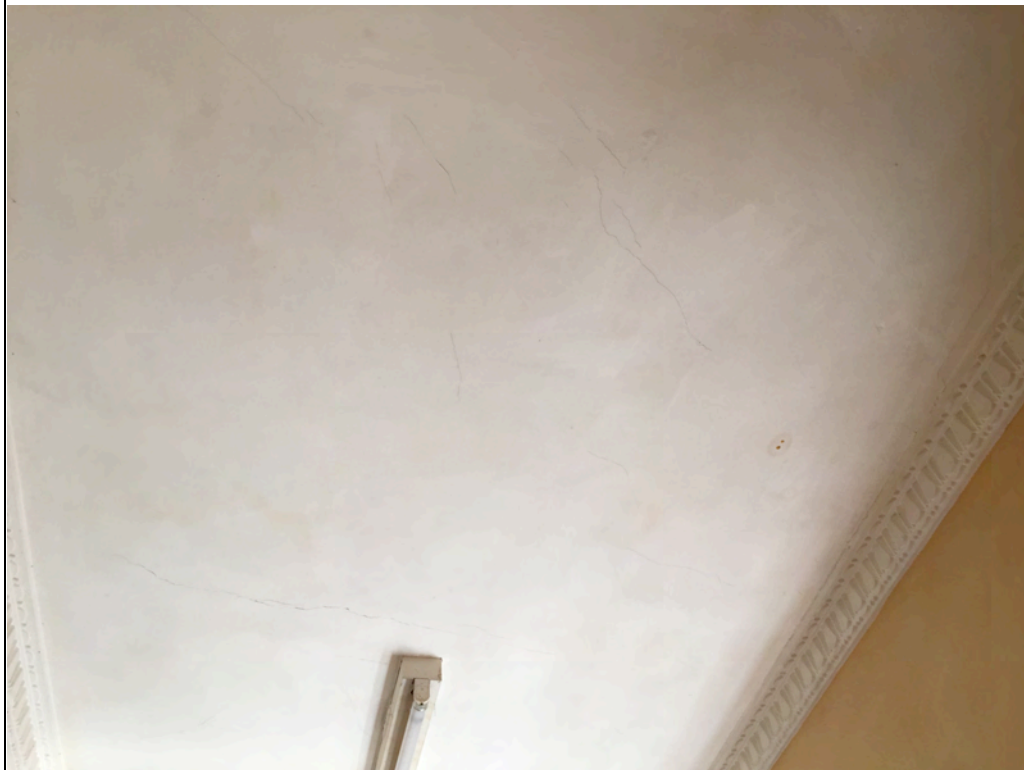
Multiple hairline cracks to kitchen ceiling.
