Childs Property
Inspections

Dilapidation Building Report

(PRE CONSTRUCTION)

The property inspected is a single storey, semi detached dwelling of full masonry construction. This structure is on pier and strip footings, with a pitched roof covered in terracotta tiles.

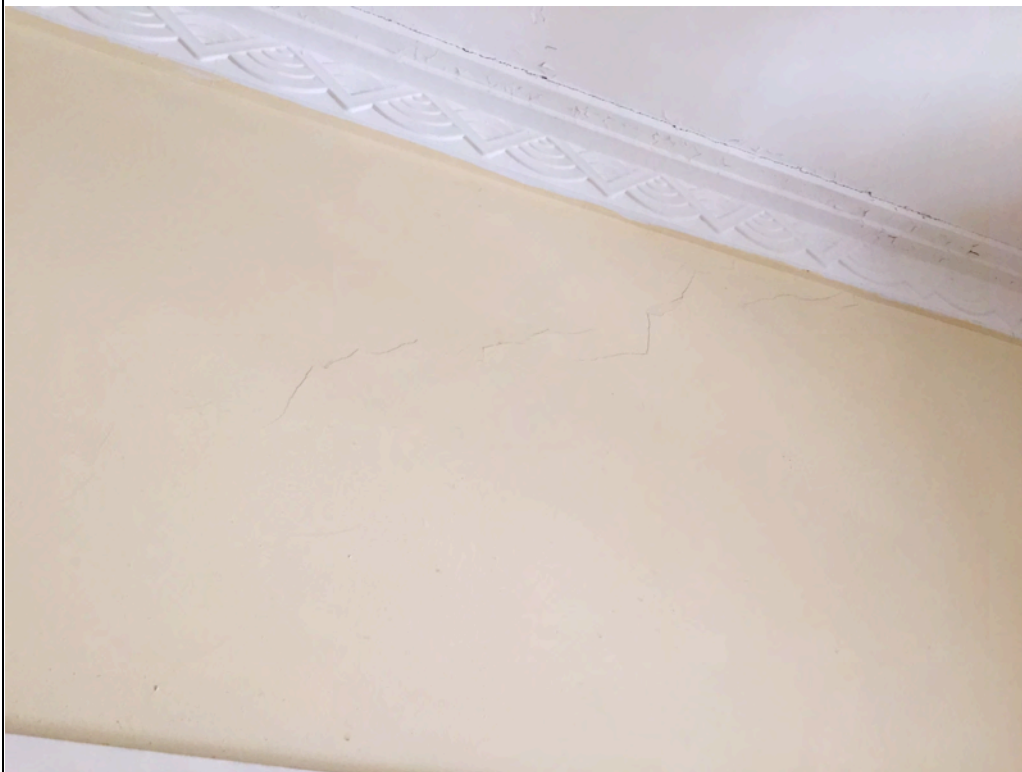
Cracked ceiling cornice north east corner of the dining area.

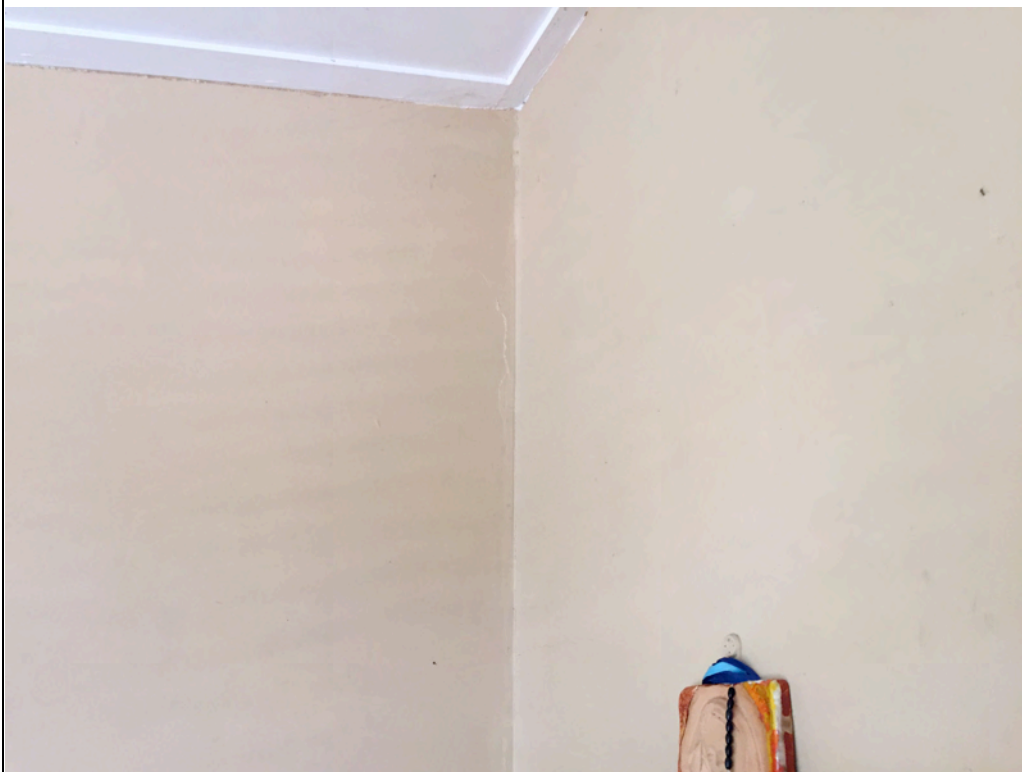
Crack to the western wall of the rear bedroom at the north west corner.

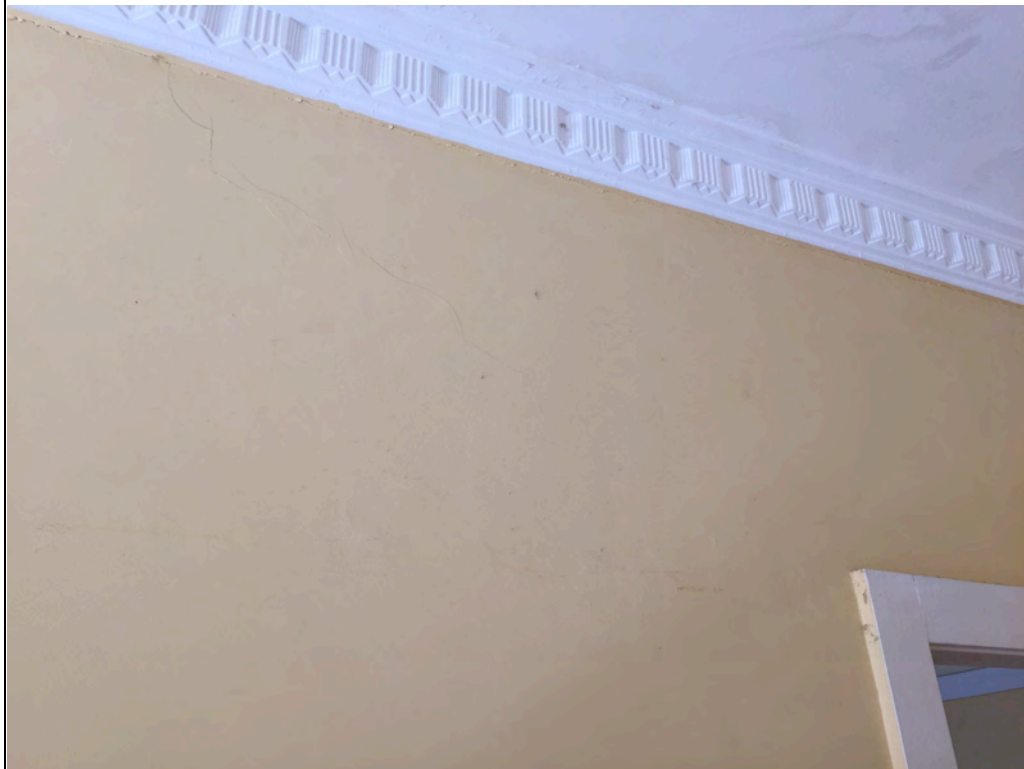
Cracked top left corner of the living room rear door.

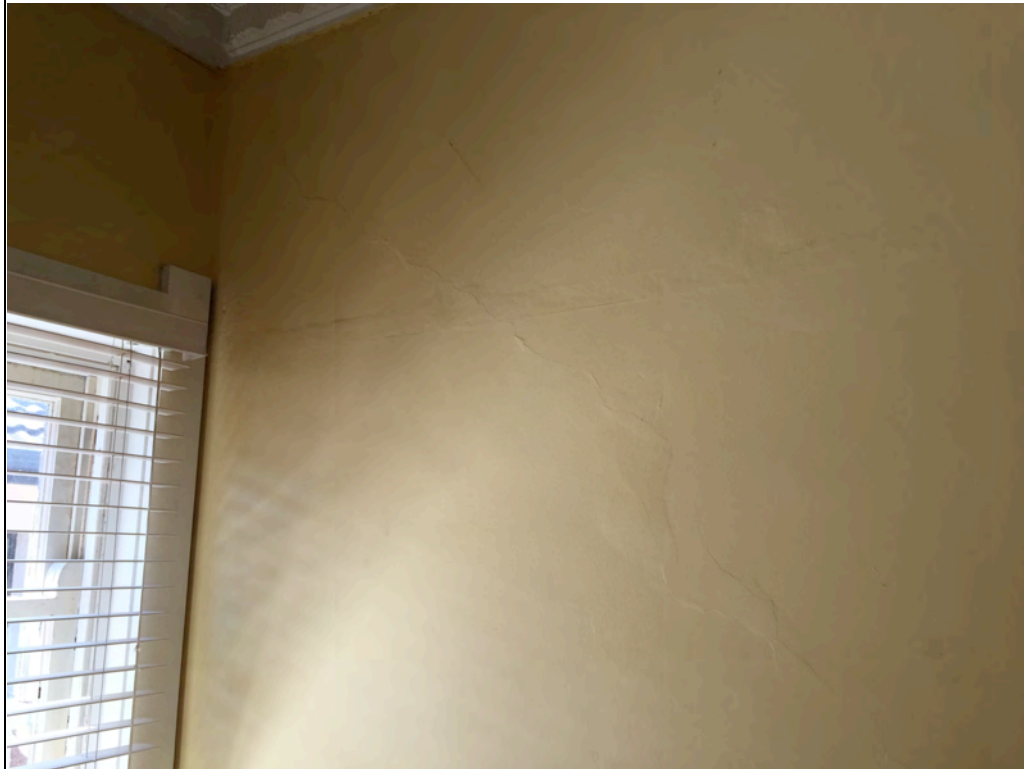
Diagonal crack to the rear left corner of the living room.

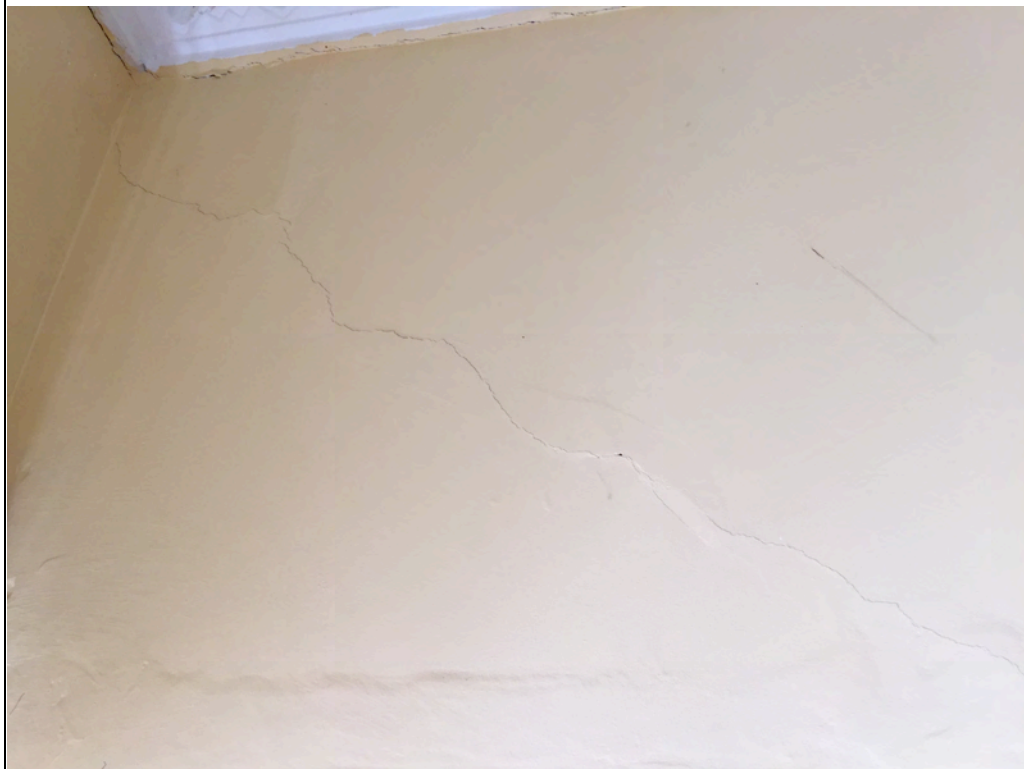
Hairline cracks above the left side window to the living room.

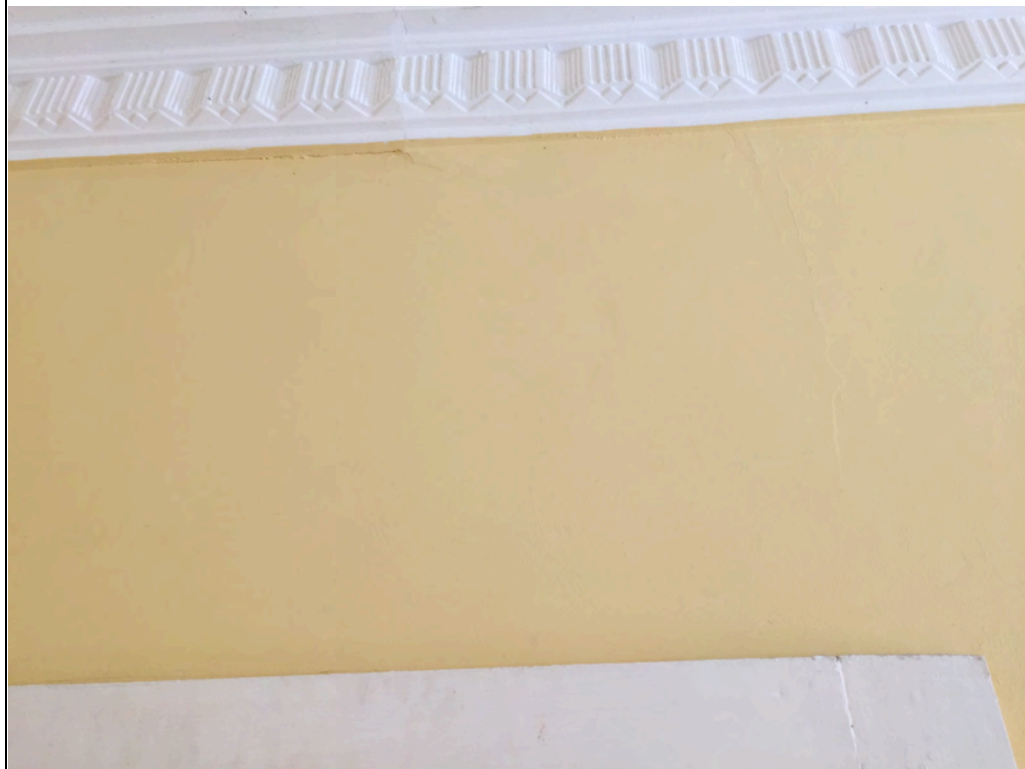
Cracked ceiling cornice at the wall junction to the living room rear and left side walls.

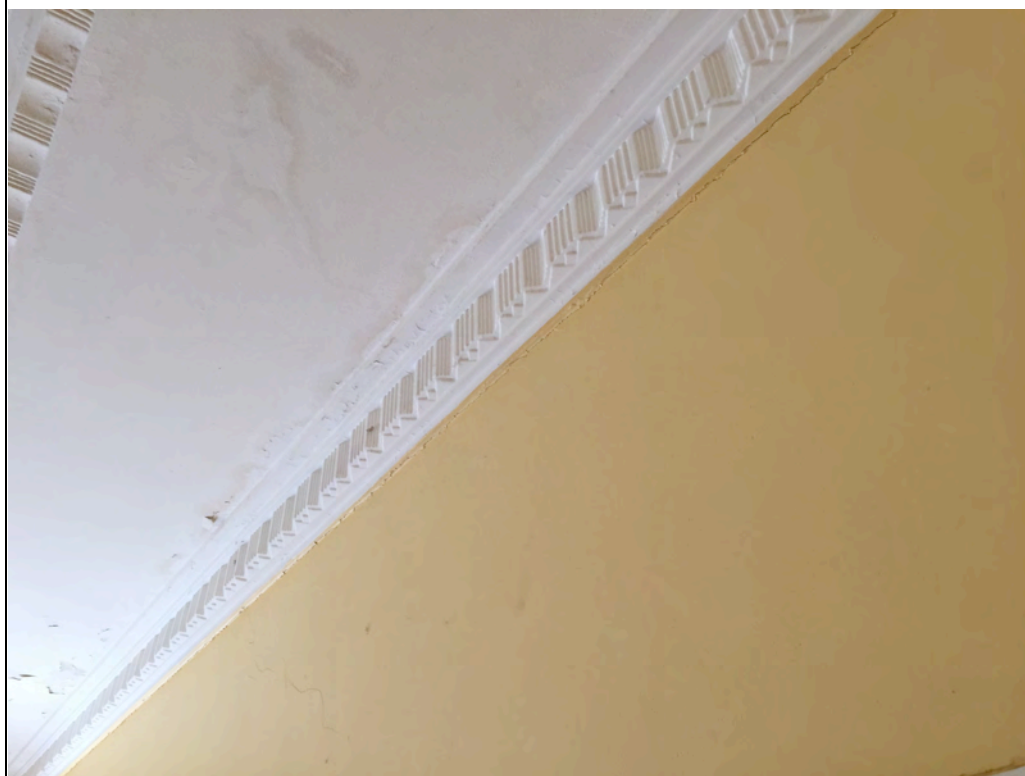
Cracked ceiling cornice at the wall junction to the living room rear and left side walls.

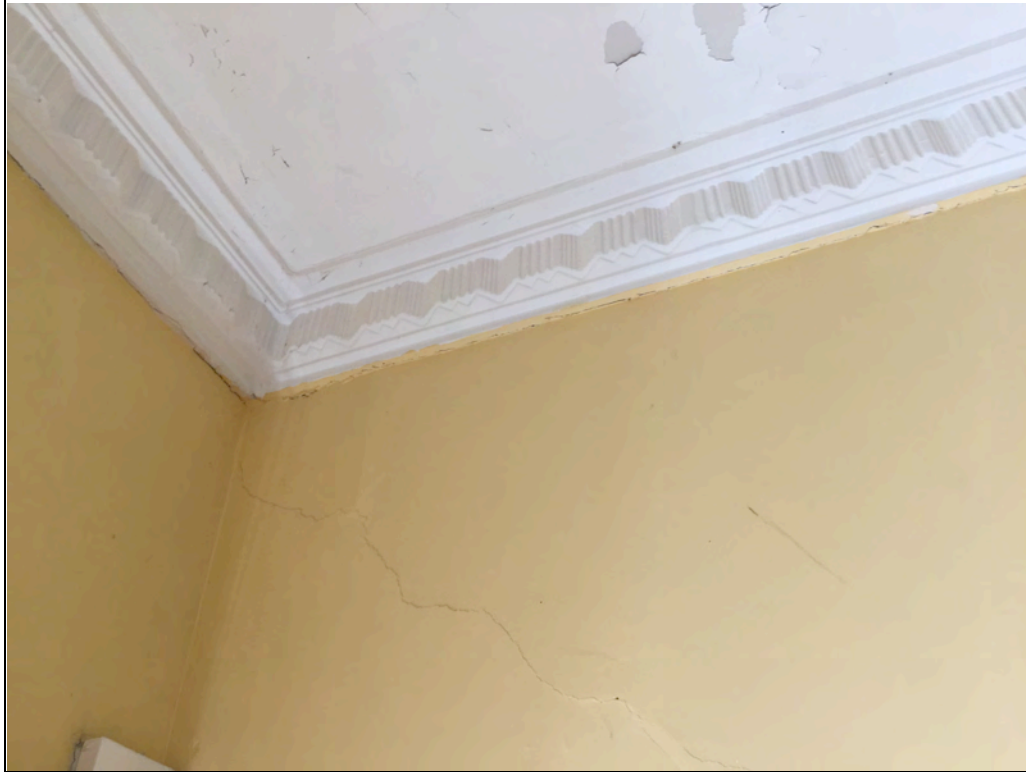
Cracked and paint deteriorated ceiling to the living room.

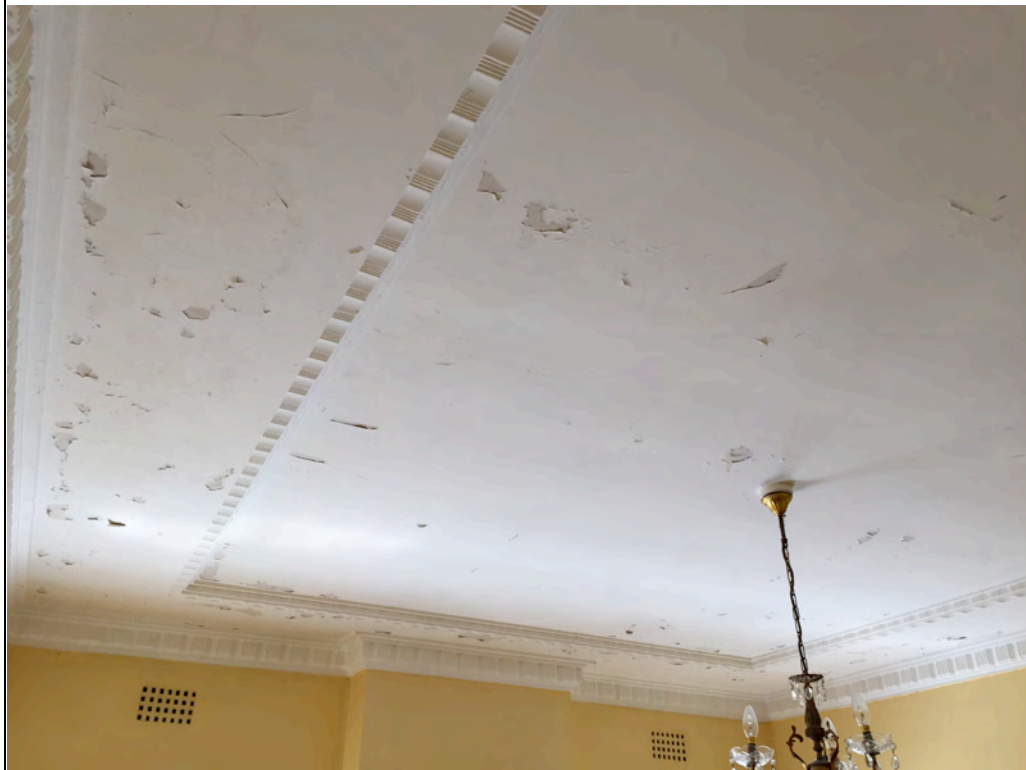
Cracked and paint deteriorated ceiling to the living room.

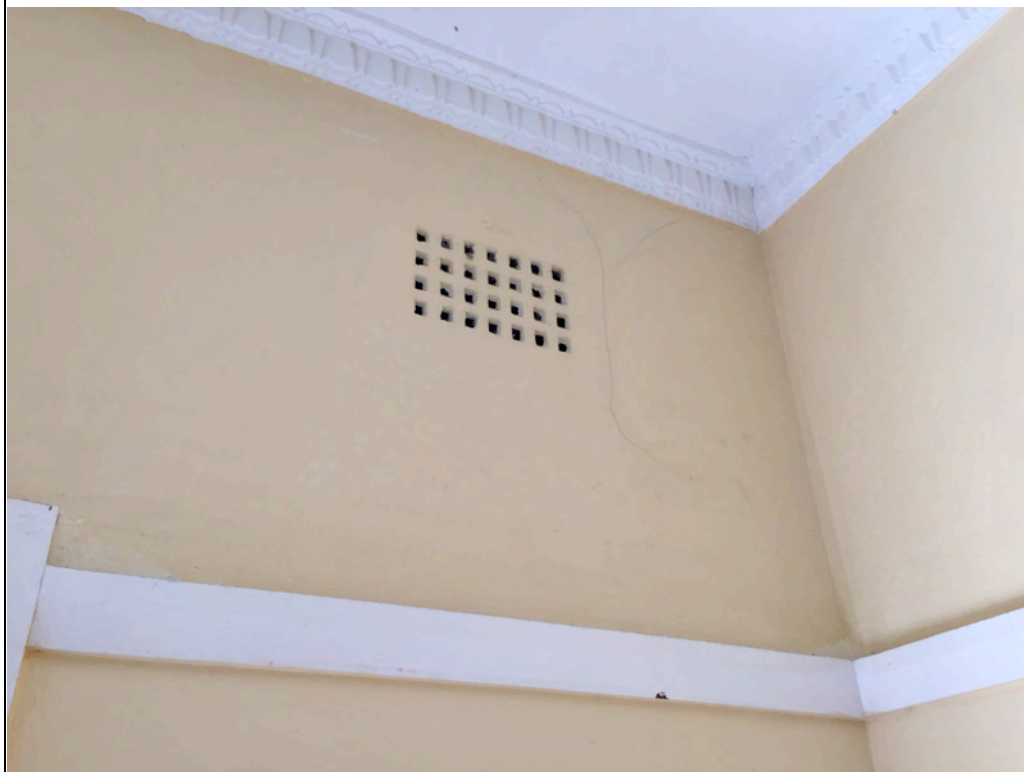
Paint deteriorated and cracked ceiling to the second bedroom.

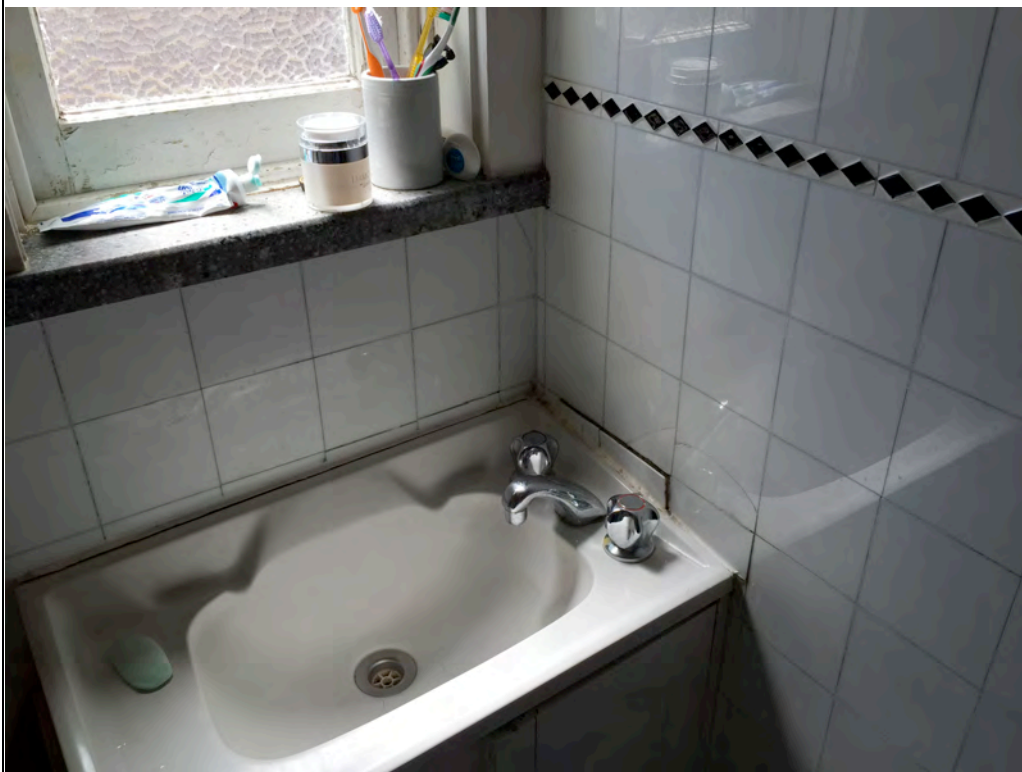
Tiling throughout the bathroom has become drummy in areas. A number of tiles are cracked and missing throughout.

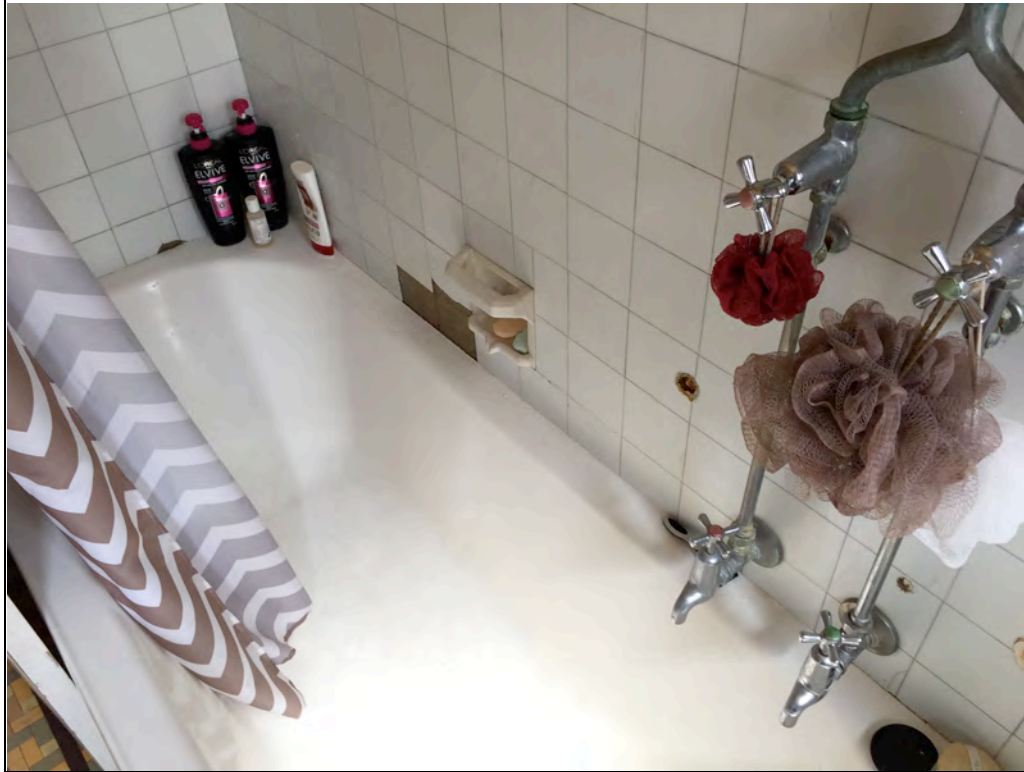
Tiling throughout the bathroom has become drummy in areas. A number of tiles are cracked and missing throughout.

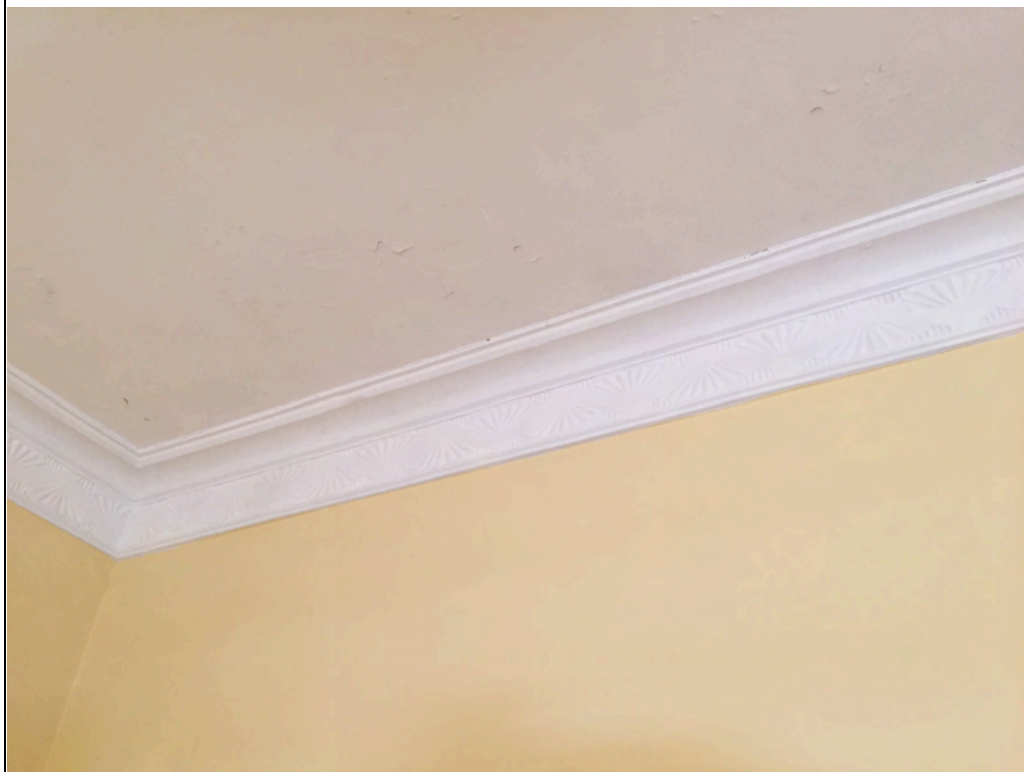
Cracked ceiling cornice and wall junction to the main bedroom front wall.

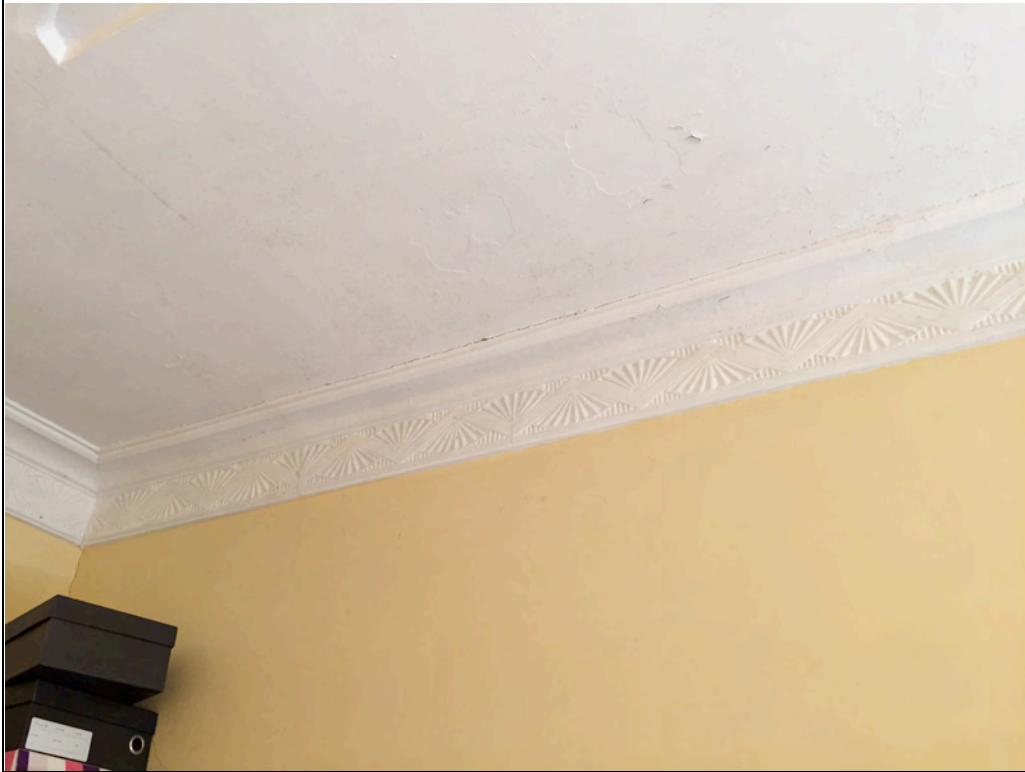
Cracked ceiling cornice and wall junction to the main bedroom front wall.

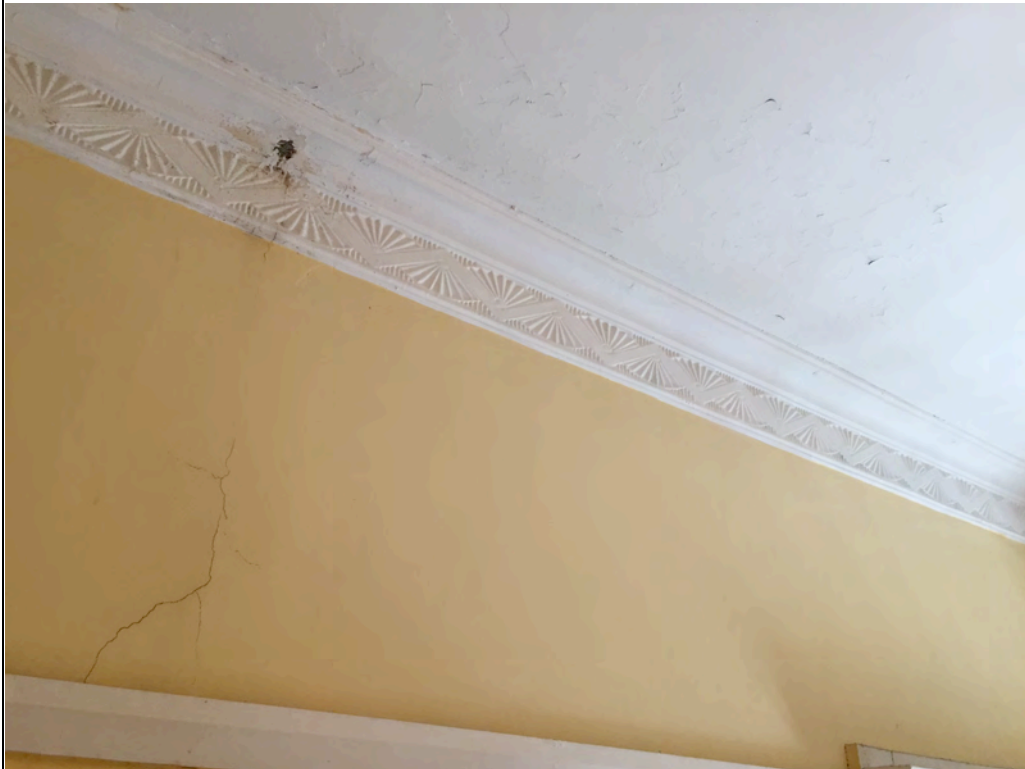
Cracked ceiling cornice and wall junction to the main bedroom rear wall.

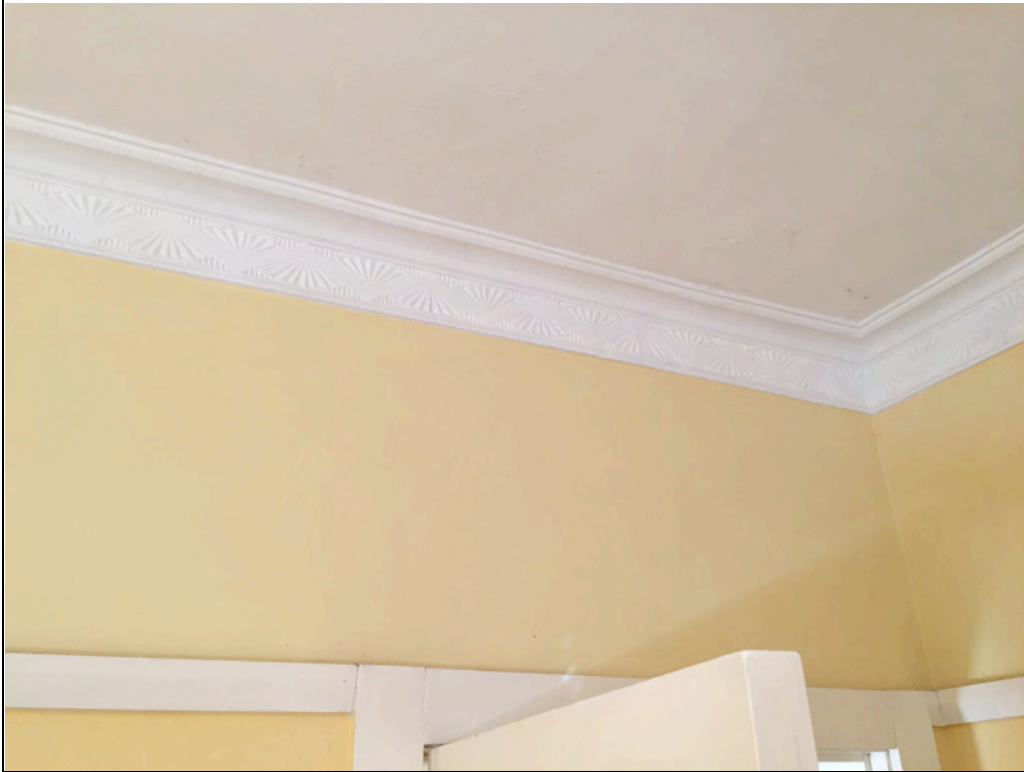
Cracked ceiling cornice and wall junction to the main bedroom rear wall.

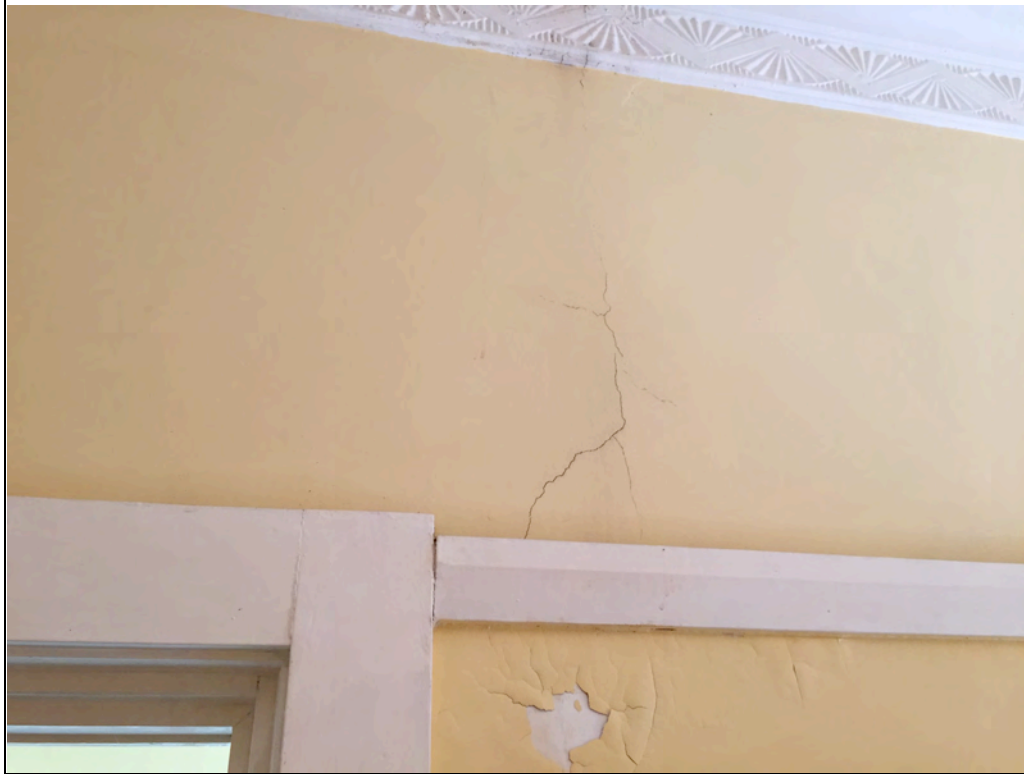
Crack to the wall render at the front right corner of the main bedroom.

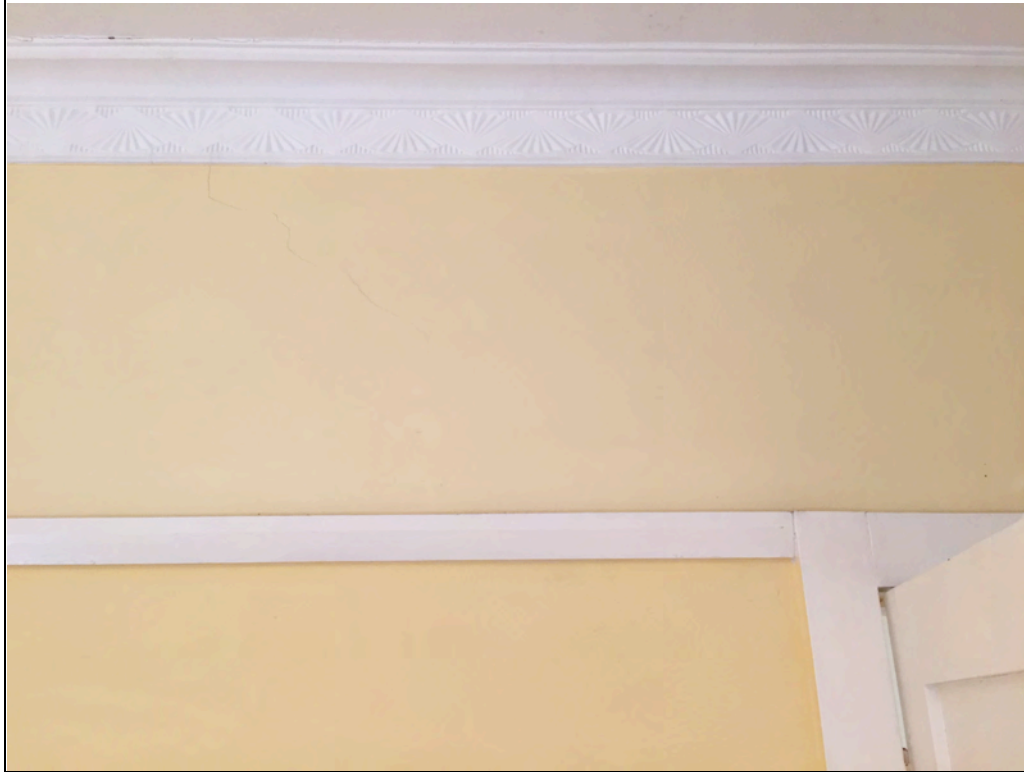
Hairline diagonal crack to the rear wall of the main bedroom, approx. 500mm left of the bedroom door.
