# PRE-PURCHASE PEST REPORT

# Visual Timber Pest Inspection & Report

in accordance with AS 4349.3

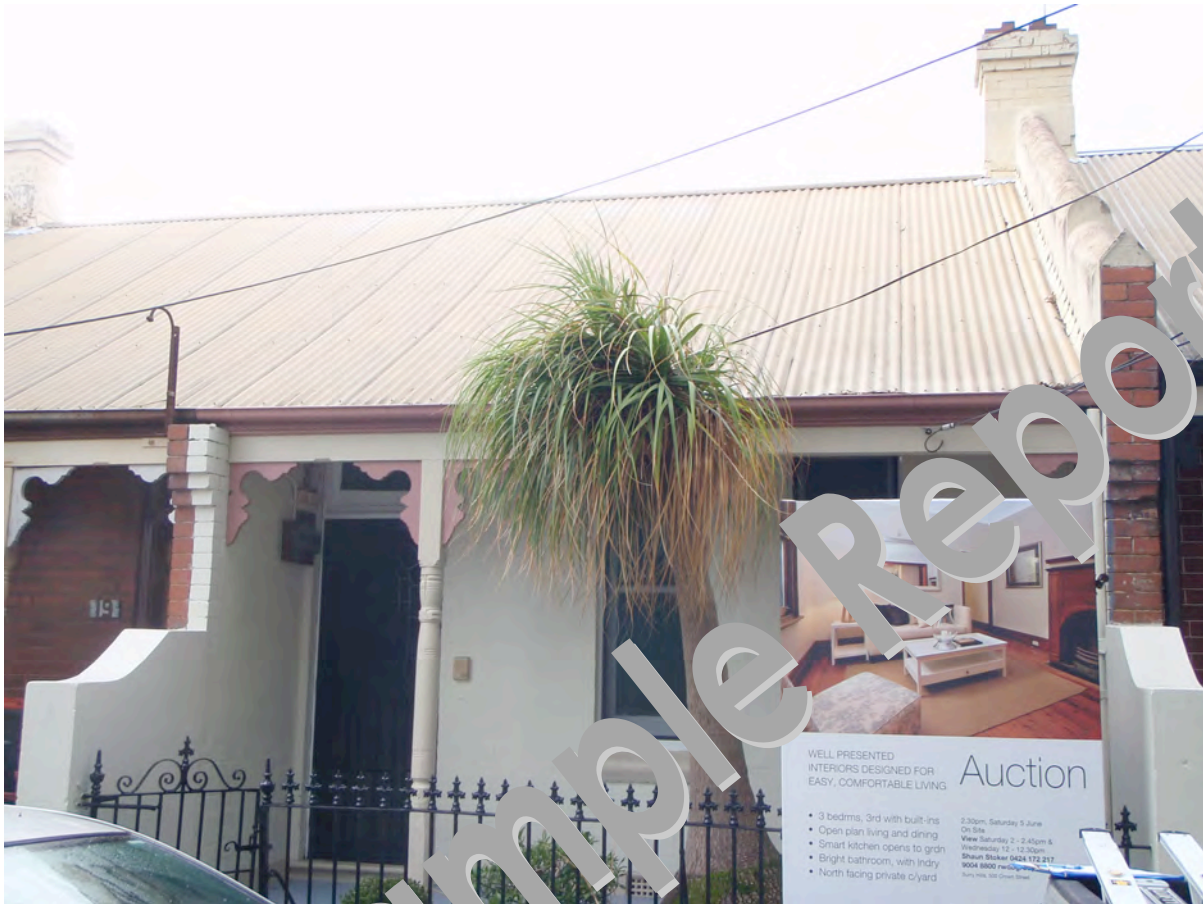
The property inspected is a single storey, semi detached building of full masonry construction. This structure is on pier and strip and concrete slab footings, with a skillion roof covered in corrugated steel.
