Childs Property
Inspections

Dilapidation Building Report

(PRE CONSTRUCTION)

The property inspected is a single storey, semi detached dwelling of full masonry construction. This structure is on pier and strip footings, with a pitched roof covered in terracotta tiles.

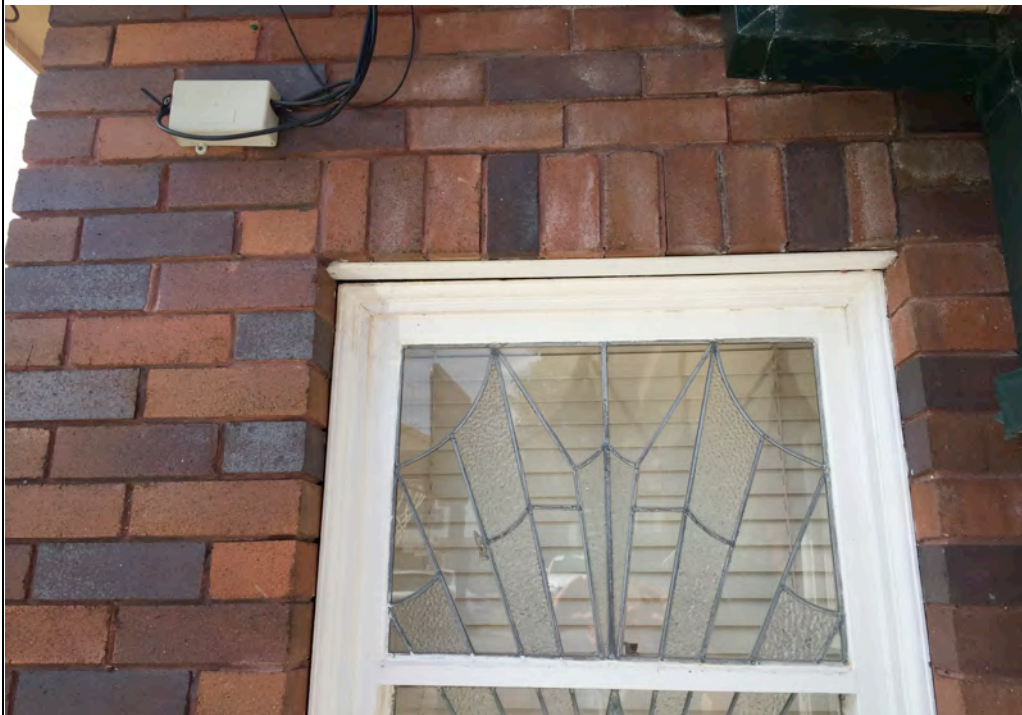
Hairline cracks to brickwork above lintel to front left corner of window.

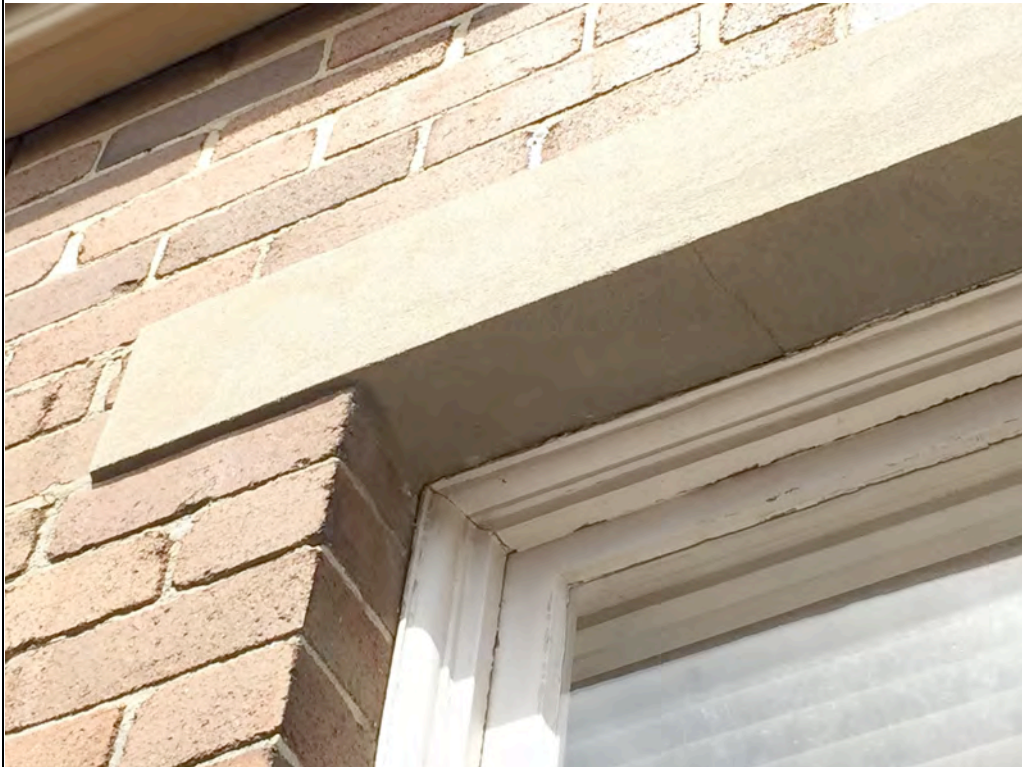
Hairline crack to concrete lintel above the third window left of the front entrance door.

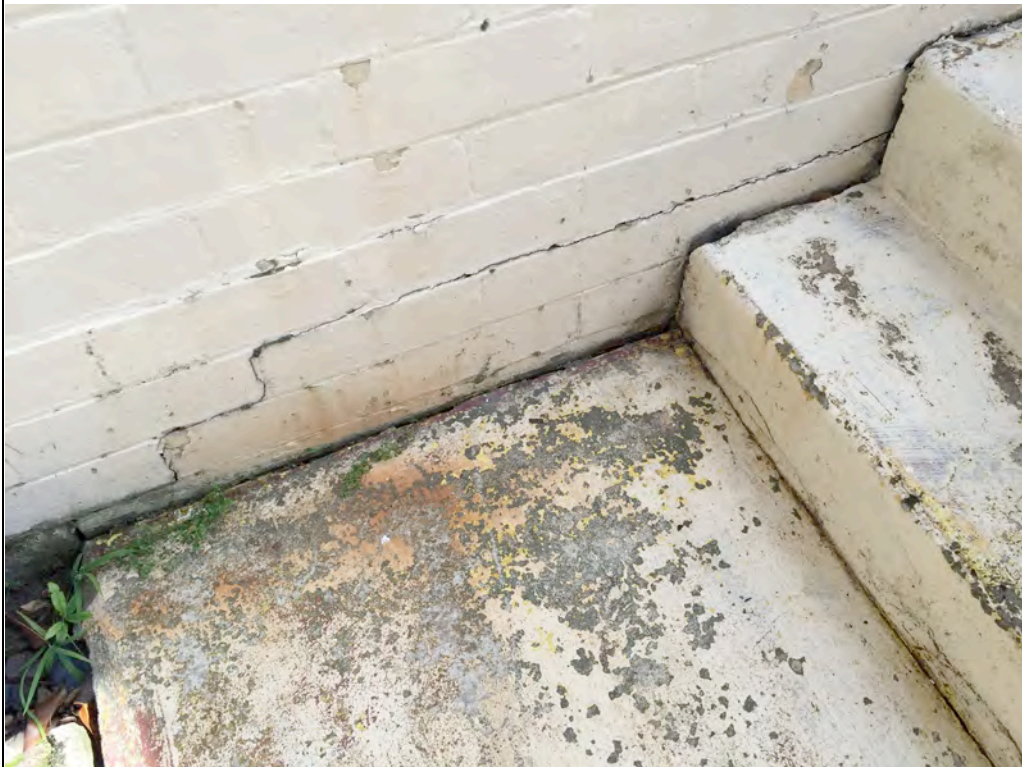
Cracks to brickwork at the rear at the base of the stairs.

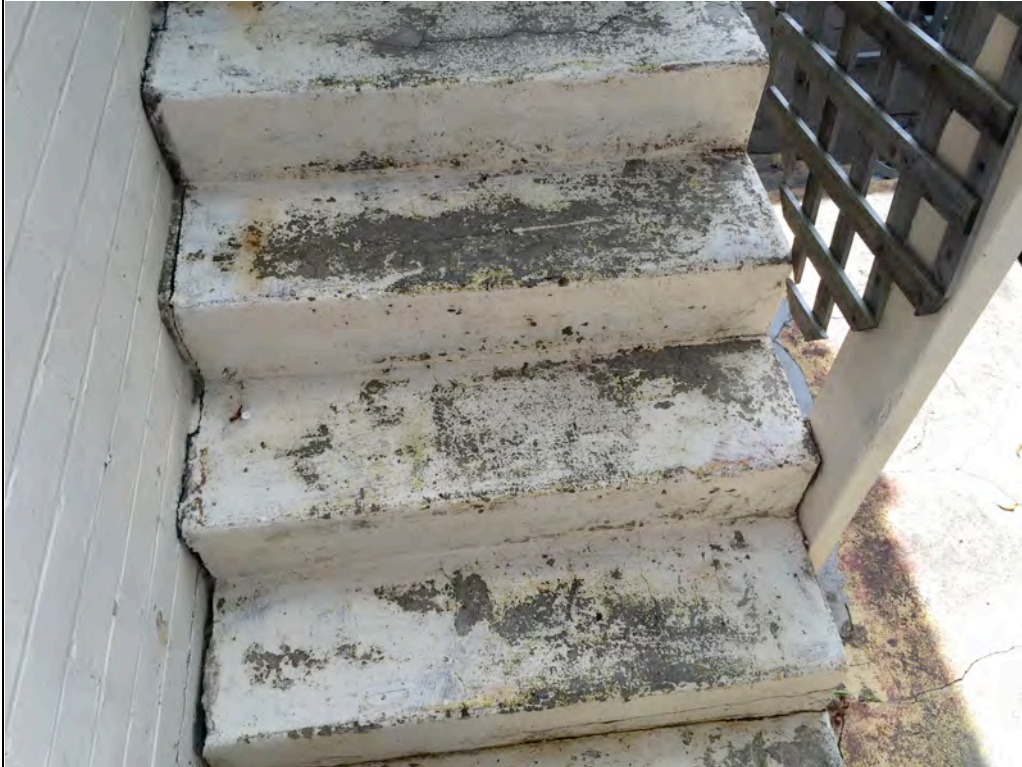
Multiple hairline cracks to the stair treads.

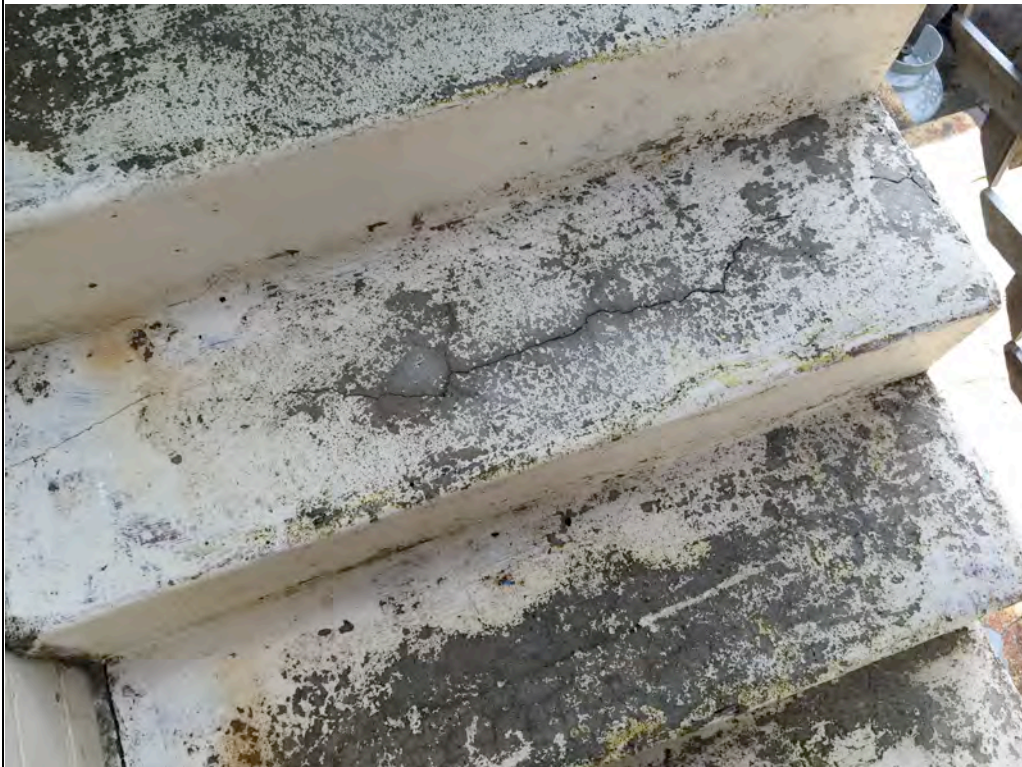
Multiple hairline cracks to the stair treads.

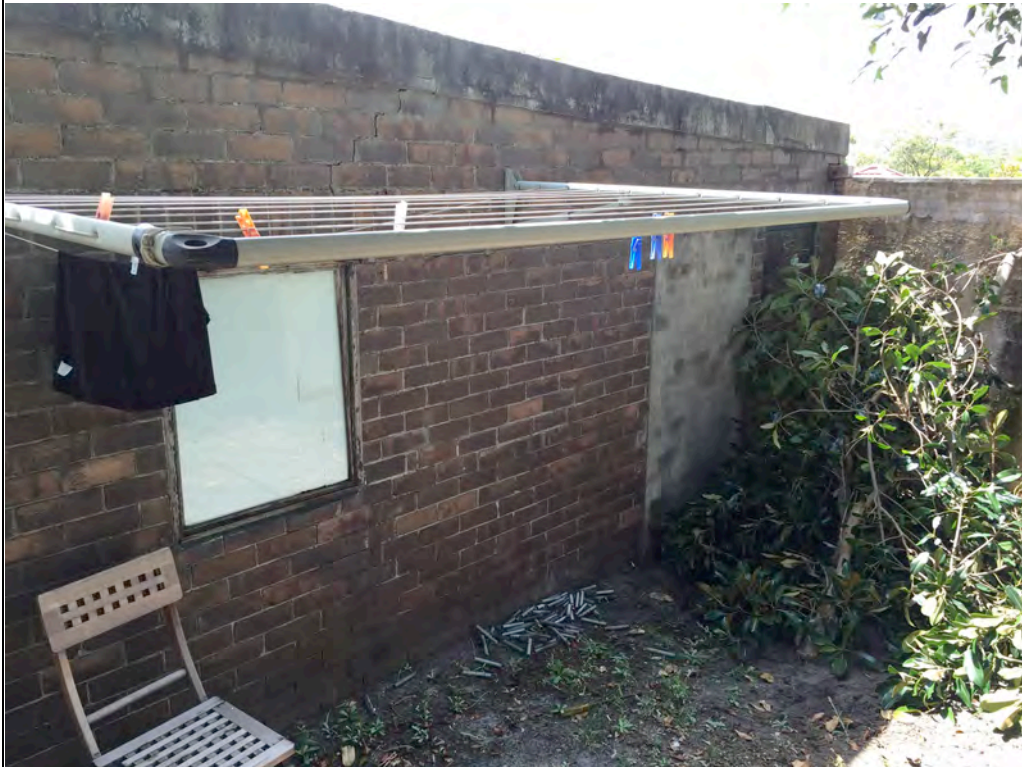
General view of right side detached garage.

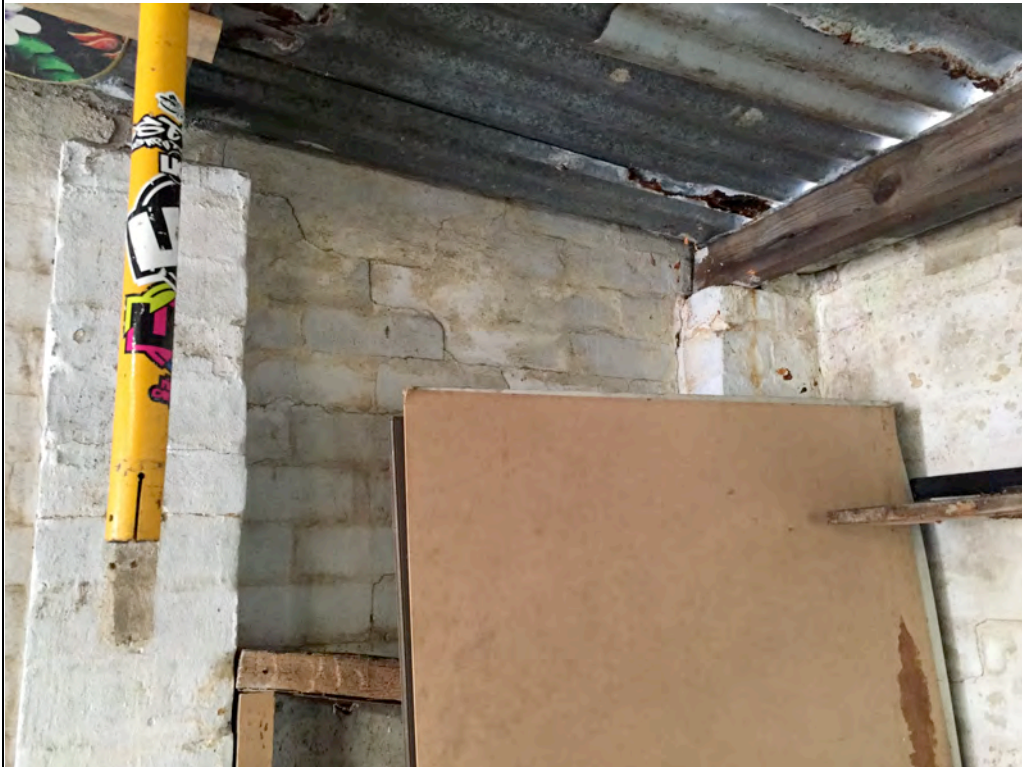
Extensive cracking to the brickwork to the garage as viewed from internally at the rear.

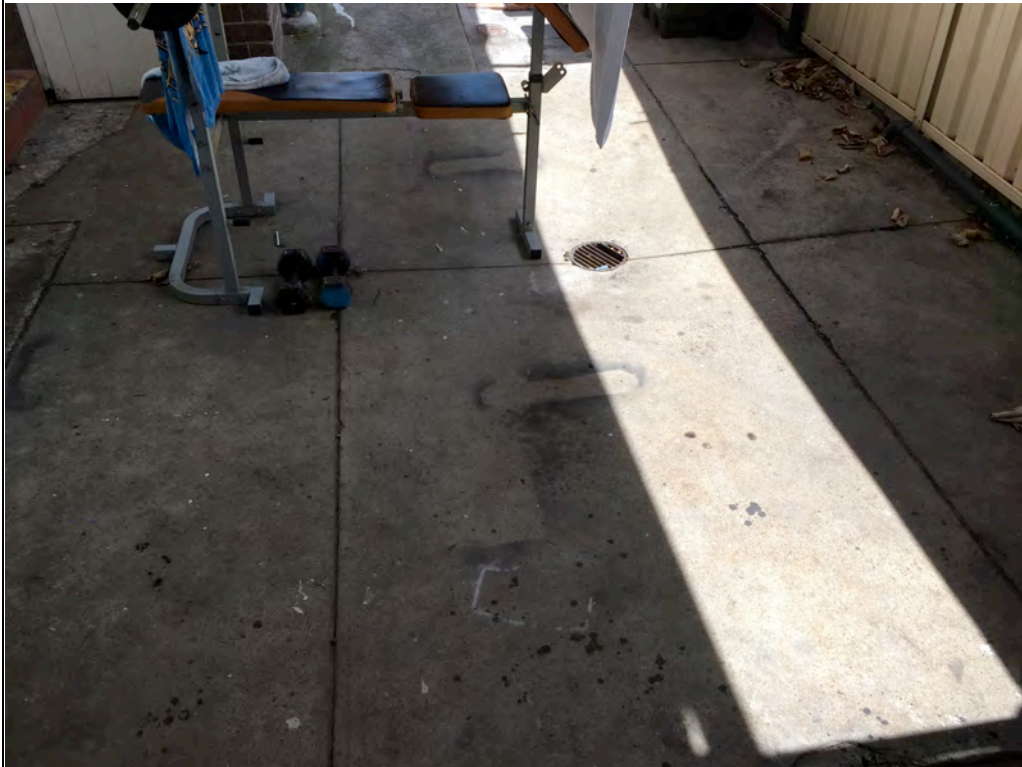
General view of driveway directly in front of the garage.

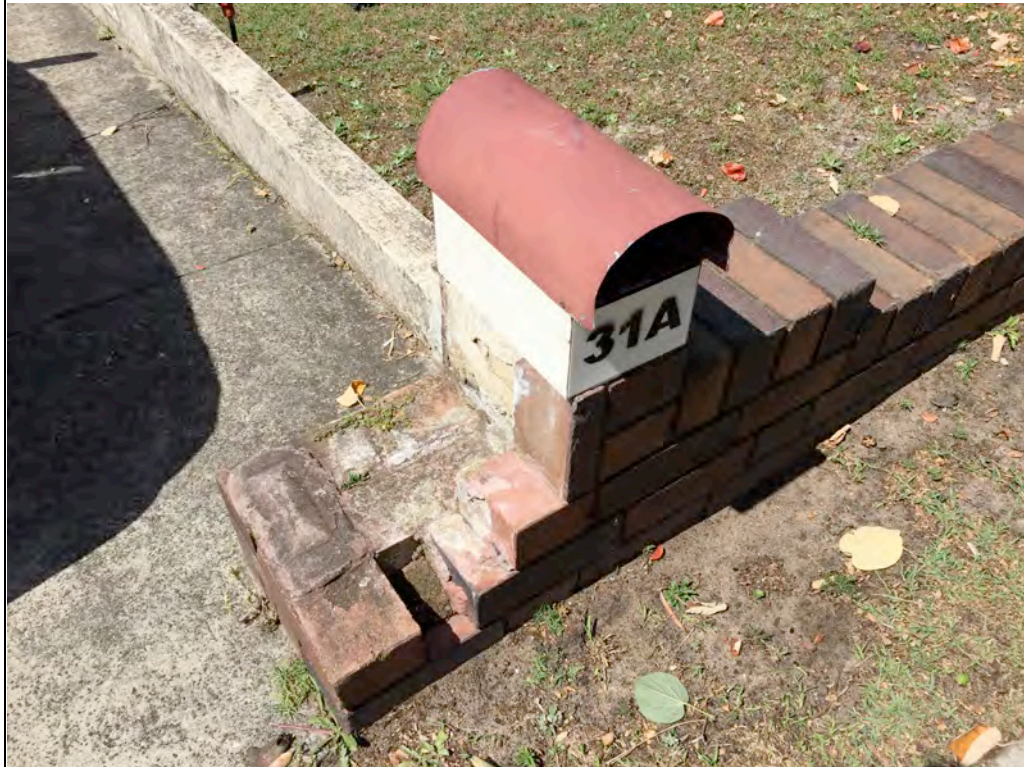
Damaged brickwork to the front boundary fence.

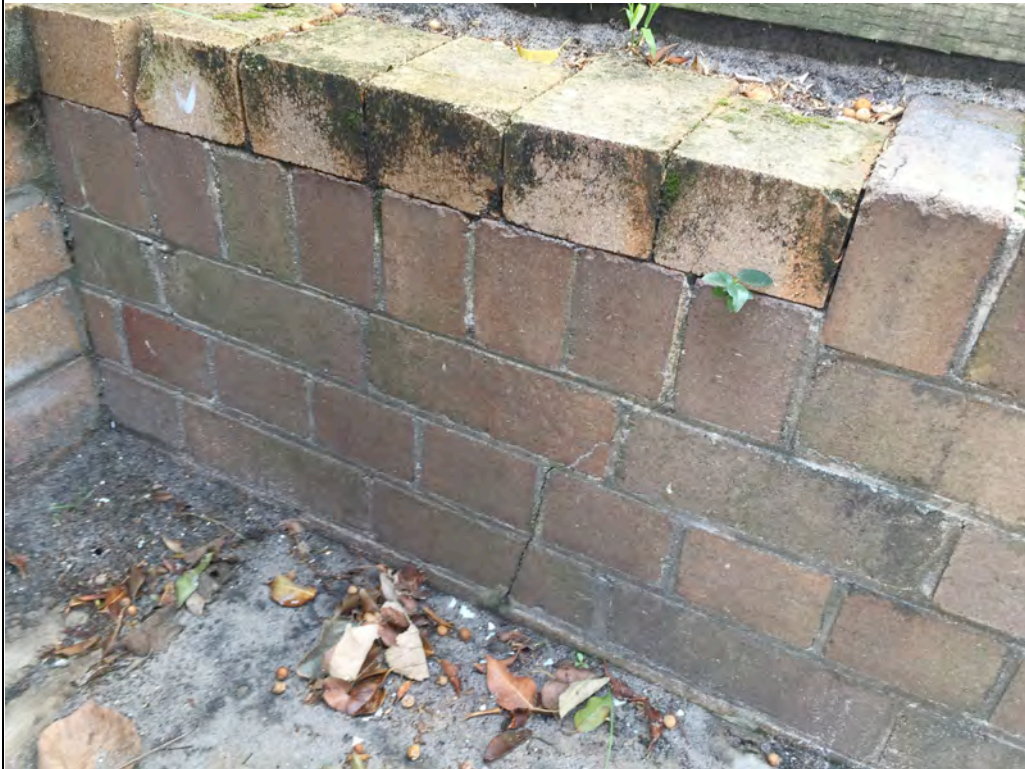
Cracked brick retaining wall at the front right corner of the garage.

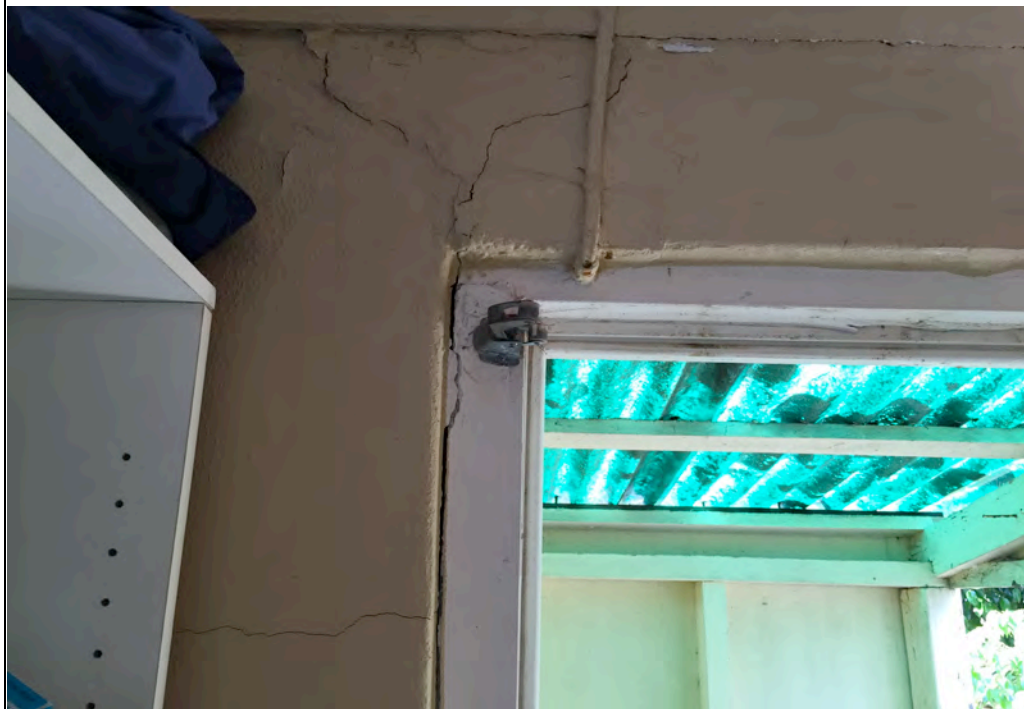
Extensive cracking to the brickwork and render above and beside the rear external door, the door also is not shutting due to movement.

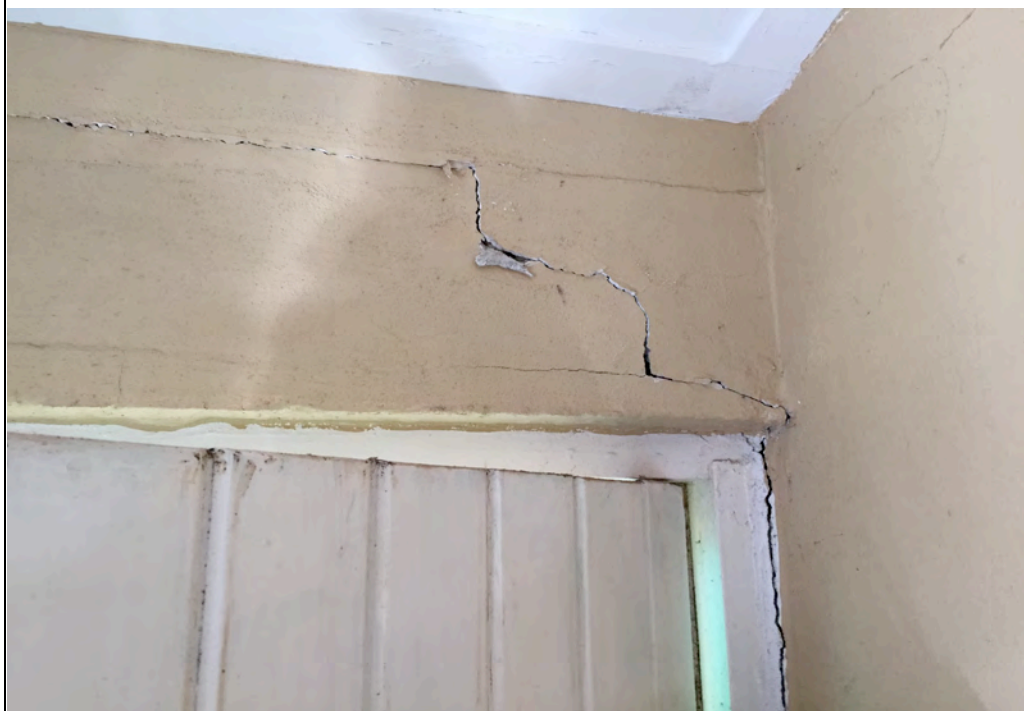
Extensive cracking to the brickwork and render above and beside the rear external door, the door also is not shutting due to movement.

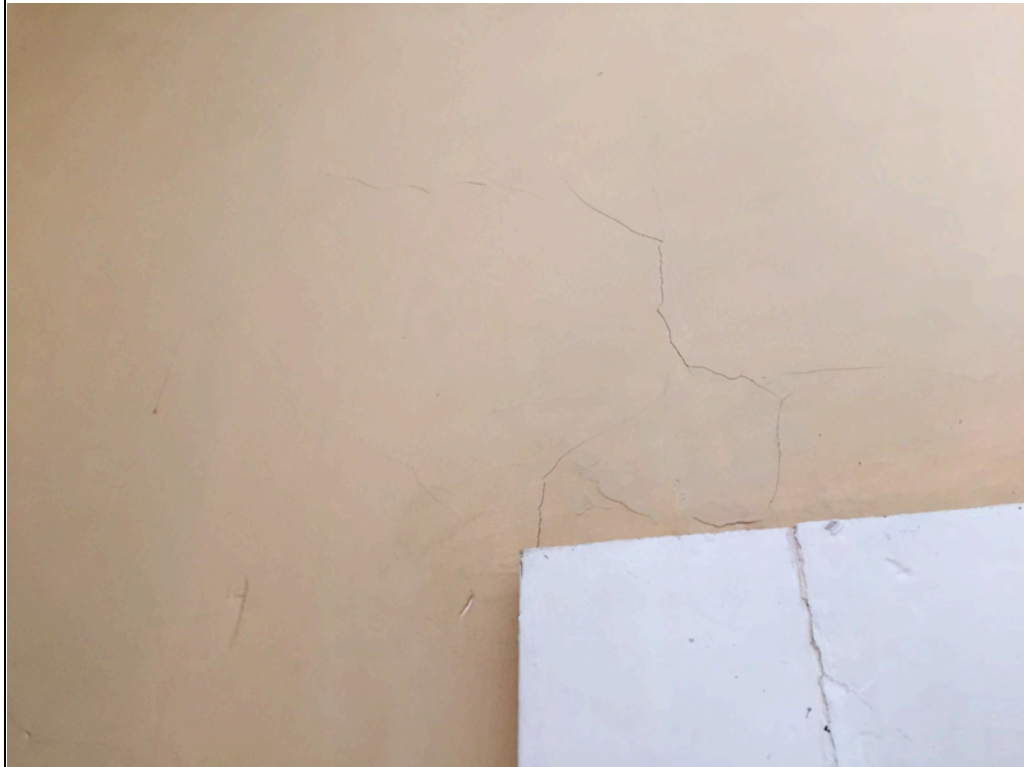
Hairline cracks and drummy plaster render to the kitchen walls in various locations.

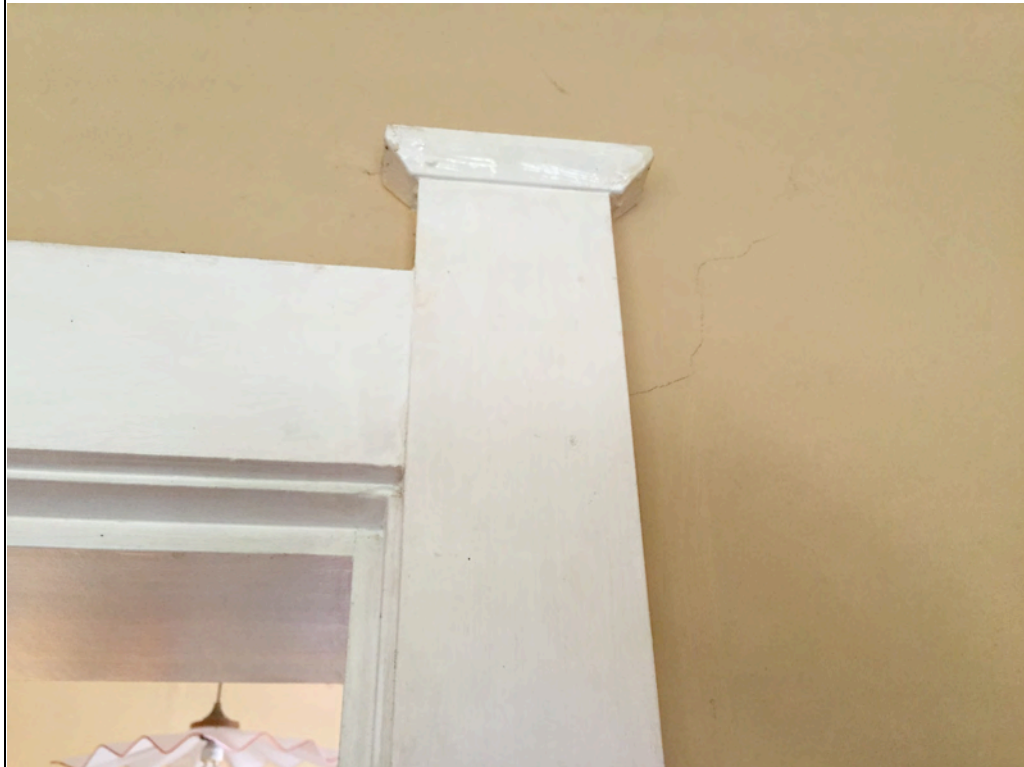
Hairline crack to the plaster render above the rear bedroom door top right corner.

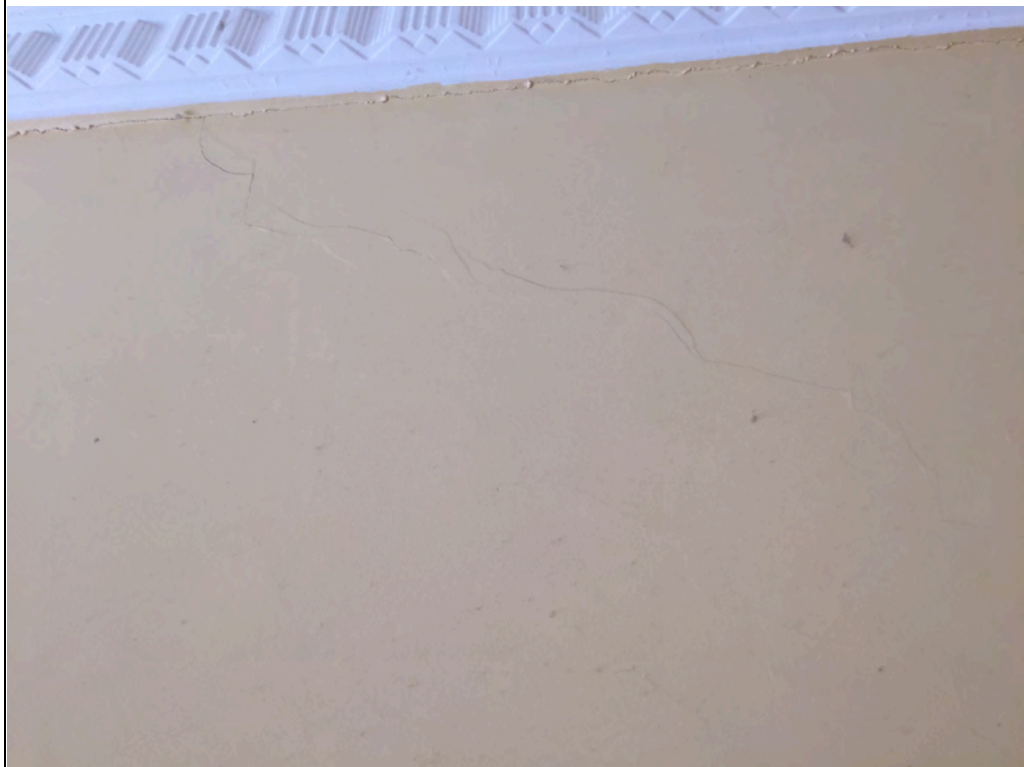
Cracked top left corner of the living room rear door.

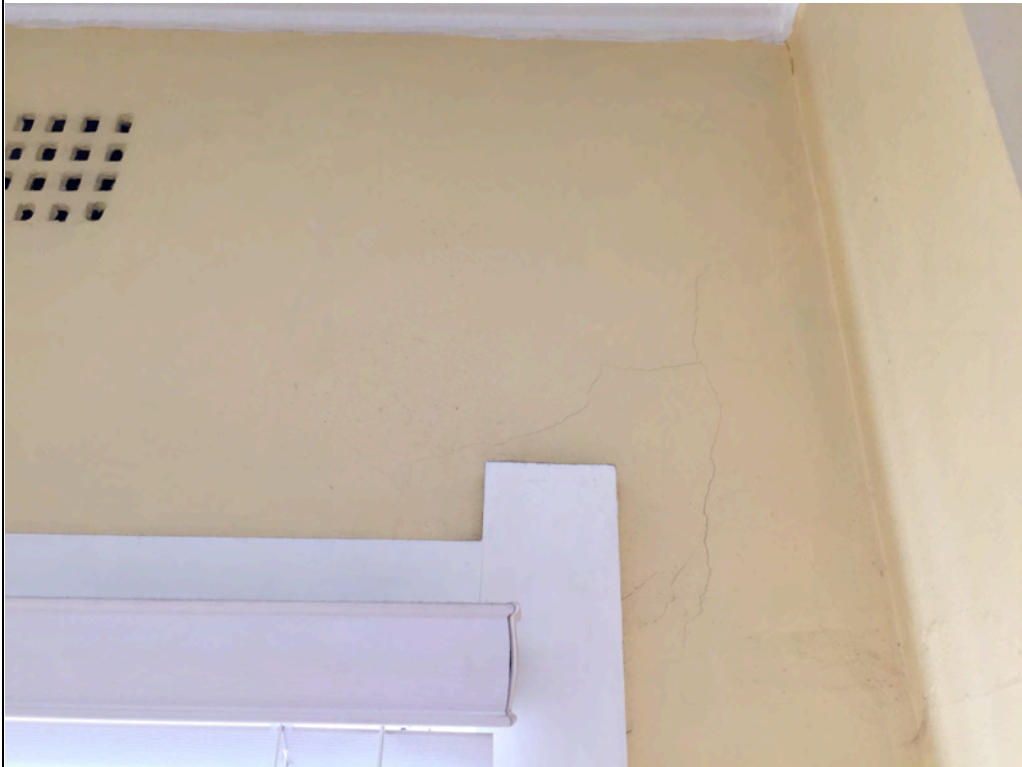
Hairline cracks above the left side window to the living room.

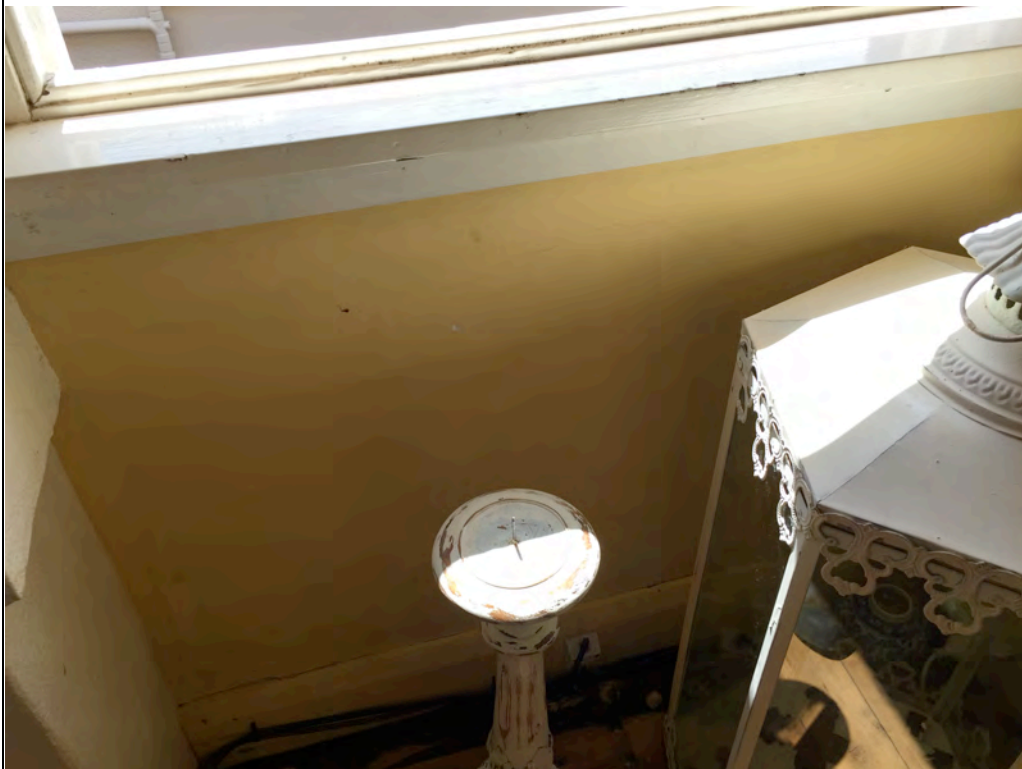
Hairline cracks below the right side window to the living room.

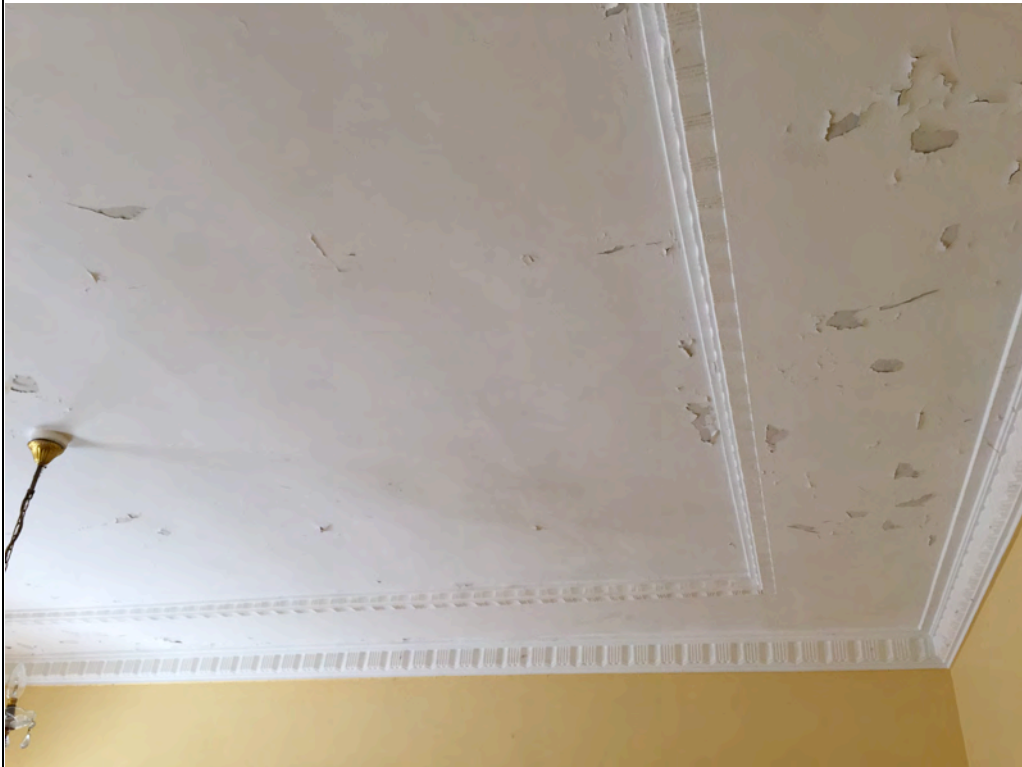
Cracked and paint deteriorated ceiling to the living room.

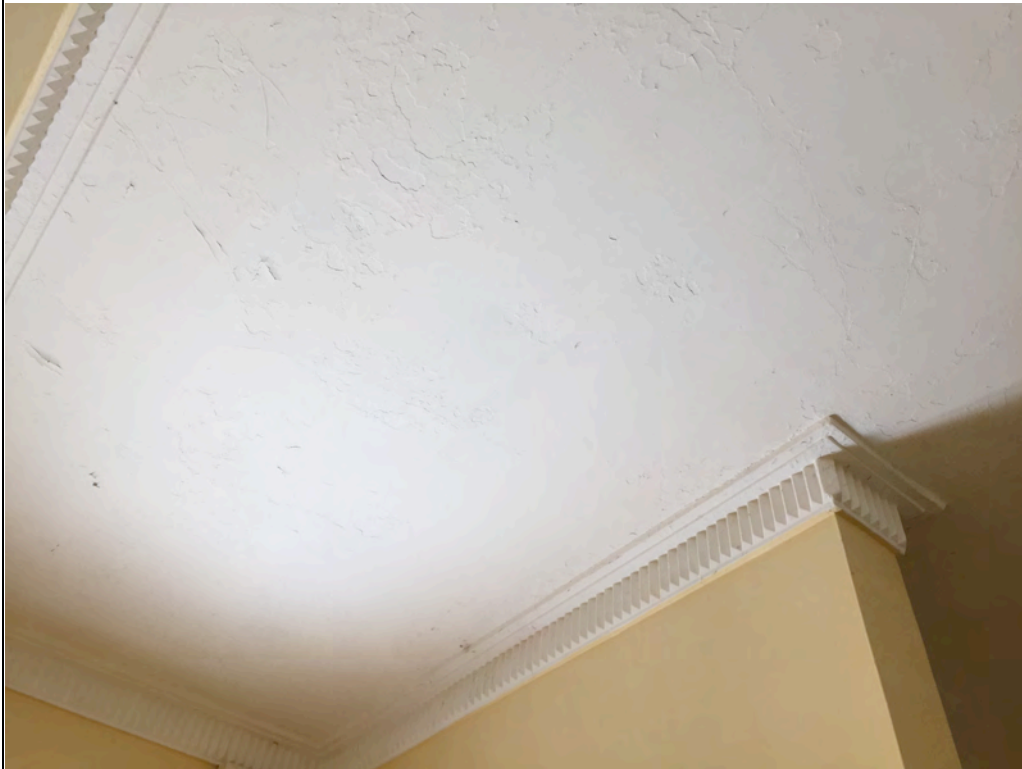
Paint deteriorated ceiling to the hallway.

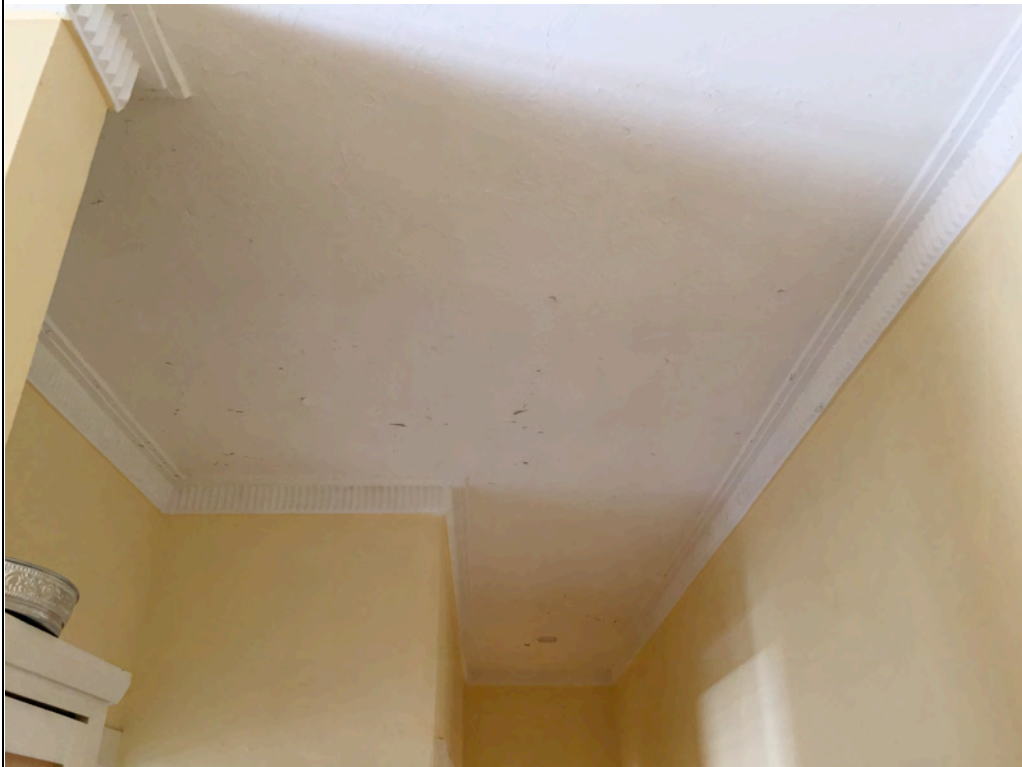
Paint deteriorated ceiling to the hallway.

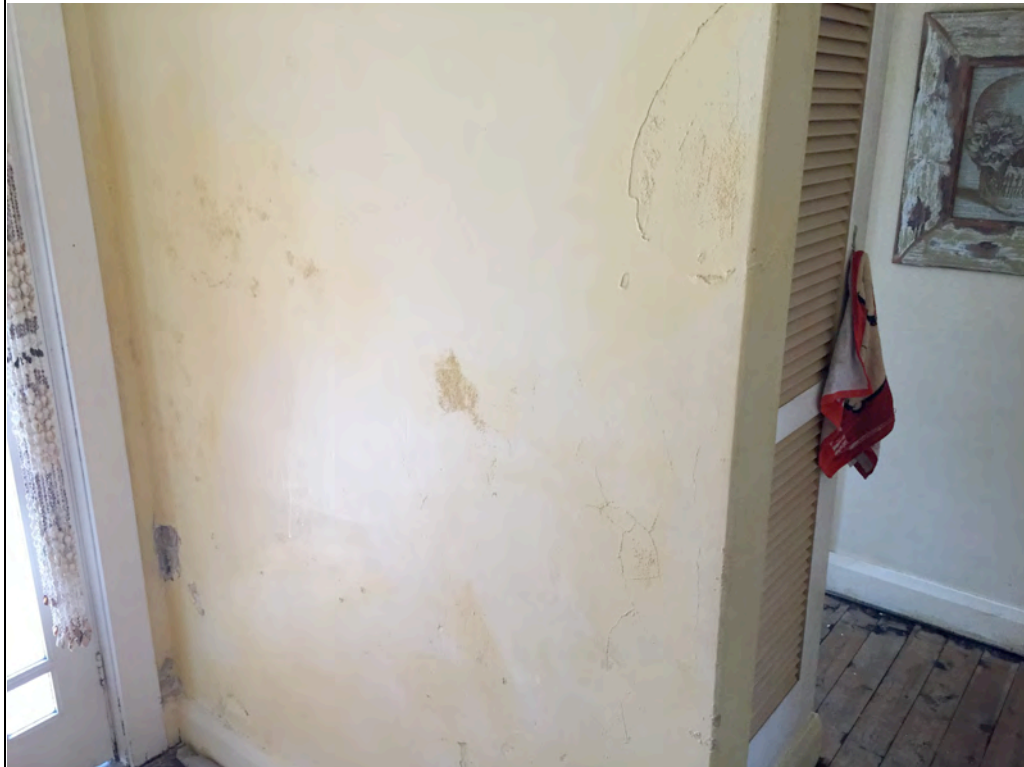
Moisture damage to the wall of the front entrance area.

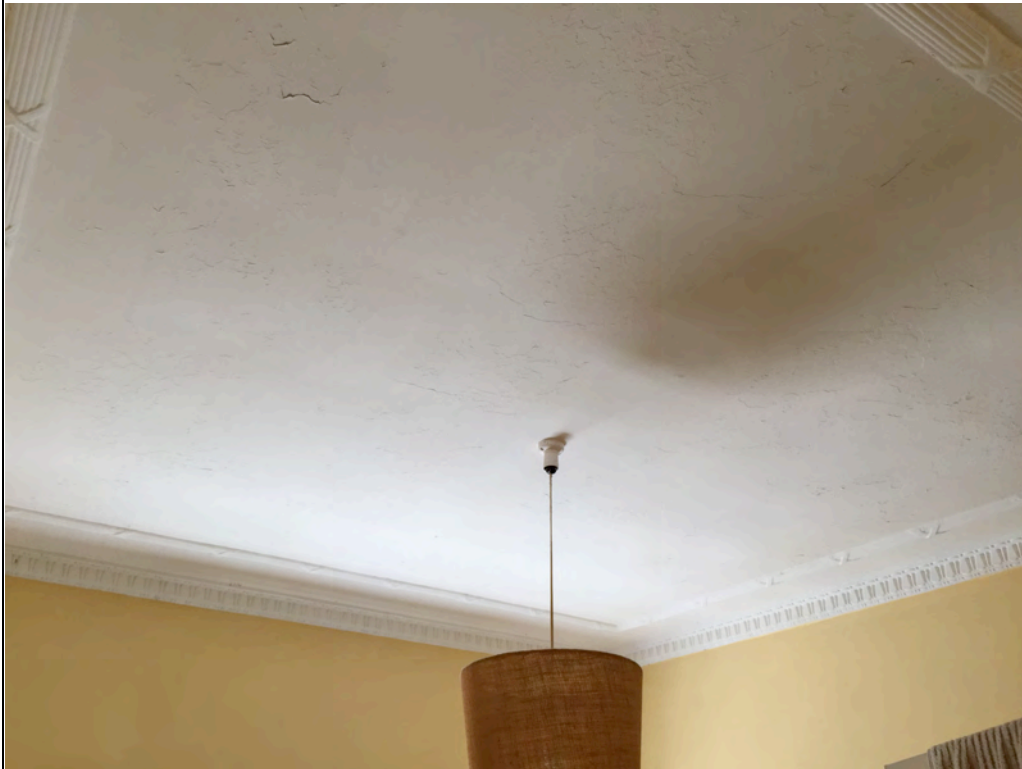
Paint deteriorated and cracked ceiling to the second bedroom.

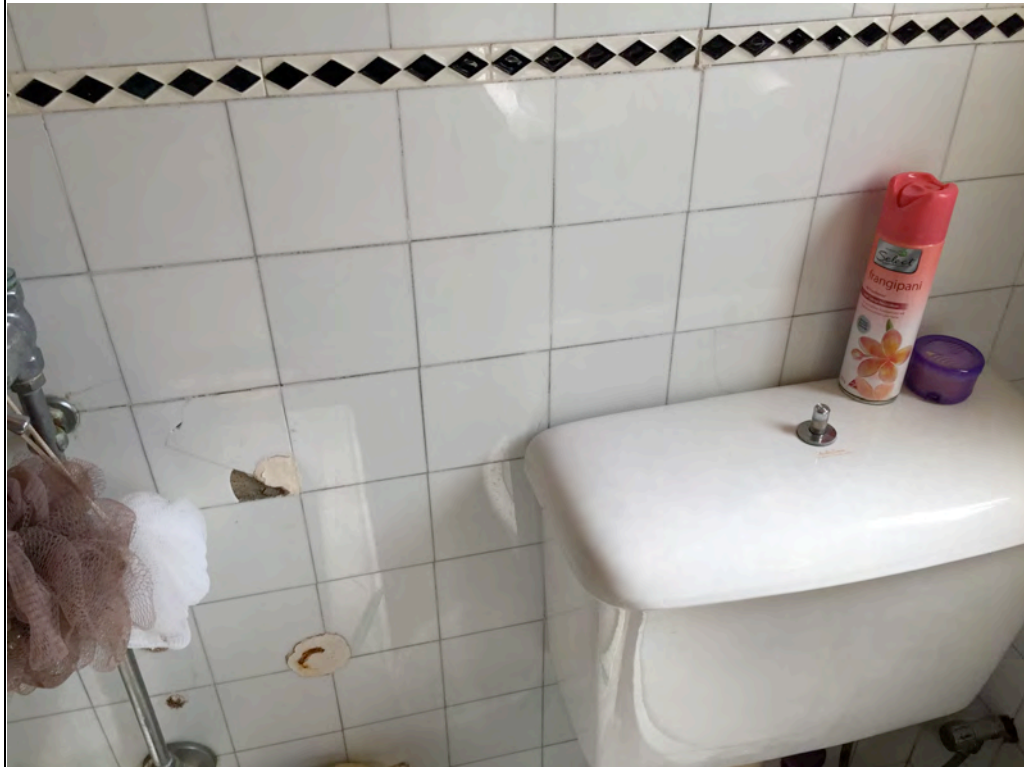
Tiling throughout the bathroom has become drummy in areas. A number of tiles are cracked and missing throughout.

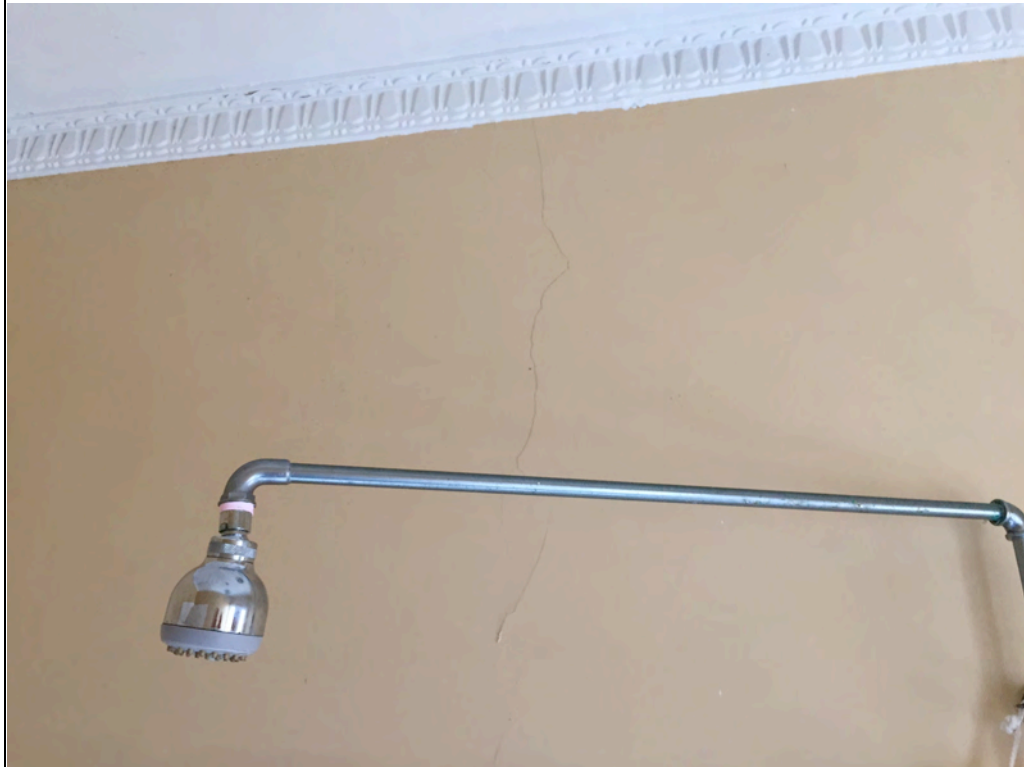
Vertical crack to the front wall of the bathroom.

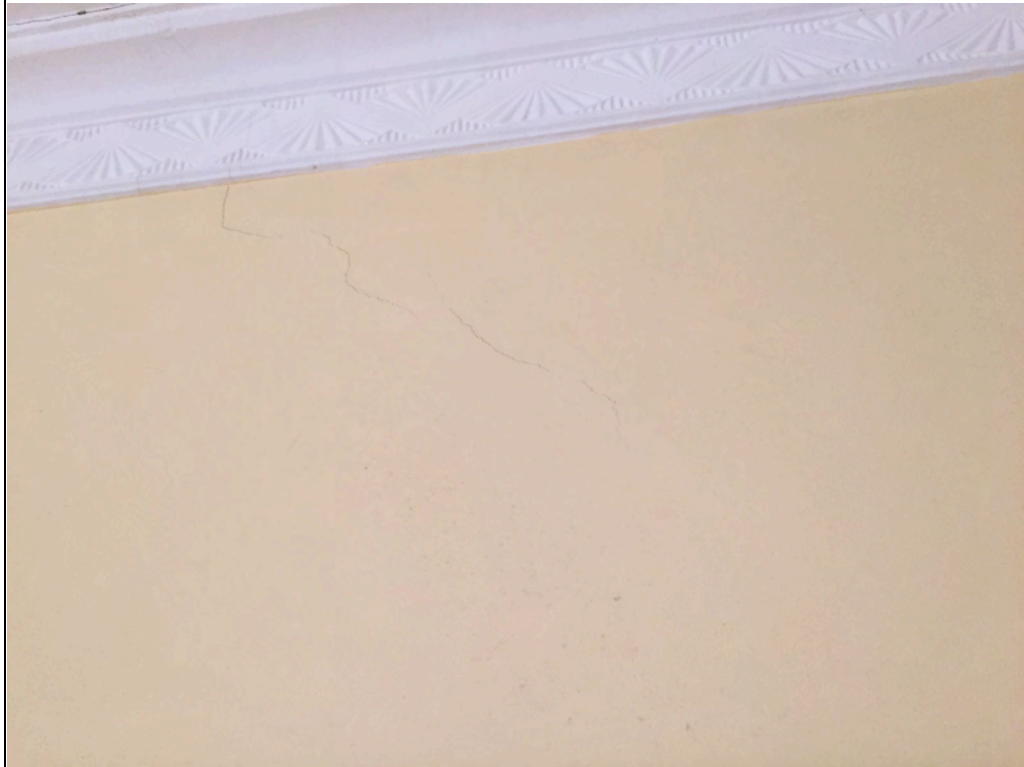
Hairline diagonal crack to the rear wall of the main bedroom, approx. 500mm left of the bedroom door.

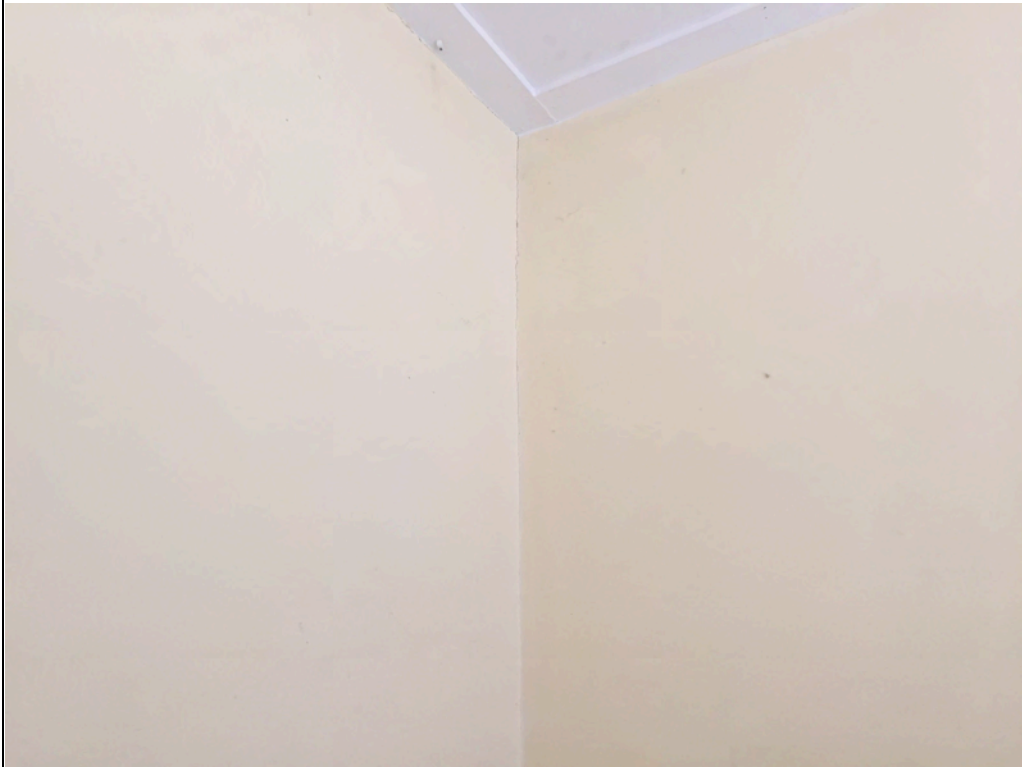
Vertical hairline crack to front enclosed balcony at the rear right corner.

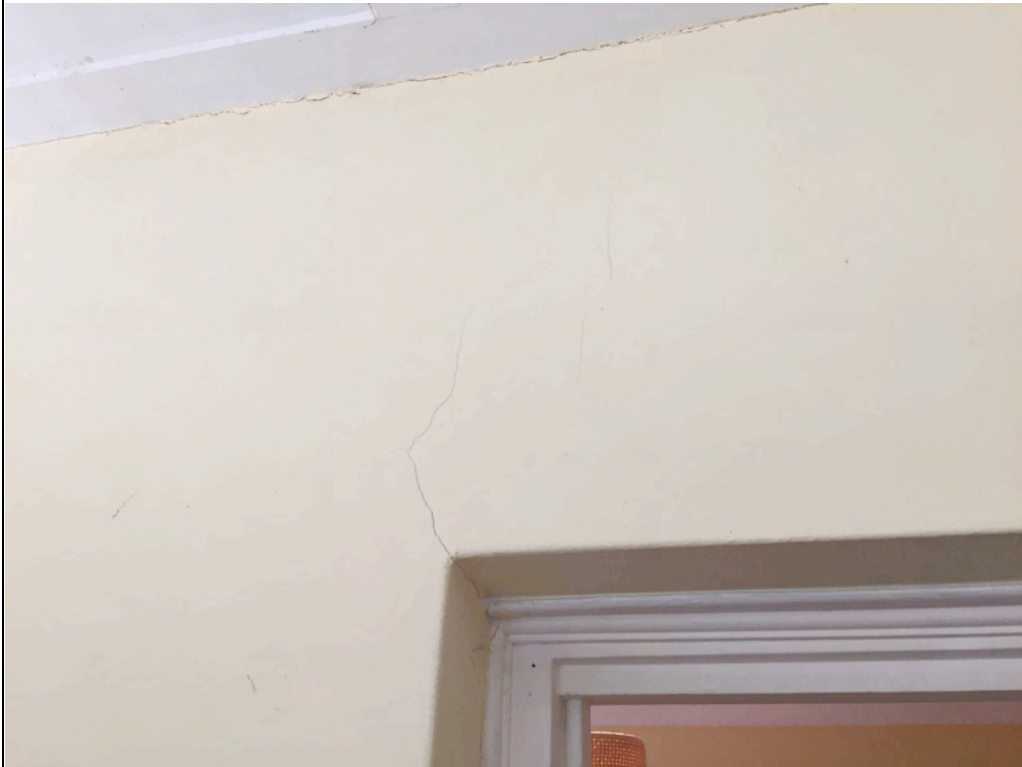
Hairline crack above front enclosed balcony door at the top left corner.
